## IN-PLACE METAL STITCHING SALVAGES ANOTHER BADLY DAMAGED ENGINE BLOCK

### GOLTENS METAL STITCHES YANMAR 6EY26L BLOCK FOR MAJOR CONTAINERSHIP OWNER

Location:	Dubai, UAE
Vessel Type:	Container Ship
Engine Make/Model:	Yanmar 6EY26L
Year Built:	2010
Tonnage:	26,030 DWT

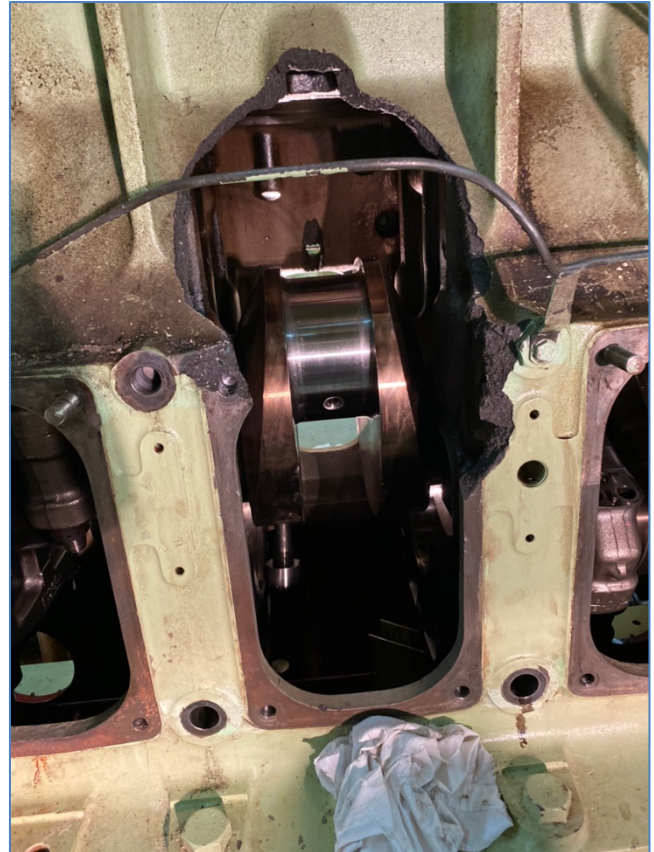
Inspection revealed that the connecting rod bolts on one of the cylinders were loose and gave way and that the resulting hole above the inspection door was substantial in size. Additionally, the pieces of the block that were broken away from the engine were not substantial enough to be stitched together. In addition to the damaged inspection door, the lower liner landing surface was also damaged.

Figure 1: Damaged section of engine block from conrod failure

Goltens removed obstructions for clear access to the damaged area and carefully measured the affected sections to determine a repair protocol. For the lower liner landing surface, line boring that area and inserting an oversized sleeve was proposed. For the inspection door damage, Goltens proposed the fabrication of a cast insert that could be metal stitched into the block for a permanent repair. Goltens created a 3D model of the complicated insert and mobilized tools and technicians to complete the repairs.

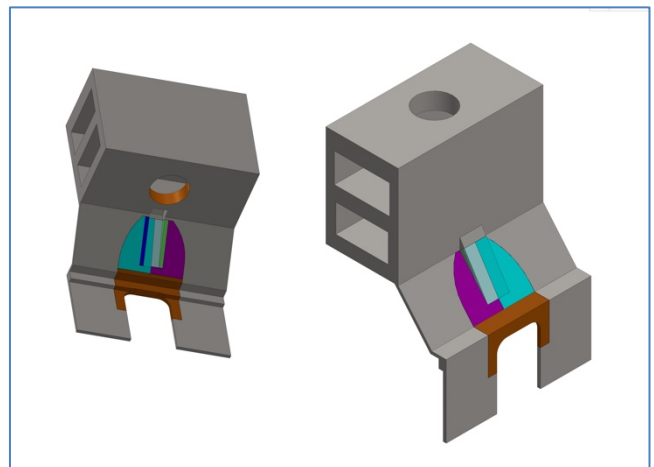
Figure 2: 3D Model of block insert

Goltens' specialists cropped out a clean area to match the shape and dimensions of the modeled insert. The new multi-dimensional insert was fabricated to match the 3-D model that was created.

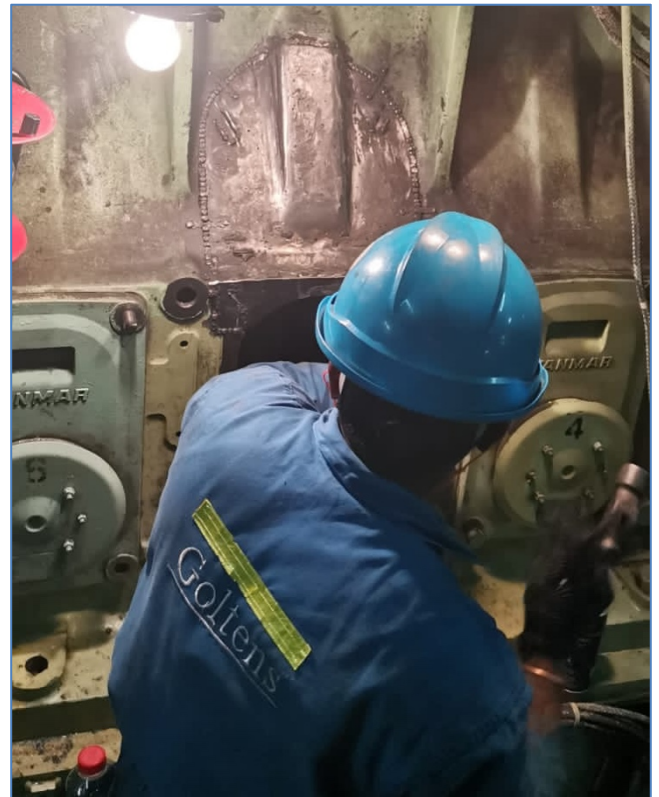
Figure 3: Stitching and locking complete-Peening in process

The fabricated insert was positioned and held in place with temporary stiffeners. Using a jig, the holes for the stitching pins were drilled and tapped and stitching pins installed to draw the sides of the cracked surfaces together. To reinforce the repair to the surface's original strength, locks are then inserted drilling and tapping with precision jigs such that the locks are inserted into place perpendicular to the cracks.

To restore the surface to its original condition and normalize the characteristics of the repair, the stitched surface was peened and ground level to the adjacent block surface. Once completed, die penetrant testing was completed across the entire surface to ensure no cracks remain and the repair is complete.

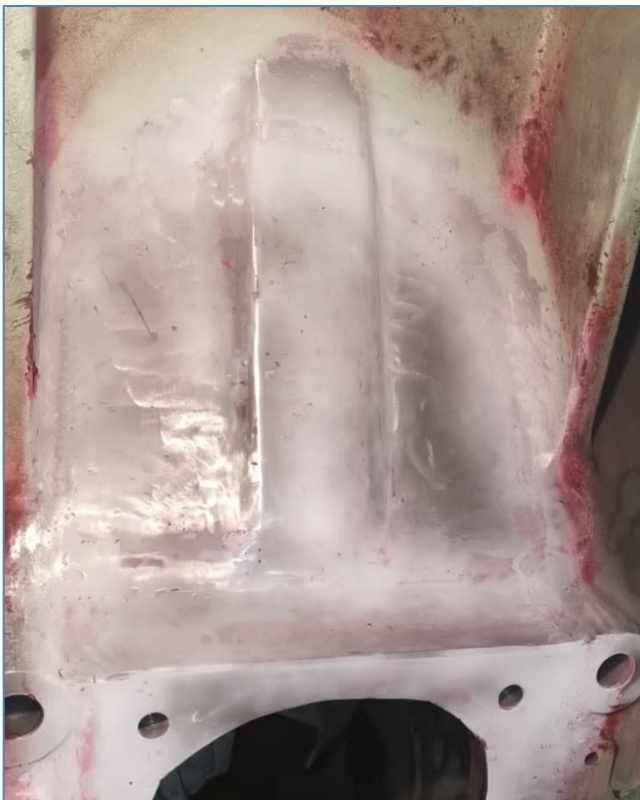
Figure 4: Die penetrant crack test of repaired surfaces

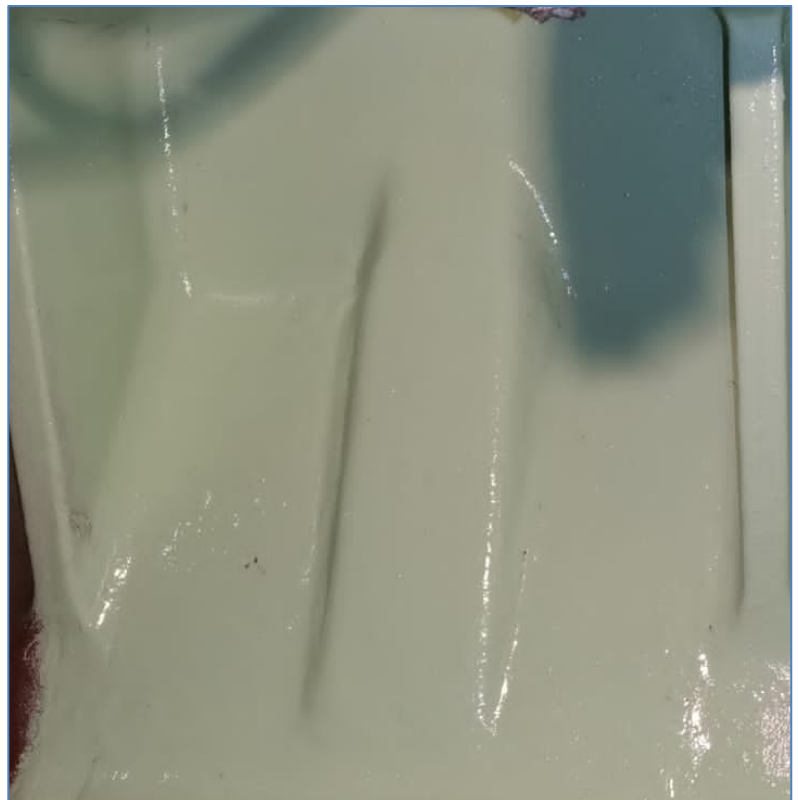
Figure 5: Metal stitched area after painting

As a final step, holes for the crankcase door were tapped with a magnetic drilling machine and the repaired surface painted. The engine was then put through satisfactory operational trials at full load.
