A COMPLETE ENGINE REPAIR JOURNAL GRINDING, ANNEALING, LASER ALIGNMENT, LINE BORING AND ENGINE REBUILD

PROJECT FACTS: SWD 8SW280

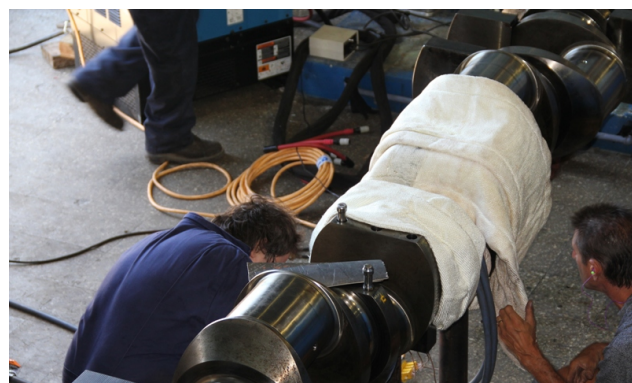
Induction Annealing Equipment being set up

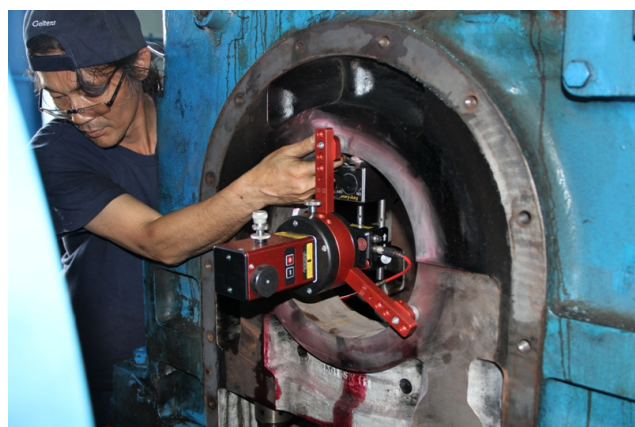
Laser Alignment check of bore prior to Line Boring

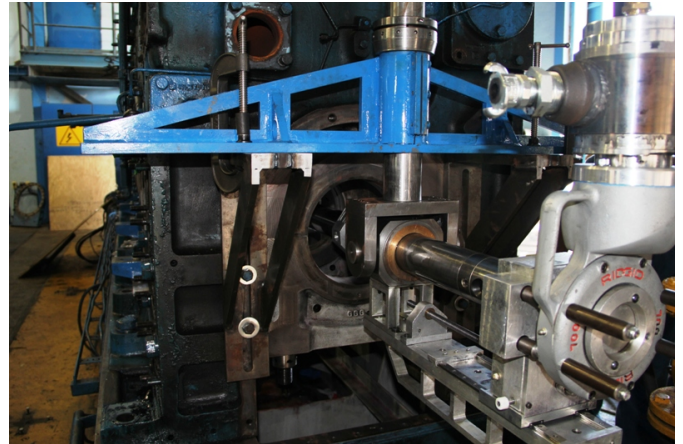
Line Boring Equipment installed for machining

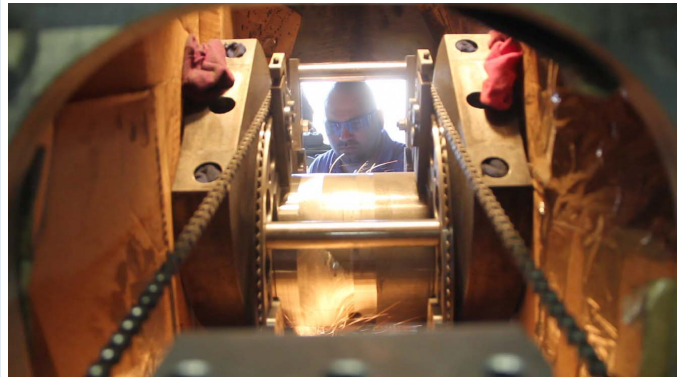
Grinding of crankpin In-Situ
