# IN-SITU MACHINING OF CYLINDER LINER LANDING SURFACES

# IN SITU MACHINING KEEPS DREDGER ON SCHEDULE

Vessel: M/V HONG XIANG JUN

Engine: PIELSTICK 12PC2-5V, 4 units × 5360KW

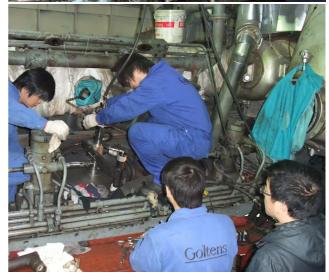
Suffering from frequent combustion gas leakage of No.4 and No.5 cylinder, ship owner requested Goltens to survey and clean up before the cutter-suction dredger was set to sail to carry out its dredging contracts. Goltens' survey revealed that the landing surfaces of cylinder liners had been damaged and required in-situ machining, and flatness checking.

- Flatness checking of No. 4, 5 and 6 cylinder covers with laser equipment;
- Grinding of landing surfaces of No. 4 and 5 cylinder liners
- Grinding of fitting surface of No. 4 and number 5 cylinder covers
