IN-SITU MACHINING OF PROPELLER HUB

IN-SITU MACHINING AVOIDS COSTLY SHOP REPAIR AND EXTENDED DOCKING

PROJECT FACTS: PROPELLER HUB

Vessel:	M/V XIN YA ZHOU
Engine:	MAN B&W 12K98MC-C
Tonnage:	102,396 DWT
Hub Outside Diameter:	1600.00mm
Hub Inside Diameter:	1393.00mm

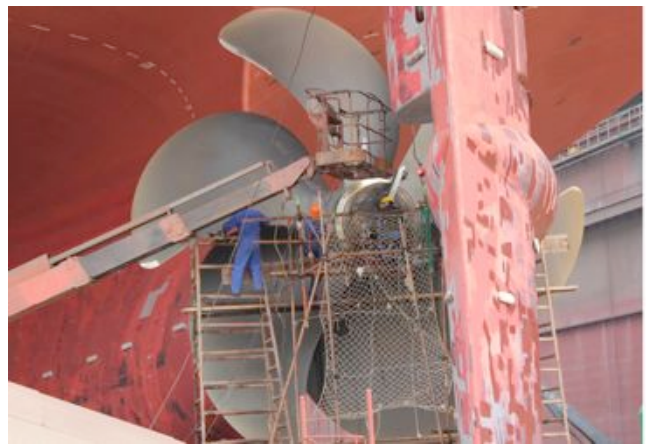
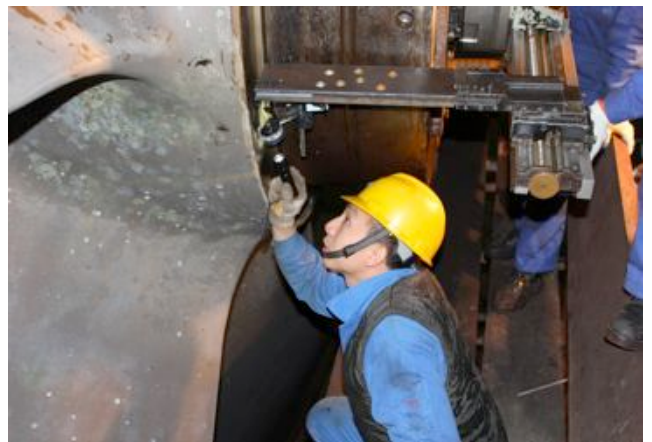
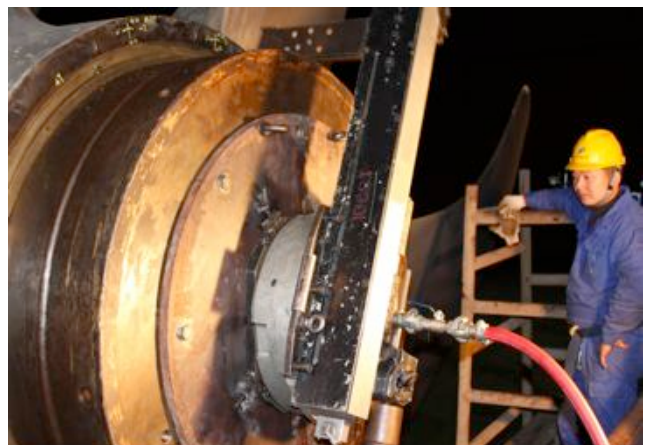
Goltens was contacted to evaluate damage observed on a drydocked vessel during a yearly propeller survey at CSIC shipyard. Goltens was engaged and performed a visual evaluation of the hub followed by dye penetrant checks to determine if there were cracks on the hub as well as the wear and scraping observed.

Inspection revealed that the hub did require reconditioning and Goltens proposed that the repair be done in-situ to avoid the cost and time associated with disassembly and reassembly of the propeller as well as avoided transport costs and extended docking time.

- Dye penetrant checking for cracks on propeller hub;
- Flatness checking of fitting surface;
- Machining off 1.00 mm on propeller hub
- Finishing polishing.
