IN-SITU MACHINING OF STERN TUBE HOUSING

**QUICK RESPONSE AND EXPERT SERVICE
ALLOWS VESSEL TO KEEP ITS DRYDOCK
SCHEDULE**

PROJECT FACTS: STERN TUBE BORING

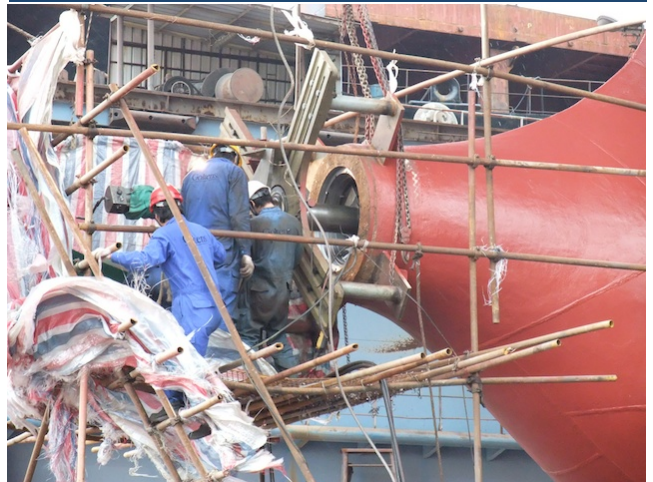
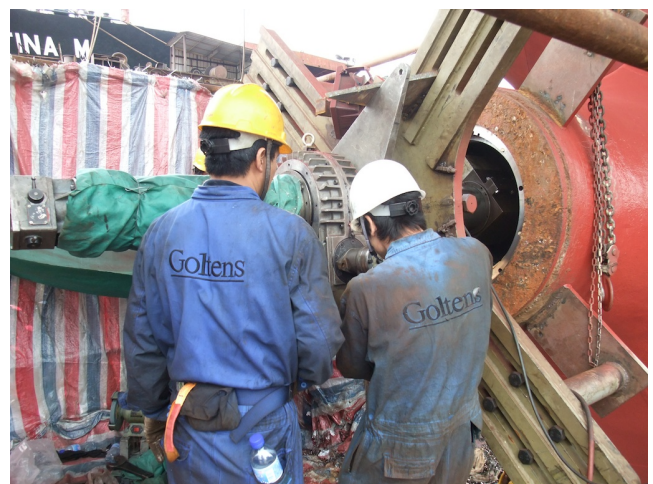
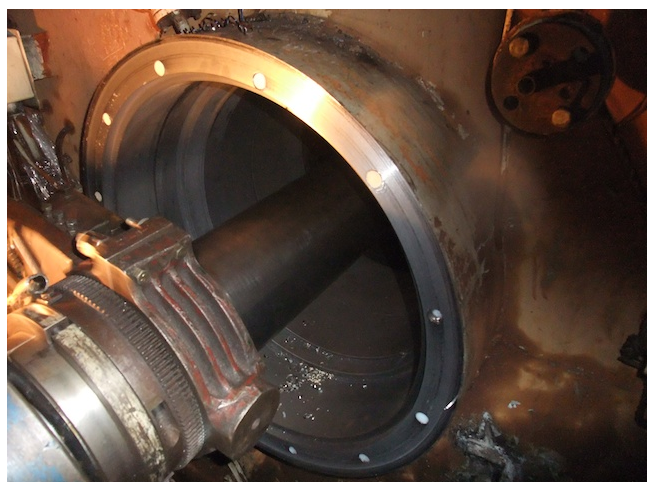
Goltens performed a thorough inspection, boring and post boring inspection on the housing.

- Full inspection and cleaning of stern tube housing.
- Laser alignment checking of whole propeller shaft line from flywheel of M/E to stern.
- Boring the FWD stern tube housing to oversize 4.03mm.
- Boring the AFT stern tube housing to oversize 6.00mm.
- Measuring and checking of the final dimensions.
- Laser alignment checking of whole propeller shaft line again for double checking.
- Finish polishing by machine.
