WHEN BORING IS INTERESTING LINE BORING MAN B&W 12K80MC

PROJECT STATS: GUAM POWERPLANT

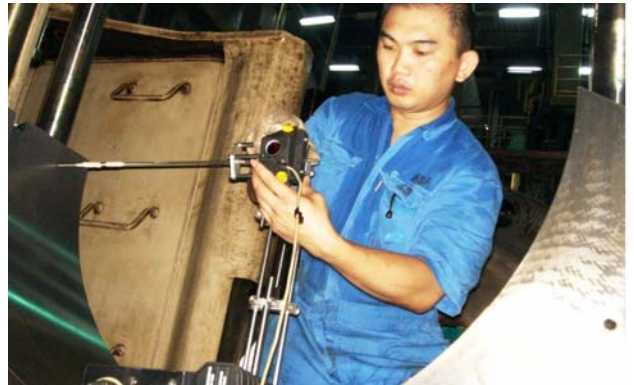
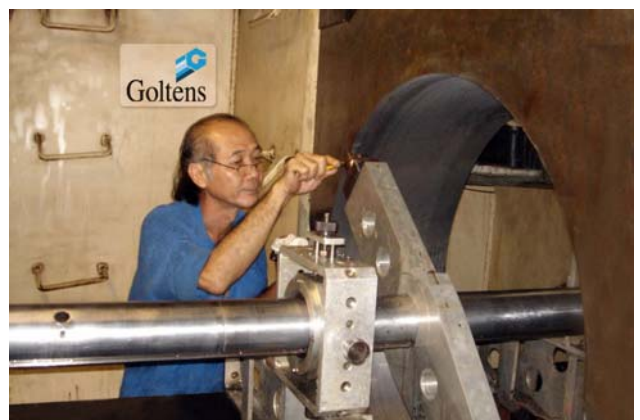
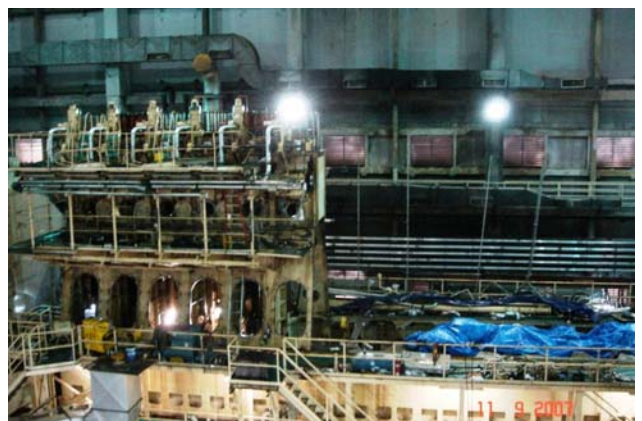
Having carried out major engine overhauls in the area in the past, it was no surprise when Goltens was awarded the contract to line bore an MAN B&W 12K80MC engine at a power plant in Guam, Micronesia. The plant had suffered a casualty that damaged one of the engine's main journals and damaged one of the bearing pockets.

Goltens Singapore first completed in-situ machining of the damaged crankshaft main journal in the agreed time and to the engine maker's satisfaction. Following this, a solution was proposed and agreed to regarding repair to the damaged bearing pocket and collapsed saddle. The solution involved removal of the crankshaft from the engine to create sufficient space for machining.

A complete inspection was then carried out, confirming the need for oversize machining of one bearing pocket as well as the correction of landing faces in order to achieve good contact before further machining. The in-situ boring bar was then mounted in the correct position using laser alignment tools, and the line bore was completed within two days.

- Assessment and laser alignment check of the all main bearing pockets.
- Correction of the main bearing pocket horizontal contact landings in way of the bearing top cap and bedplate.
- In-situ boring of the one main bearing pocket to engine maker tolerance.
