CRANKPIN JOURNAL MACHINING AND ANNEALING MAN MITSUBISHI 9V 40-54 – ANNEALING SAVES ANOTHER DAMAGED SHAFT

PROJECT FACTS: MAN MITSUBISHI 9V 40-54

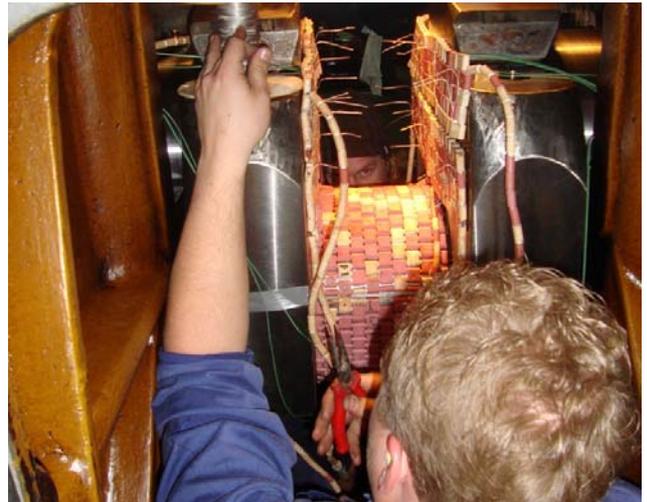
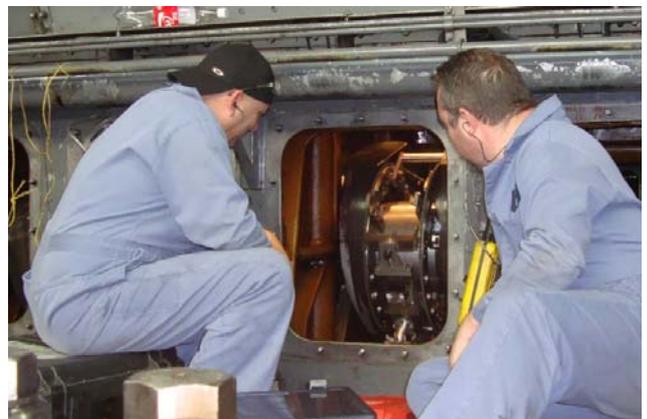
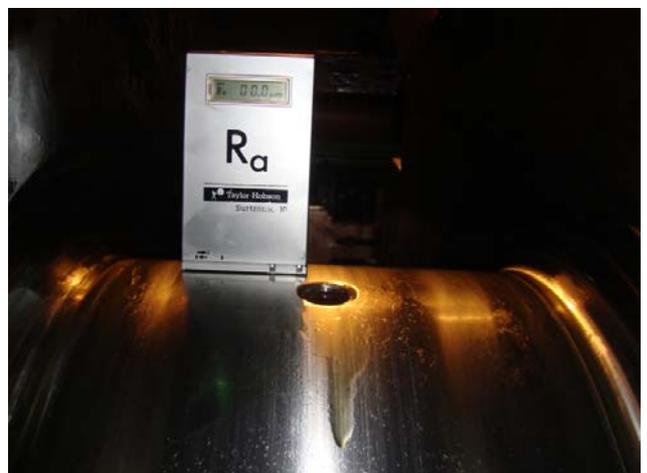
A power plant suffered a severe accident involving one of their generators. Assessment of the Crankpin journal #5 showed that the big end bearing had failed and damaged the crankpin journal surface. The Crankpin journal surface was scored and blued by the heat generated during the bearing failure. Mechanical damages with a depth of more than 0.40mm were found. Big end bearing material was “welded” up on the Crankpin journals surface.

Magnaflux and hardness testing showed heat cracks all around the circumference of the Crankpin journal surface and severely hardened areas of more than 650 Brinell. Goltens machined the journal surface clean in order to verify there were no larger cracks underneath the bearing material residue.

Since the hardness values and the size of the hardness area itself barely changed during the first 3.00mm, and maximum reduction of 5 mm is allowed by the maker, Goltens advised annealing in order to save the shaft. Goltens annealed the crankshaft reducing hardness from 650 Brinell to between 250 and 300 Brinell and finish machined the journal at 316.00 mm (-4.00 mm).

Goltens also peened the shaft to straighten it as run out on the adjacent main journals (straightness) was more than 0.10mm

- Annealing of the CP Journal #5 in – situ
- Machining of journal to final size of 316.00mm
- Straightening of the shaft
- Fillet radii machined under journal surface
- Lube oil holes rounded off and polished
- Journal polished to 0.3Ra
