THRUST COLLAR BEARING MACHINING

HYUNDAI MAN B&W 80MC

PROJECT FACTS: THRUST COLLAR BEARING

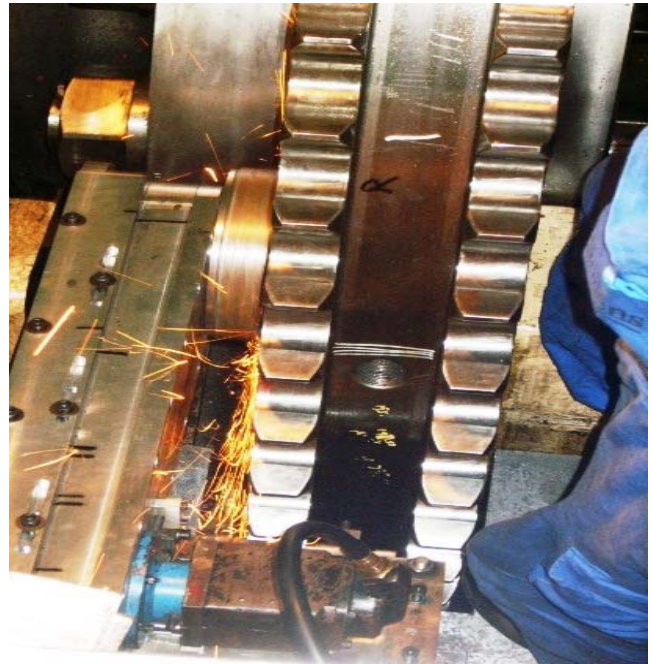
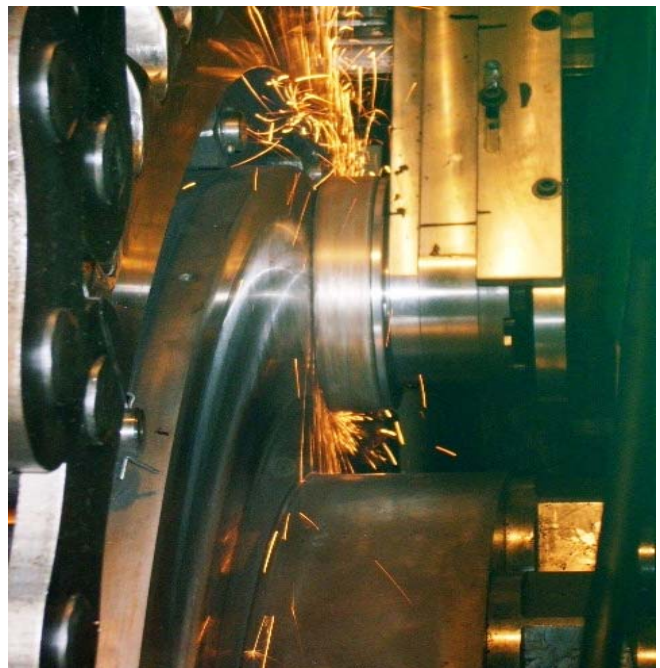
Goltens technicians dismantled the chain drive for the cam shaft prior to grinding the damaged thrust collar surface, and rebabbited the thrust bearing pads to oversize. After reassembly, Goltens completed a successful sea trial with the vessel superintendent and engine maker representative.

- Dismantling thrust bearings/removal of chain drive to cam shaft.
- In-situ machining of the thrust collar surface on the crankshaft.
- Inspect for high hardness on damaged collar
- Removal of all surface cracks and magnaflux inspection
- Rebabbing of the thrust pad and final machining.
- Assembly of thrust bearing and chain drive.
