IN-SITU CRANKSHAFT MACHINING

6RT-FLEX-50B CRANKSHAFT REPAIR

PROJECT STATS: Wartsila 6RT-FLEX 50B

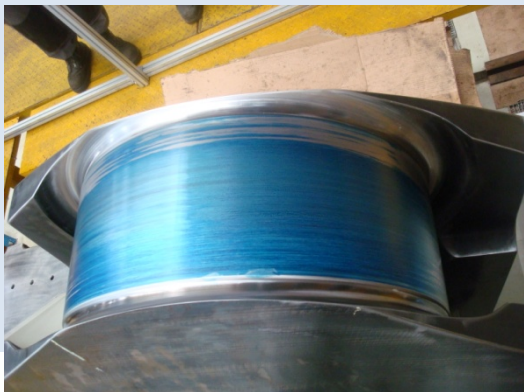
Repaired Crankpin after machining and blue fitting

Goltens immediately mobilized an experienced team and a wide array of tooling to deal with the compact space available to machine the crankshaft. As the fillet radii were not true, the crankshaft had to be installed in the bedplate to provide a reference for the machining of the fillet radii. Once completed, Goltens then machined the damaged crankpin to a perfect finish diameter of 598 mm.

- Assessment of fillet radii (which were out of line due to the shaft manufacturing process)
- Machining new fillet radii for reference
- Machining crankpin journal to undersize 598 mm
- Manufacture of bluing and lapping dummy
- Super polishing by machine

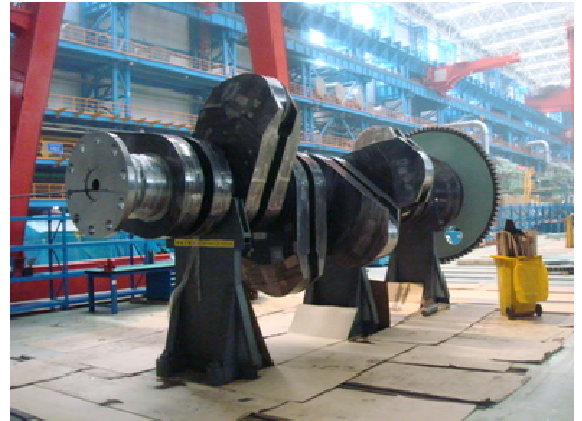
Accidents happen in shipyard and factory environments, and when a forklift operator accidentally drove into a new Wartsila 6RT- Flex-50B crankshaft in China, a 600 mm crankpin was damaged and repairs needed to be done and done quickly.

Flex50 Crankshaft in position where damage occurred

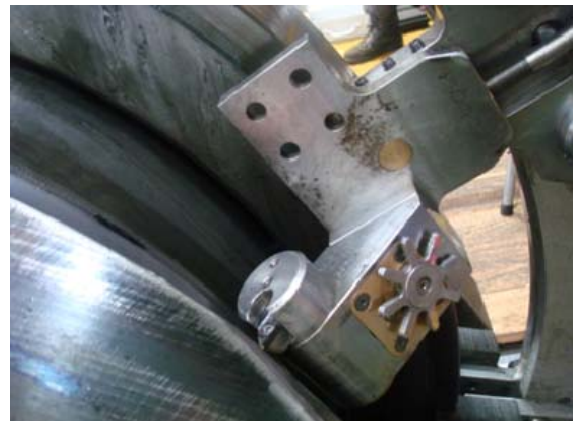
In Situ Machining of new Fillet Radii

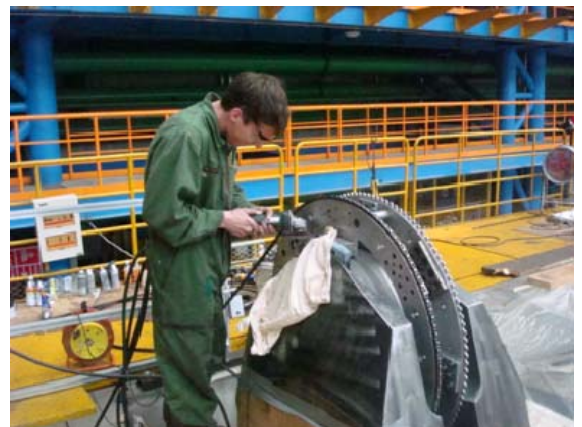
Goltens In Situ Machinist machining damaged Journal
