MAIN ENGINE BEDPLATE & INTERMEDIATE BLOCK REPLACEMENT ABOARD 30 YEAR OLD LIVESTOCK CARRIER

MAK 6M551AK BEDPLATE REPLACEMENT

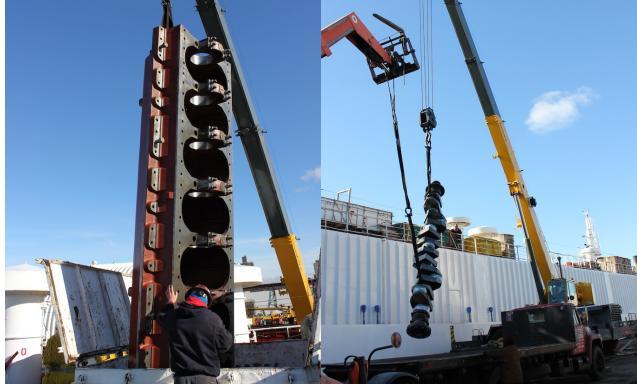
Rigging replacement bedplate and inspected crankshaft aboard for installation
