OVERHAULING OF 10MW STEAM TURBINE & GENERATOR SET BY GOLTENS INDIA

LONG LEAD TIME AND COST LEADS TO COMPLETE OVERHAUL OF TURBINE IDLE FOR 10 YEARS

PROJECT FACTS: STEAM TURBINE GENERATOR Location: Goltens India Workshop, Mumbai Rating: 10MW Years Idle: 10 Years

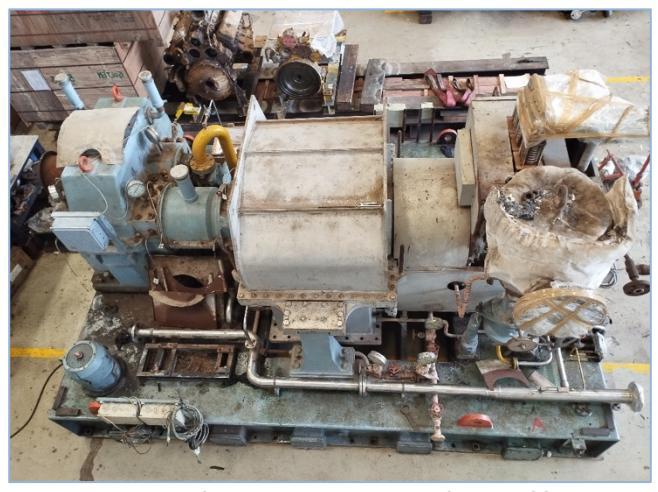
Figure 1: Steam Turbine Generator prior to disassembly

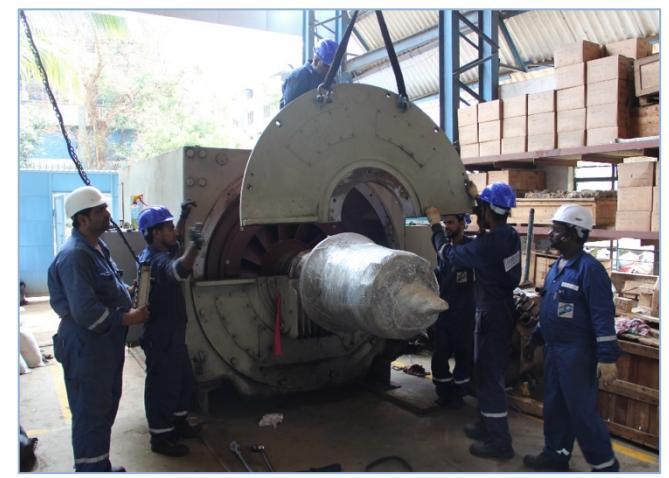
Figure 2: Dismantling of generator

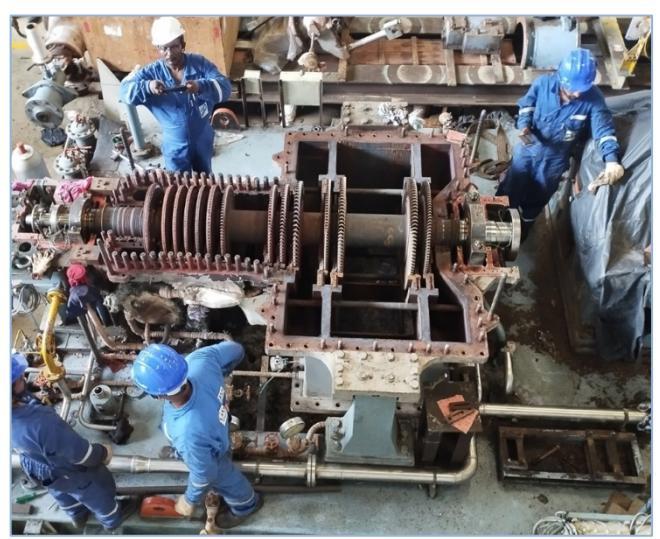
Figure 3: Disassembly of Turbine

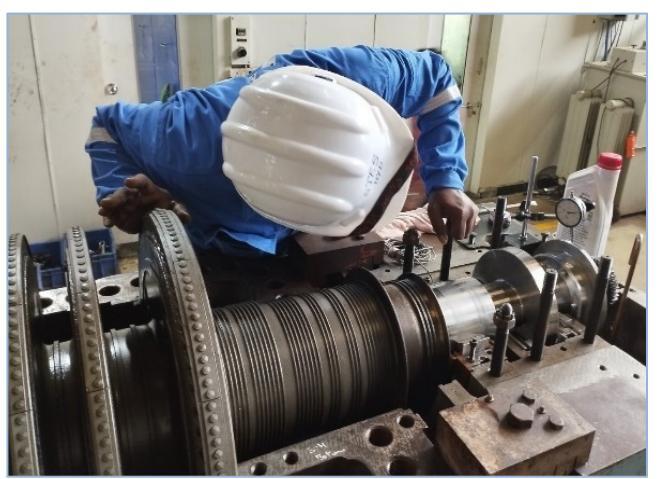
Figure 5: Run out checks on Rotor

After replacement of 8 damaged turbine rotor blade stages, dynamic balancing, and reassembly, run out and clearances were checked and brought within OEM allowed tolerances. Blue contact checks were completed and a joint inspection with the customer and the end user was successfully completed. The entire generator set was then sprayed with a preservative coating and reassembled.

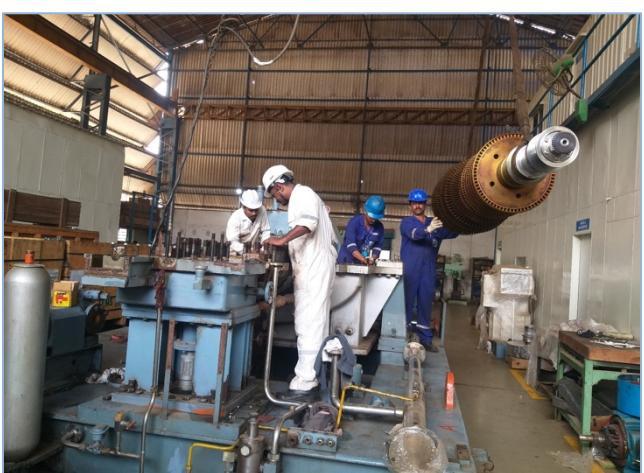
Figure 6: Assembly and blue fitting of diaphragm

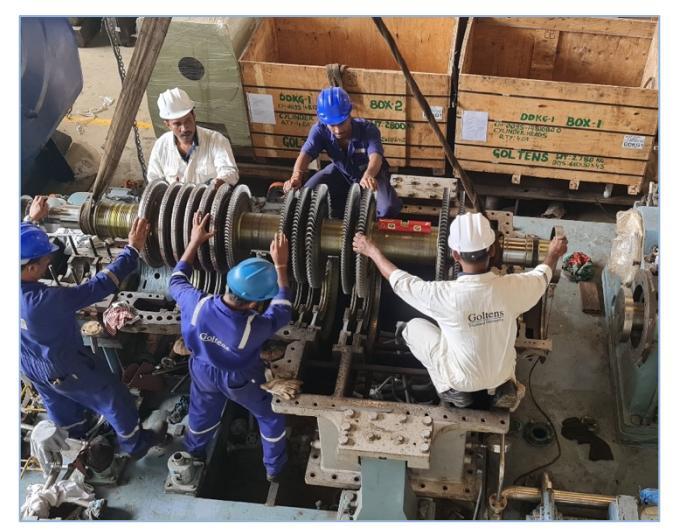
Figure 7: Clearance checks on rotor placement

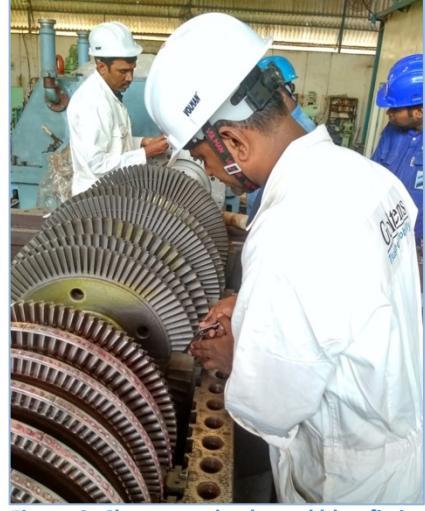
Figure 8: Clearance checks and blue fitting

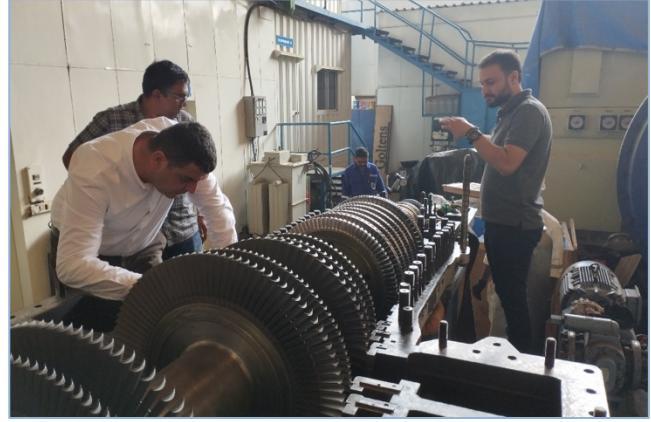
Figure 9: Joint inspection by customer and end user

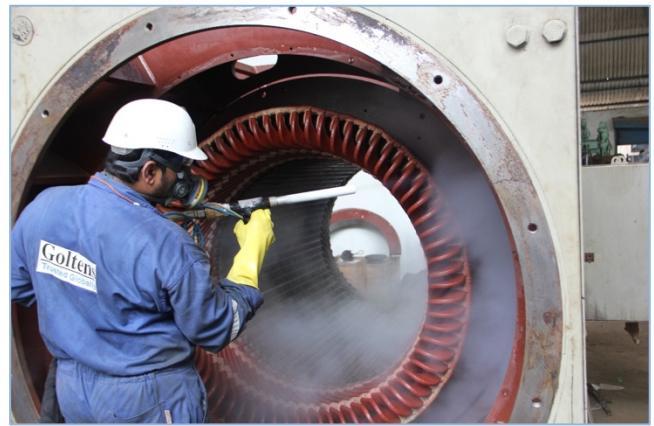
Figure 11: CO2 Cleaning of generator stator

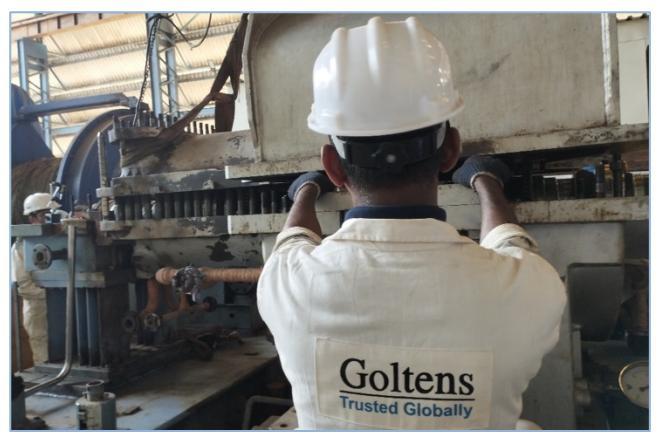
Figure 10: Assembly of turbine

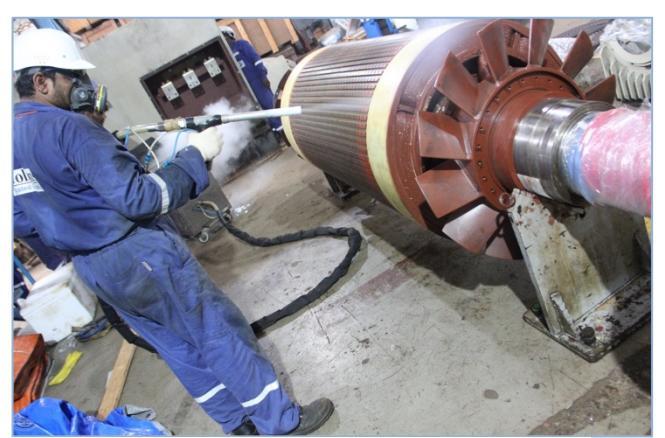
Figure 12: CO2 Cleaning of generator rotor

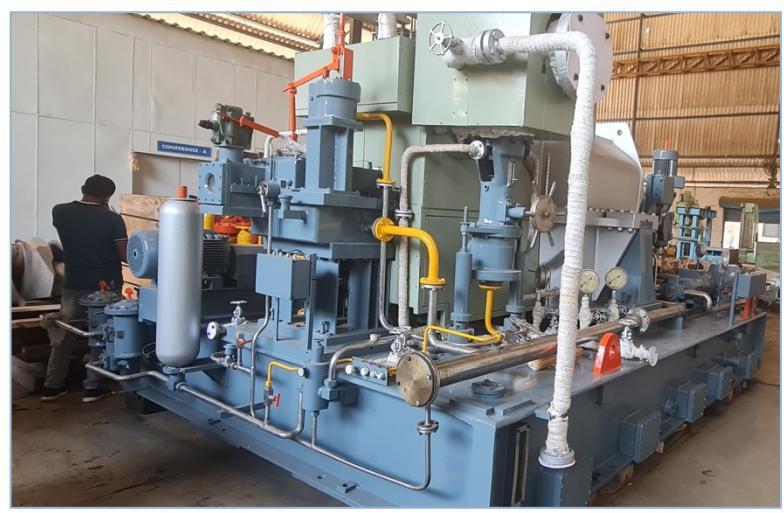
Figure 13: Fully reconditioned steam turbine ready for dispatch
