IN-SITU ANNEALING SAVES CRANKSHAFT CONDEMNED BY THE ENGINE MAKER MAN B&W 6L48/60 MAIN ENGINE CASUALTY

PROJECT FACTS: MAN 6L48/60 ANNEALING

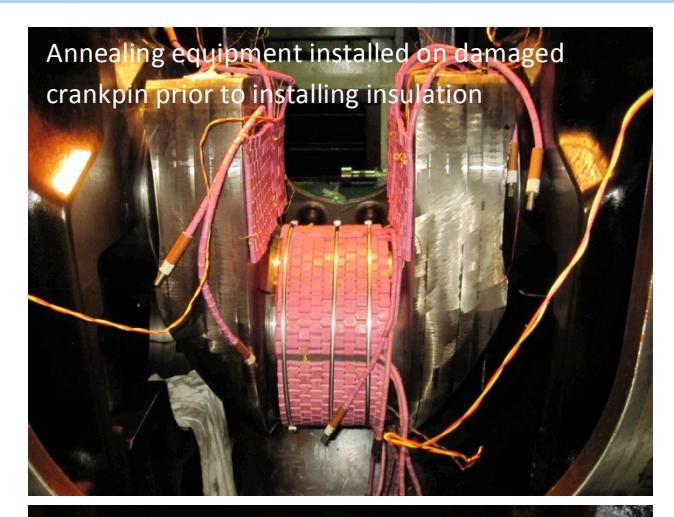
Post annealing hardness reduced to <300 hB

Once preparations were taken care of, Goltens completed the annealing of the crankpin and subsequent testing showed that the hardness had been successfully reduced to below 300 Brinell. The shaft was then carefully peened and the straightness of the shaft was restored. Goltens then set up its single-point cutting tools, finished machined the journal to -5mm and then machine polished it to its finished surface.

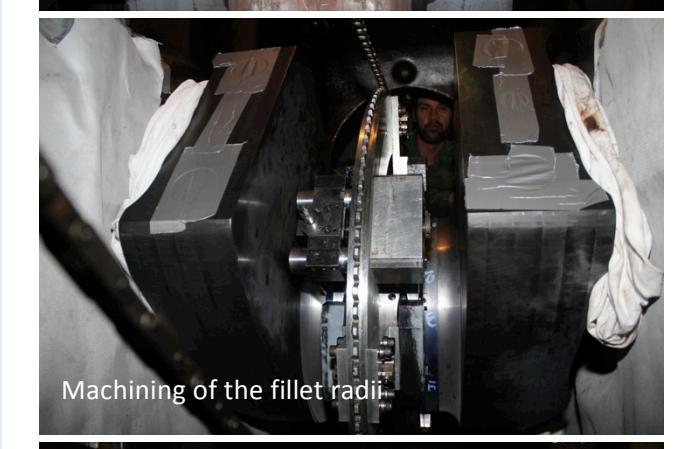
Finish machining of the crankpin post annealing – crankshaft saved at 410.00mm (-5.00mm)
