# TIME WASTED - SHOULD HAVE WAITED FOR GOLTENS

## GOLTENS RECTIFIES DAMAGED INTERMEDIATE PROPELLER SHAFT AFTER COMPETITOR FAILS

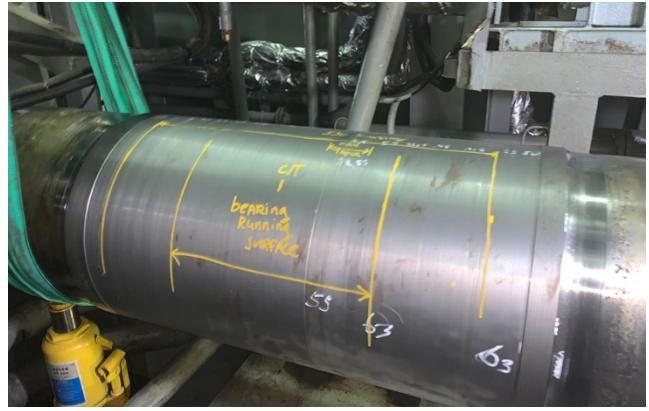
Upon inspection, Goltens found multiple scoring marks from the failed machining, as well as taper that ran 350mm along the shaft length with high ovality. Radius grooves were machined at the edge of the shaft for alignment of the in-situ machines and Goltens proceeded to remove 0.30mm from the shaft to correct ovality and taper. Once ovality was removed, a deep radial groove caused by the other company, remained on the shaft surface. This required Goltens to machine an additional 0.30mm prior to final honing and polishing the shaft surface.

Figure 1: Condition of journal after competitor failure

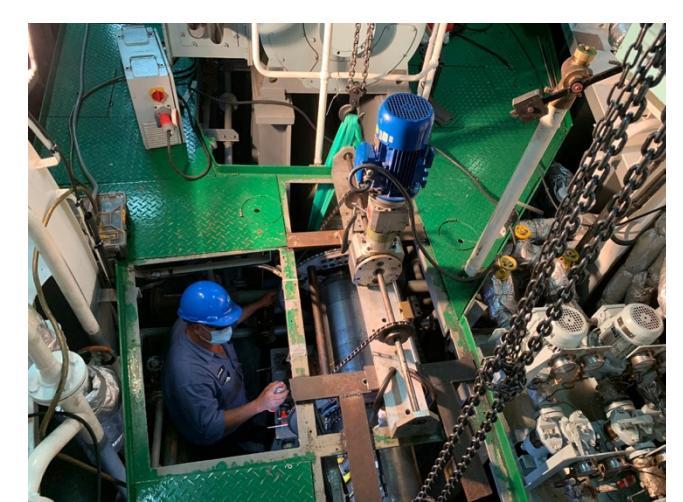
Figure 2: Journal machining in process with custom tooling

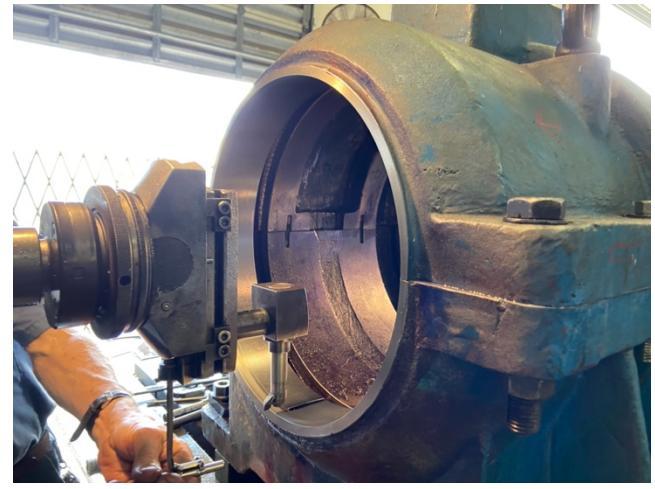
Goltens received the bearing housing in the workshop and set to work repairing it. The heat from the failure had caused the lower housing to collapse 0.8 to 1.0mm and the labyrinth seal cast into the housing was badly damaged. Goltens set to work machining the mating surfaces to restore flatness, along with machining out the forward and aft labyrinth seals. Final machining would be delayed until the finish diameter of the shaft and custom bearing shells was known.

Figure 3: Machining out the damaged labyrinth seals

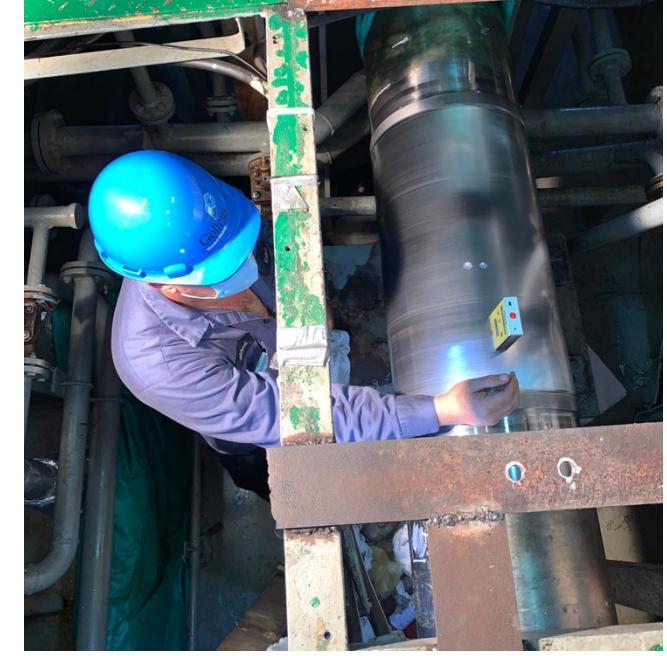
Figure 4: Checking surface roughness after journal polishing

Goltens finished the machining in seven days with a final diameter of 367.30mm. A custom bearing was machined to a +.55mm inside diameter, with cast iron labyrinth seal inserts fabricated and locked into the housing set to an inside diameter of 370.00mm.

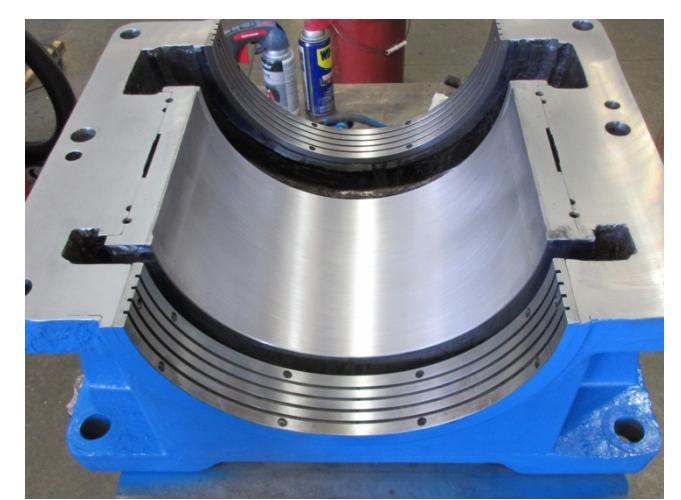
Figure 5: Bearing and Labyrinth seals installed

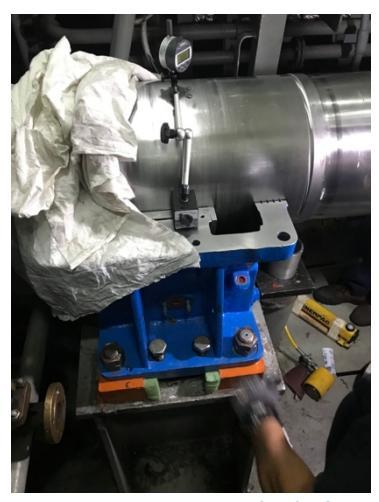
Figure 7: Lower Bearing Chocked undergoing jack test

Goltens then transferred the repaired pedestal bearing to the vessel and rigged it into place and aligned the bearing. A successful jack up test was then performed on the shaft with 6.3 tons before reaming the fitting bolt holes and installing the fitting bolts in place. Goltens then poured the Chockfast foundation and waited for the compound to cure before tightening the foundation bolts. Final scraping adjustments were made to the ensure the right clearance before a final jack up test was completed. The bearing was then reassembled and tested at low RPM with satisfactory oil flow.

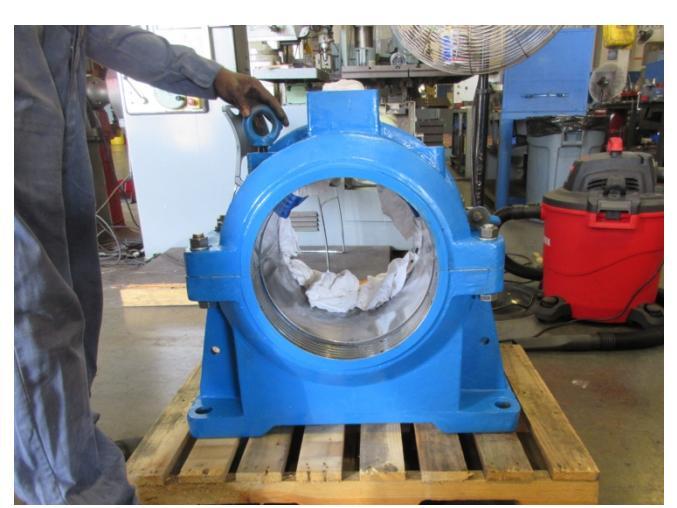
Figure 6: Bearing Housing repair complete

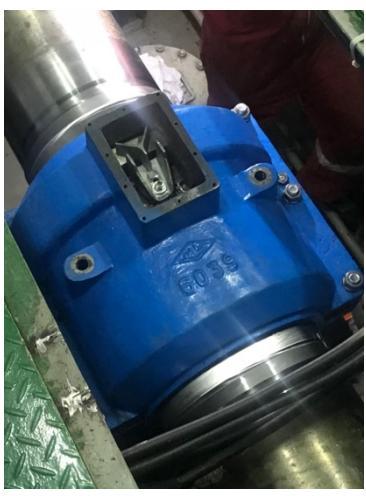
Figure 8: Upper housing installed – repairs complete
