# MAN 6L35MC MAIN-ENGINE **CRANKSHAFT REPLACEMENT MINIMIZES DOWNTIME FOR CHEMICAL TANKER**

## **INSPECTION LEADS TO COMPREHENSIVE REPAIR INCLUDING LINE BORING AND** SOURCING REPLACEMENT CRANKSHAFT

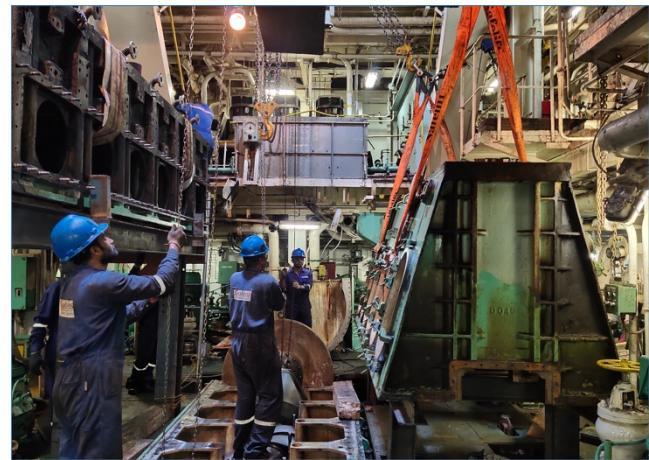
Block removed from bedplate to enable crankshaft removal

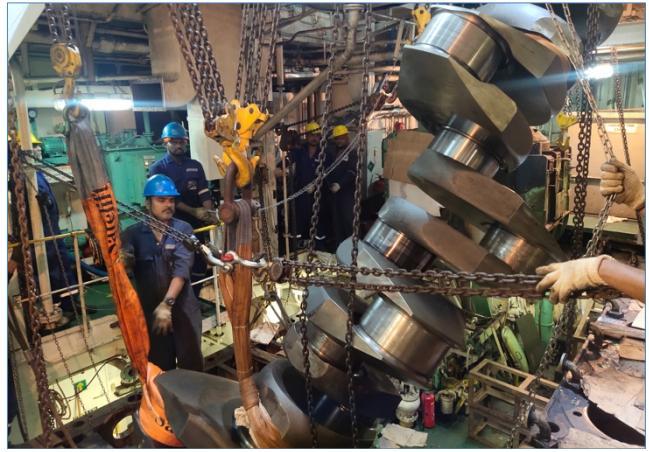
Goltens was engaged to inspect the main-engine crankshaft on a 23-year-old, 11,700-dwt chemical/product tanker anticipating that the crankshaft could be salvaged with insitu machining. The tanker had suffered major bearing failures on three of its main journals. Inspection revealed major damage to the running surfaces of the main journals that could not be rectified within the OEM's specifications. Goltens therefore recommended replacement of the crankshaft as well as a full inspection of the bedplate for potential replacement.

Rigging condemned crankshaft from engine room

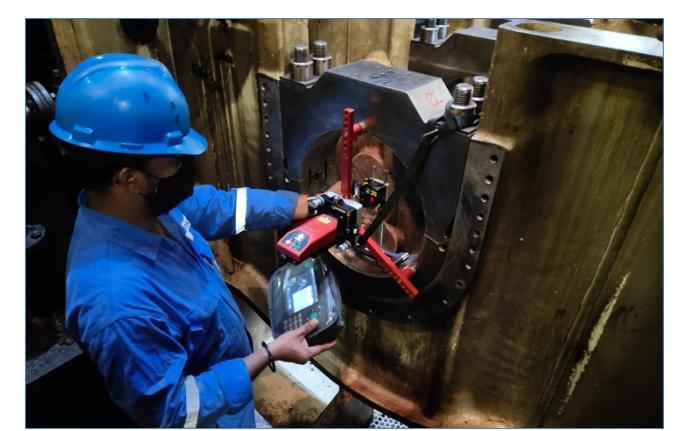
Laser alignment check of main bearing pockets

major components transported to Goltens' workshop for overhaul. On board, the in-situ specialists used lasers to check the main bearing pockets for damage and determined that, although the engine required line boring, the bedplate could be salvaged.

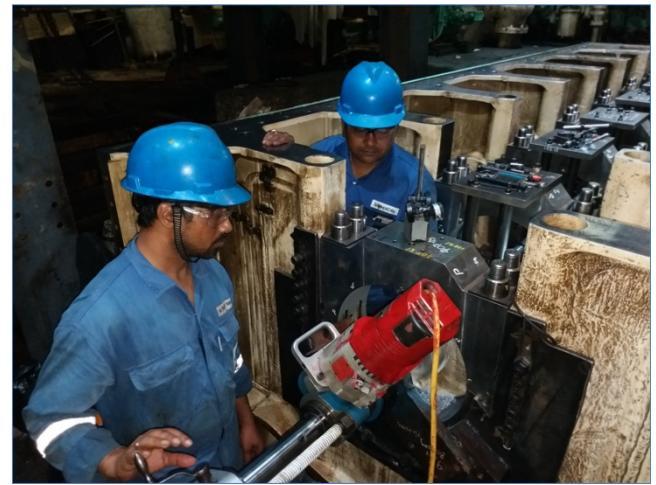
Line boring of main engine bearing pockets

While the engine components were being overhauled and the replacement crankshaft transported to site, Goltens completed line boring of the engine now fitted with three replacement bearing caps provided by Goltens in preparation for installation of the crankshaft.

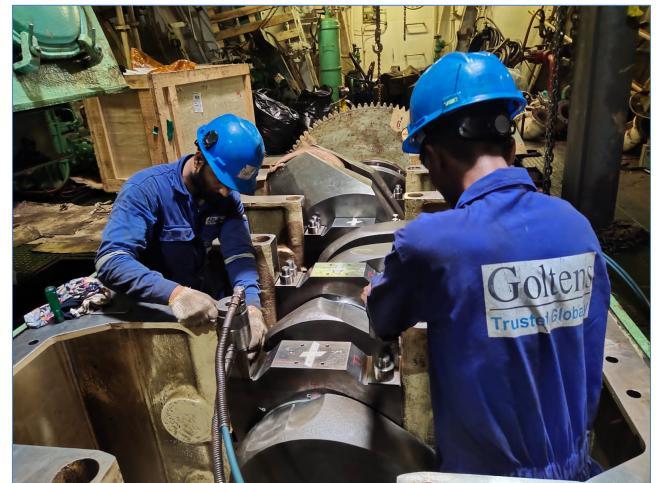
Tightening main bearing caps once crankshaft is installed prior to engine rebuild

The technicians installed the crankshaft and rebuilt the engine before completing successful sea trials and handing the repaired engine over to the ship's Chief Engineer. Goltens specialists completed this challenging repair with the vessel afloat, supplying the crankshaft and other key components and arranging for an emergency berthing space.
