# ANNEALING AND MACHINING SALVAGES ANOTHER BADLY DAMAGED CRANKSHAFT

# MAN B&W 9L 48/60 CRANKSHAFT REPAIR FOR 600-TEU CONTAINERSHIP IN DUBAI

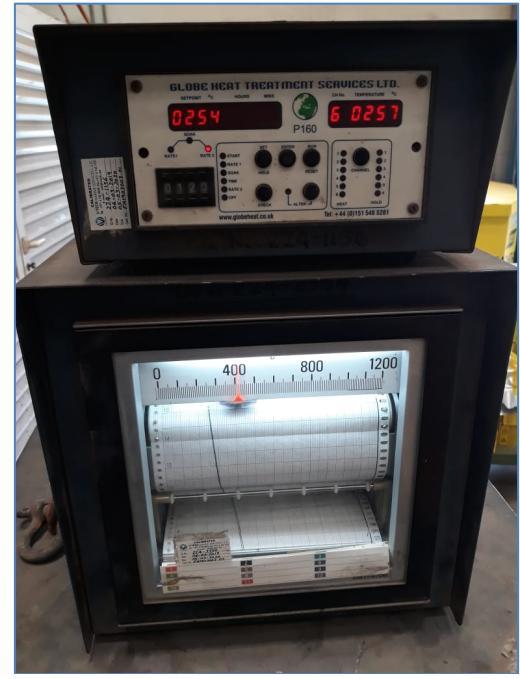
Figure 4: Annealing control unit
