# A MATTER OF MILLIMETERS - NO ROOM TO SPARE

## ANNEALING SAVES MAIN ENGINE CRANKSHAFT FOR OWNER AFTER FAILED ATTEMPT TO MACHINE AWAY THE HARDNESS

#### MAIN ENGINE ANNEALING

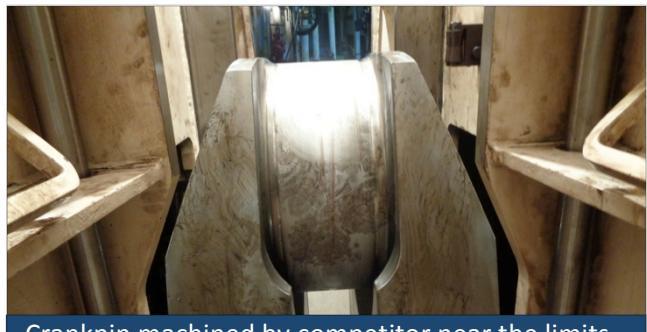
The owner opted to go with a competitor and allowed them to machine more than 5.00mm, dangerously close to the 6.00mm limit, from the 600.00mm crankshaft diameter. With less than half a millimeter remaining within the rated diameter, the hardness levels were still too high for either class or the maker to accept. Machining the journal beyond -6.00mm with hardness still present would condemn the shaft. At this point, looking for a solution, Goltens was requested to engage to try to salvage the crankshaft with only a fraction of a millimeter to work with.

Crankpin machined by competitor near the limits

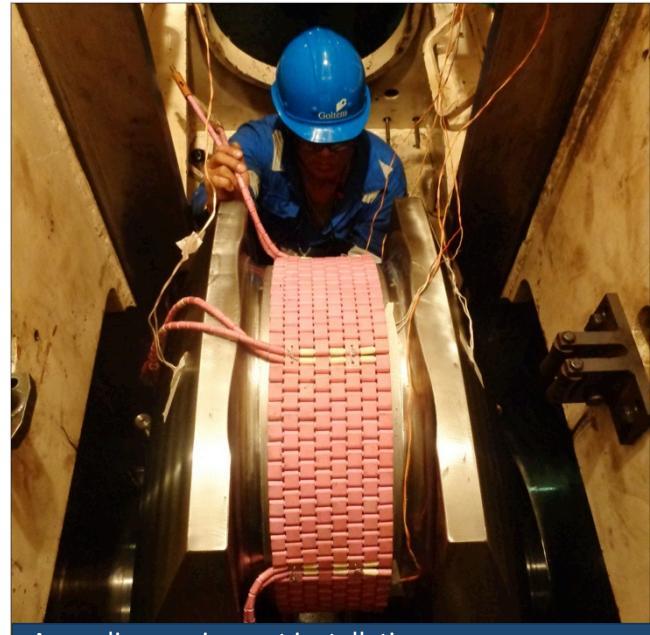
Annealing equipment installation

Goltens deployed its tooling and machinists to the vessel and inspected the condition of the shaft and found a significant section with excessive hardness still present. Goltens executed its proven annealing process to remove the hardness and carefully machined and final polished the journal to remove the final few tenths to finish the job within the rated diameter at -6.00mm. The team completed the process in seven days time.

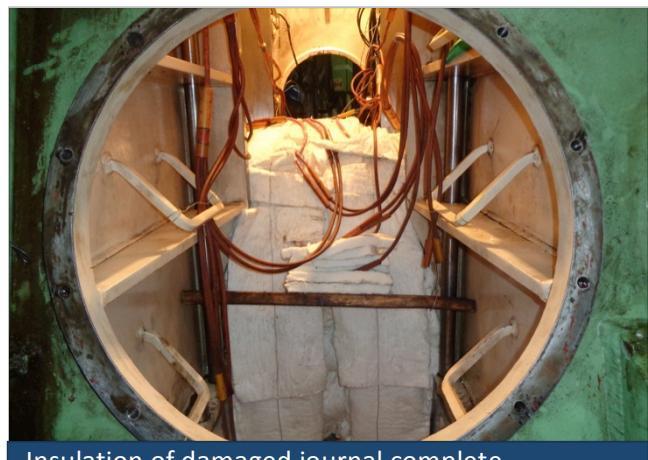
Insulation of damaged journal complete

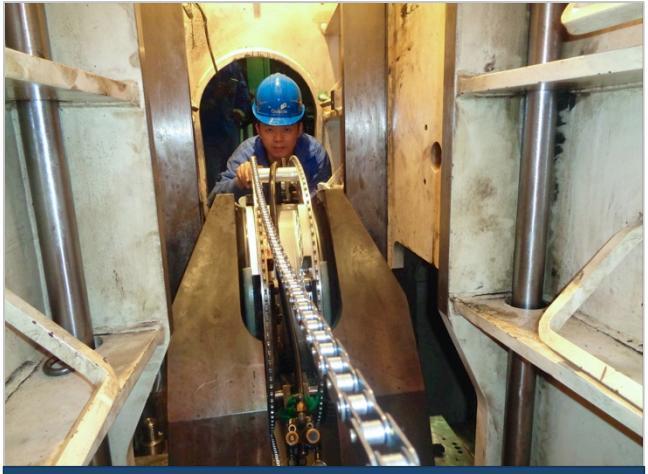
Installation of crankshaft machining tooling

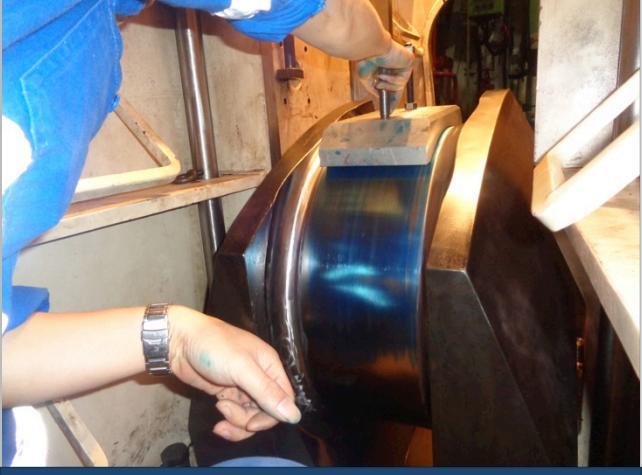
Blue fitting check on journal surface after honing

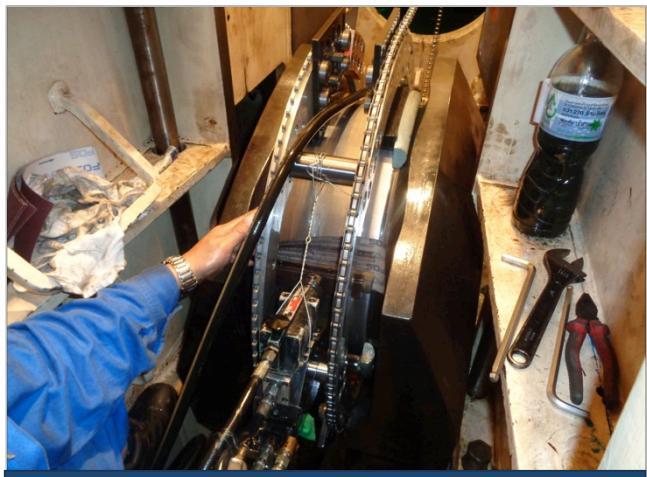
Finish honing to the -6.00mm limit

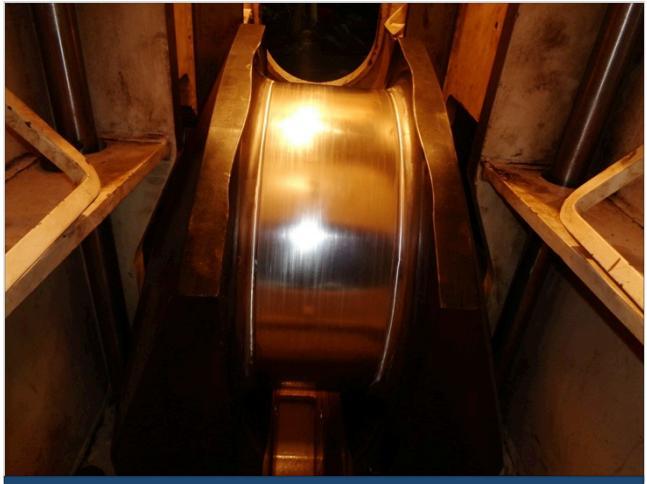
Repaired journal within 6.00mm limit
