## NUCLEAR POWER STATION EMERGENCY GENERATOR REPLACEMENT

IN-PLACE MACHINING INSPECTION LEADS TO FULL ENGINE REPLACEMENT

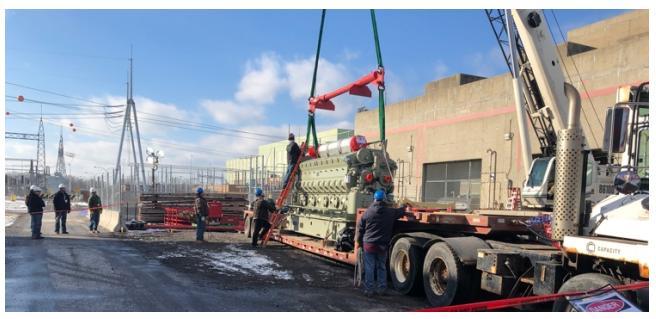
Figure 1: Rigging replacement EDBG from trailer to skid

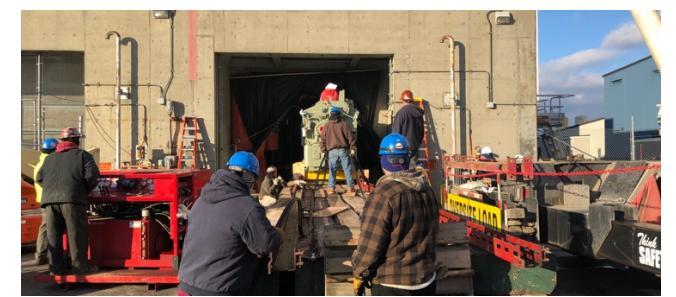
Figure 2: EDBG being slid into powerhouse on skid

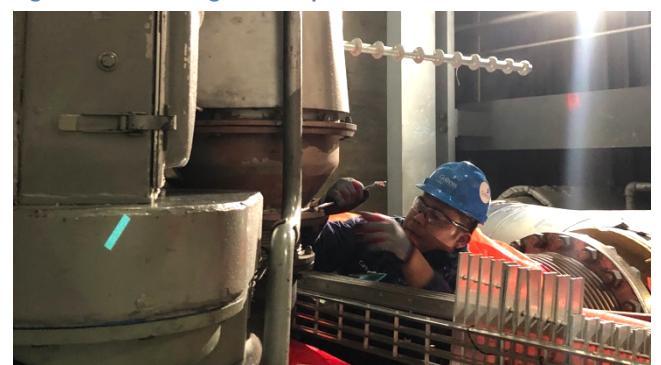
Figure 3: Installation of EDBG Exhaust Bellows

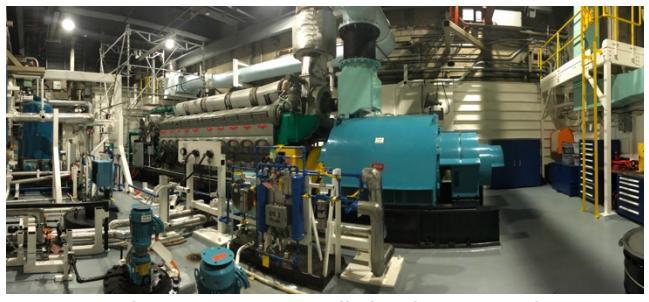
Figure 4: Replacement EDBG installed and operational

Once completed, Goltens installed the coupling to the generator and performed engine alignment prior to successful operational testing. The overall job was completed roughly 2 weeks ahead of schedule.
