# ON-SITE MACHINING OF DAMAGED GAS TURBINE SHAFT IN SAUDI ARABIA

## FIAT TG 20 B-7/8 GAS TURBINE FOR SAUDI ELECTRIC COMPANY

NAJRAN POWER PLANT

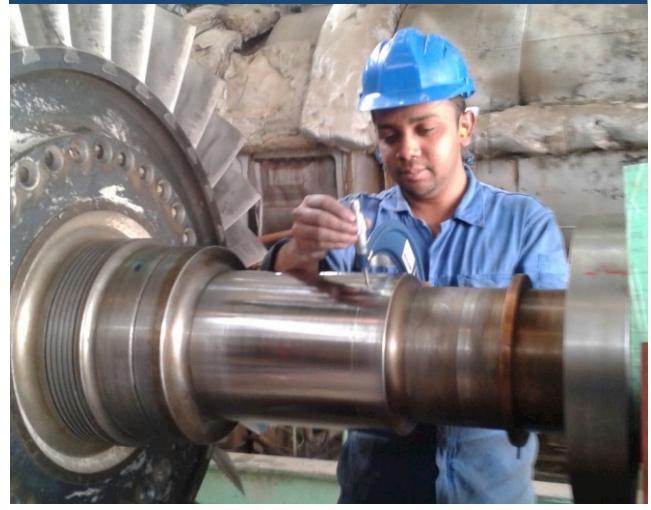
Calibration of the damaged shaft

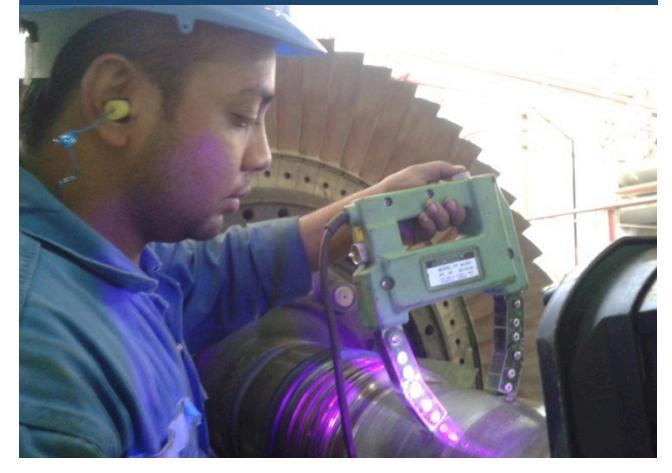
- MPI tests showed no cracks on compressor or exhaust side journals
- Hardness checks found hardness values within acceptable limits between 239Hb and 309Hb
- Visual inspection showed heavy scoring on the compressor side bearing journal and minor scoring on the exhaust side bearing journal

MPI Crack tests being performed on Journal
