STEAM TURBINE ROTOR SHAFT MACHINING - INDONESIA

GOLTENS' MACHINISTS RECTIFY THE DAMAGED SHAFT IN ONLY 4 DAYS

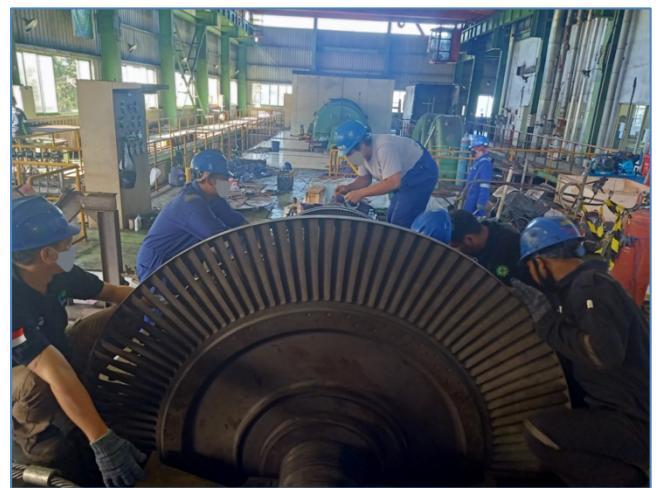
The surface of the 200mm diameter journal was damaged but no deep cracks or irreparable damage was found. Goltens quickly mobilized the required tools to the site along with machining specialists to machine the journal to undersize.

Figure 2: Inspecting the damaged rotor shaft journal

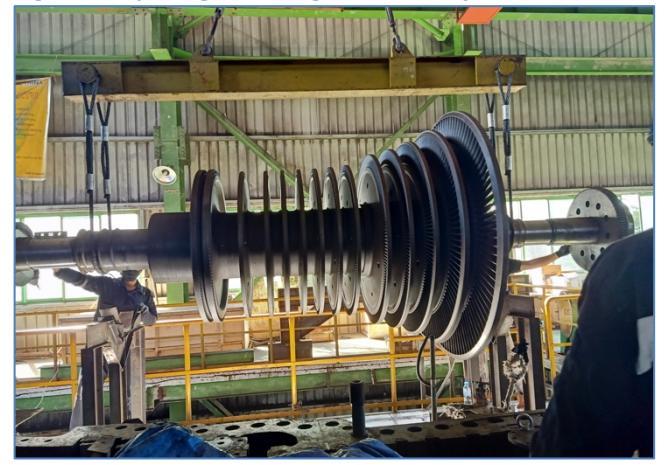
Figure 3: Removal of the rotor shaft from the casing

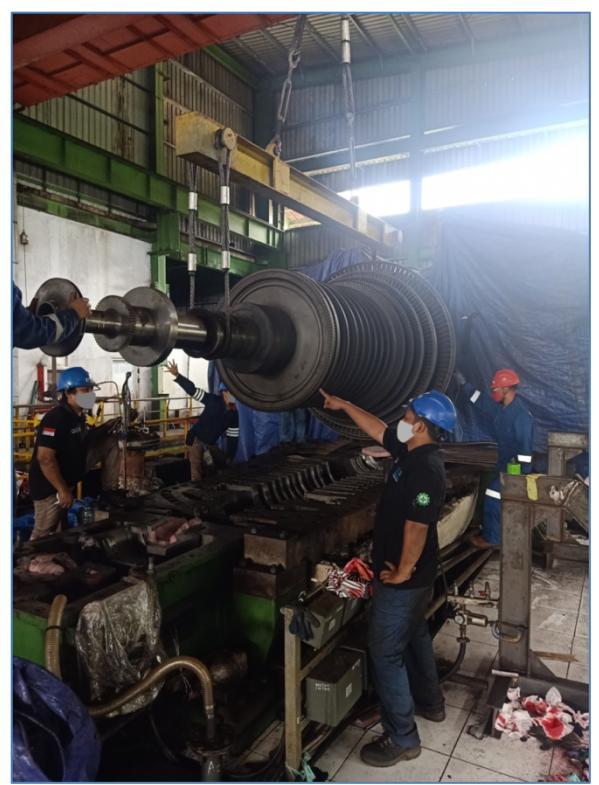
Figure 4: Rigging rotor shaft to repair location

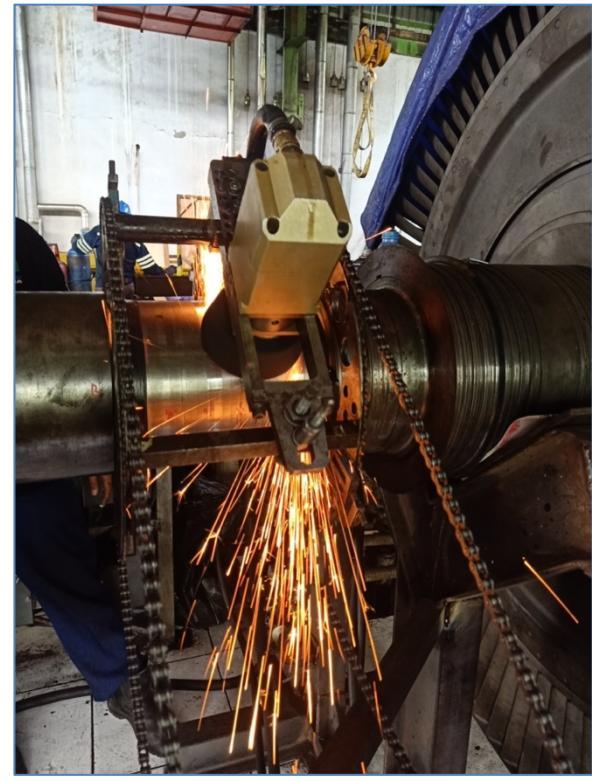
Figure 5: Grinding damaged journal surface

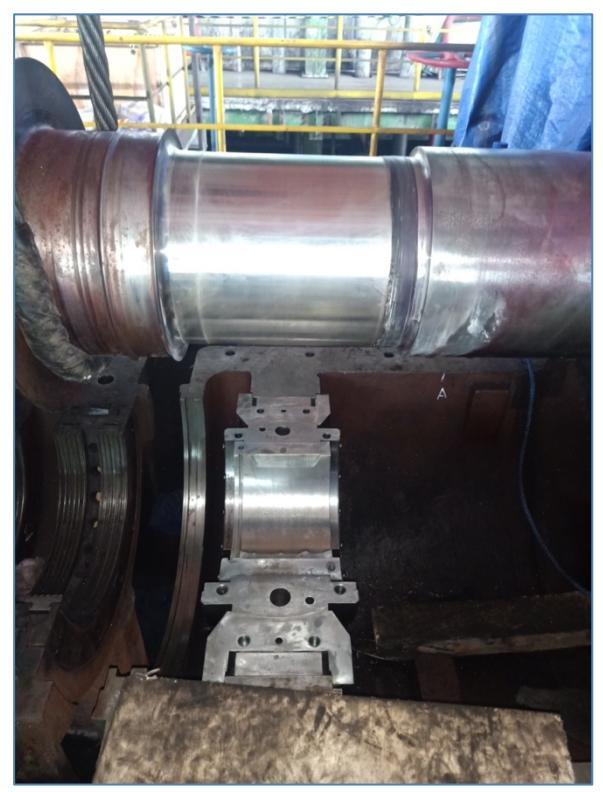
Figure 6: Journal finished at 199.5mm diameter

Goltens' machinists managed to salvage the shaft with the least possible material removal, taking only 0.5mm from the shaft for a finished diameter or 199.5mm. Final polishing and inspection to confirm final measurements were then completed and the plant could get to work restoring the turbine to operation.
