# METAL STITCHING SALVAGES BADLY DAMAGED HP AND LP COMPRESSOR CASINGS

## OVER 6 METERS OF DAMAGE REPAIRED IN ONLY 11 DAYS WORKING AROUND THE CLOCK

#### PROJECT FACTS: Metal Stitching Repair on

Turbine Compressor Casings Pennsylvania, USA Machinery Repair Co. h: 6.1 meters 11 Days

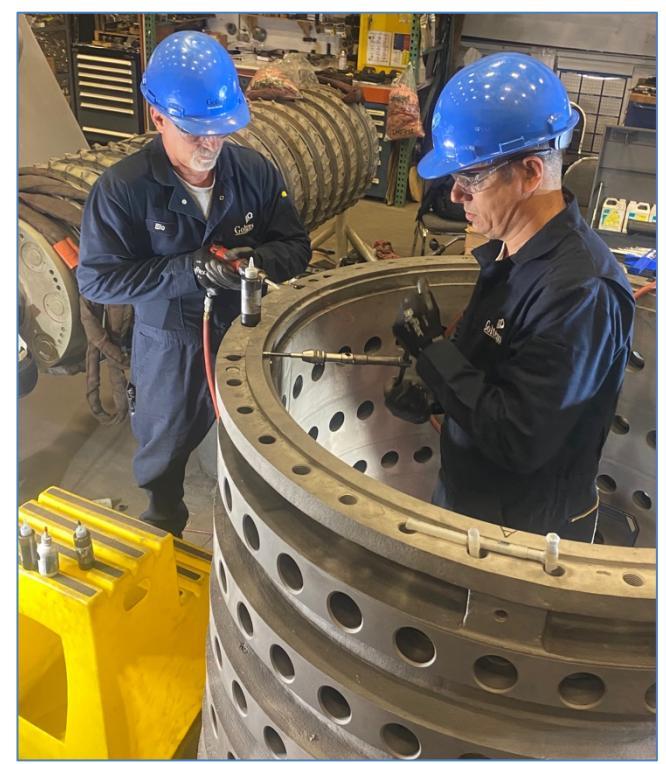
Tapping drilled holes along crack for Stitching pins

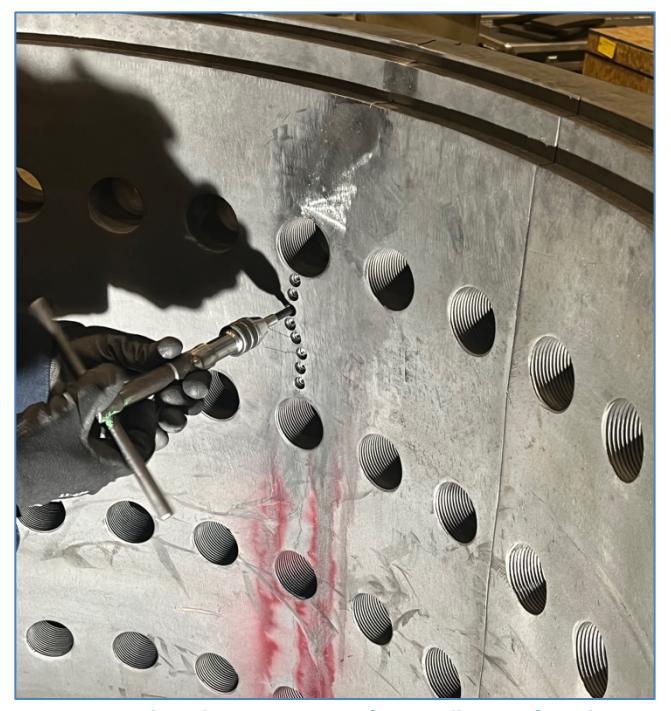
Tapping metal crack in preparation for installation of stitching pins. Stitched area above repaired and dressed clean.

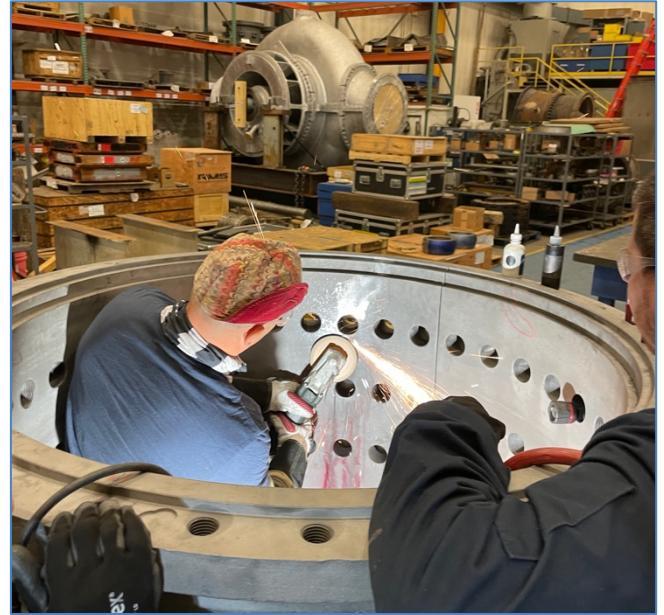
Surface grinding crack after stitching pins installed

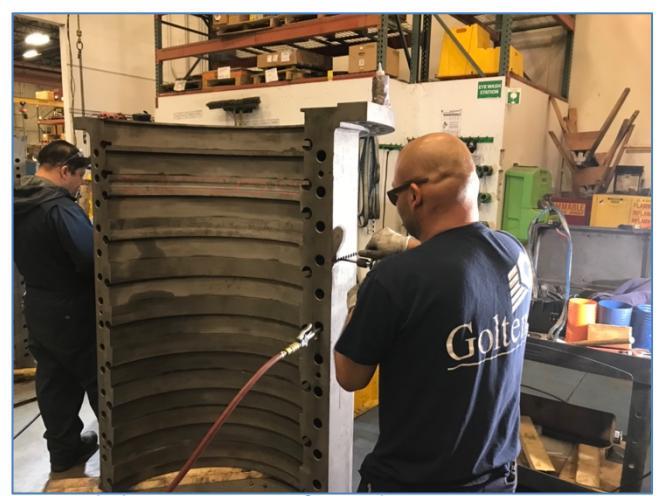
Tapping holes in preparation for stitching pins

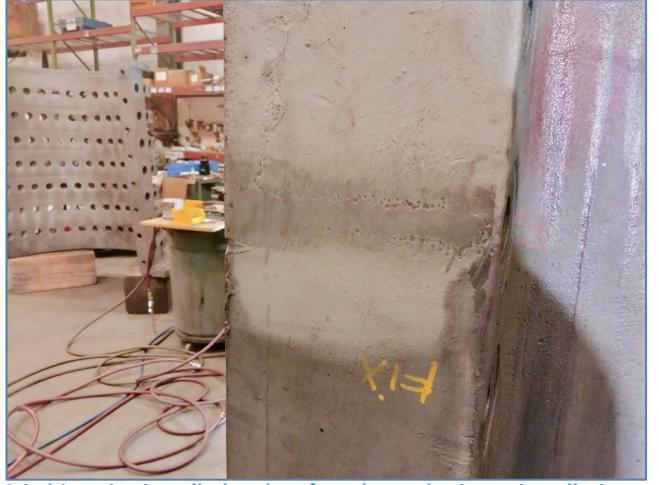
Stitching pins installed and surface dressed prior to installation of metal lock

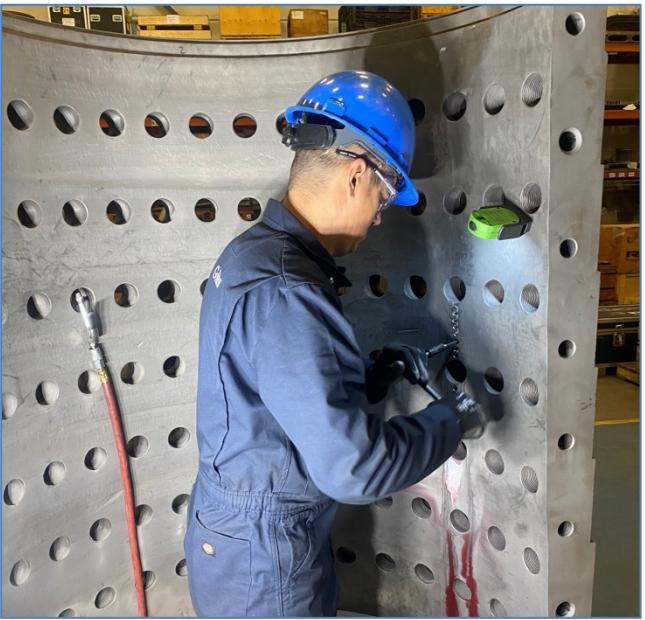
Installation of stitching pins on interior crack

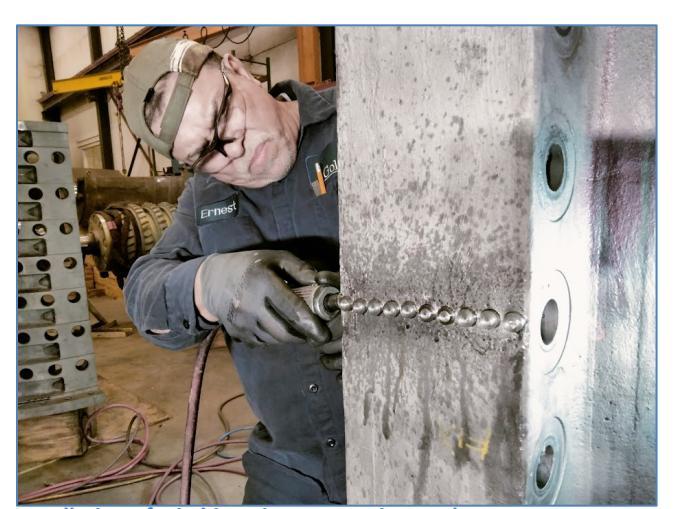
Installation of stitching pins on exterior crack

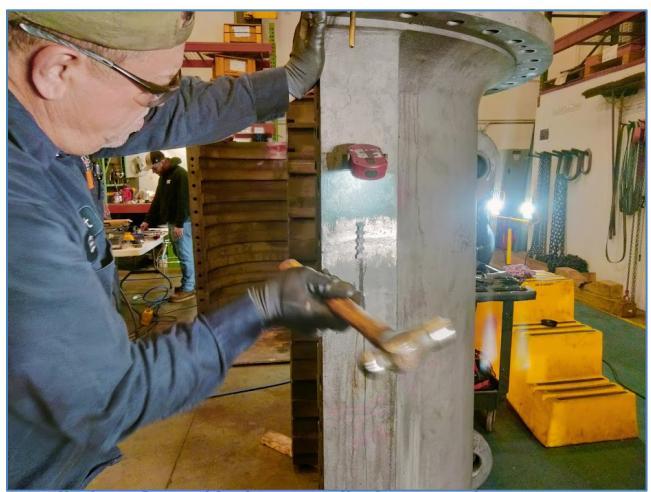
Installation of metal lock perpendicular to crack

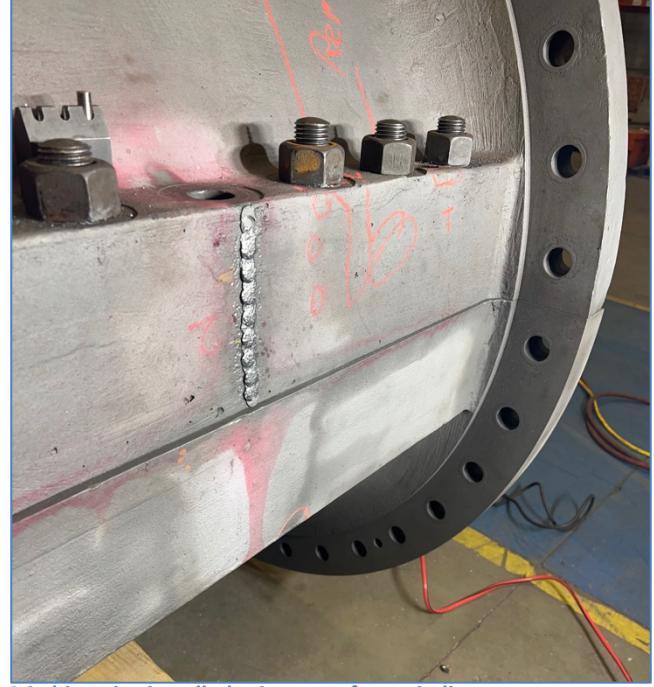
Stitching pins installed prior to surface grinding

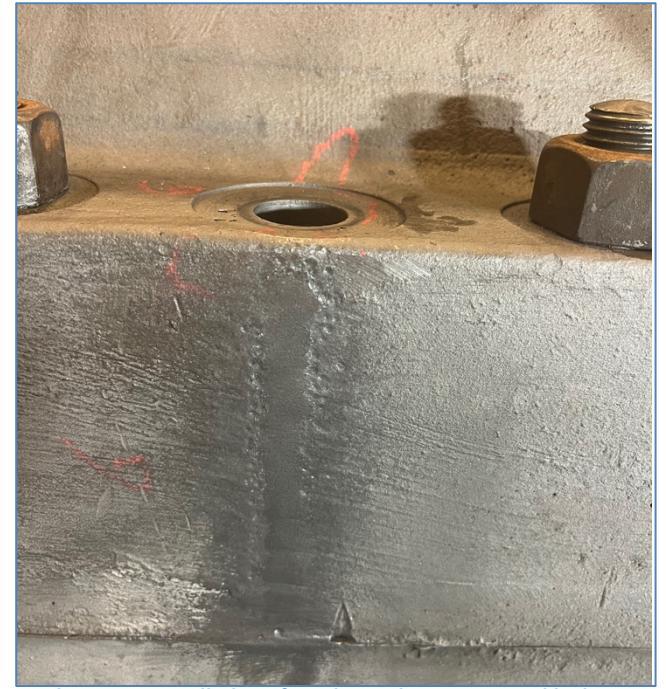
Stitching pins installed, surface dressed prior to metal lock installation
