Minimizing Asset Downtime

The Value of an Independent Opinion and Approach

Goltens salvages condemned MAN crankshaft for Containership

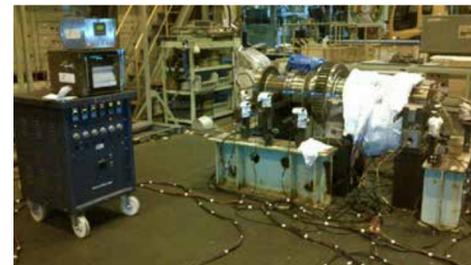
Annealing equipment set up on trial shaft in Yokohama

After the successful shop trial, Goltens was engaged to anneal the damaged crankpin and mobilized its technicians, annealing equipment and in-situ crankshaft machining tools to Senegal to conduct the work. Goltens undertook all of the engine preparation required by its process to ensure the operation would not cause any damage to the engine casing from linear expansion of the crankshaft and machined the crankshaft surface free of cracks. The technicians then connected the annealing equipment and performed the heat treatment of the shaft.

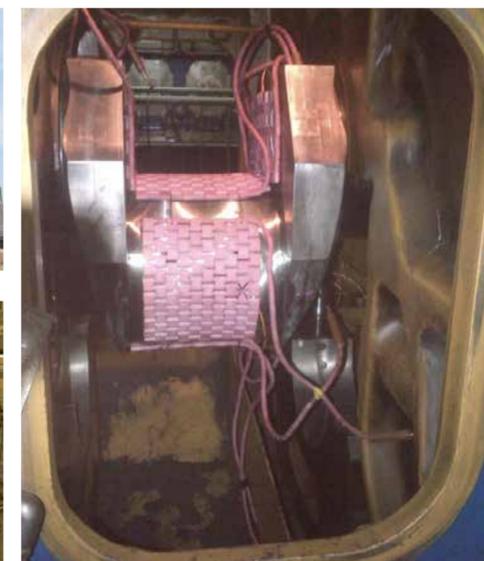
Annealing pads installed on damaged crankpin

Goltens had previously successfully performed in-situ machining at the plant and was very familiar with the engines. An inspection revealed that the 330mm crankpin journal had suffered a bearing failure that had resulted in hardness levels as high as 596 Brinell. Goltens proposed to Mitsubishi to anneal and machine the crankshaft to salvage the shaft within the rated diameter.

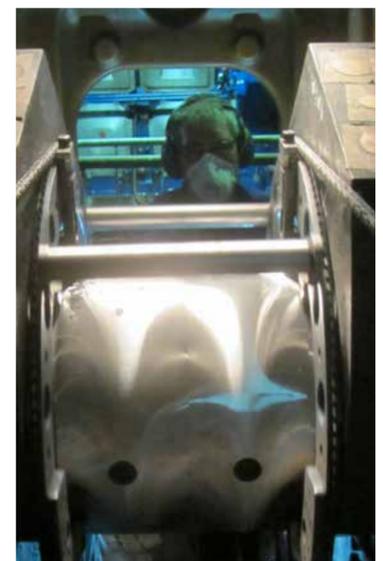
In-Situ Machining of the annealed crankpin in progress

After annealing, Goltens took hardness readings and the results were accepted by Mitsubishi. The crankpin was then machined and polished to a finish diameter of 326mm removing only 4mm from the shaft diameter.

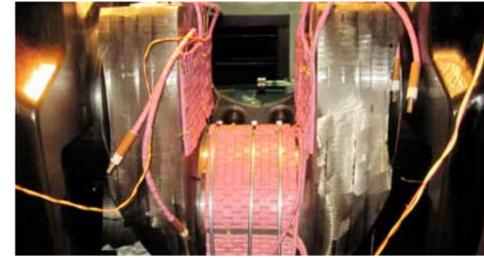
Annealing equipment mounted on damaged crankpin

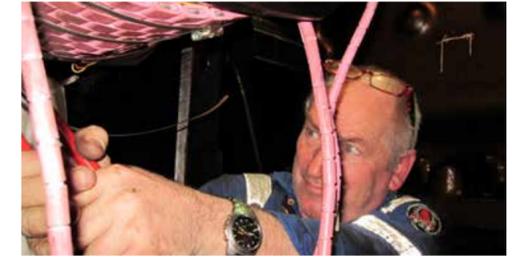
Installation of ceramic tile heating blankets for annealing

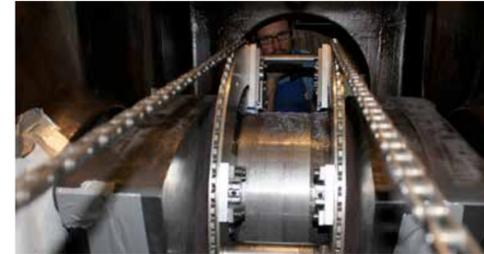
Post-Annealing machining of the crankpin journal

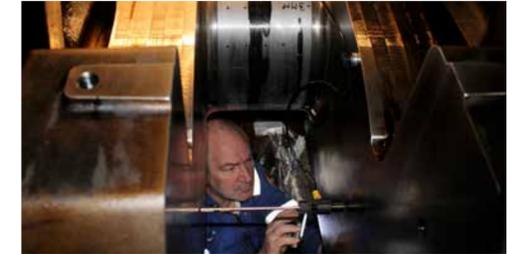
Checking deflection at -3mm (high hardness areas visible on center and right side of crankpin journal)

At that point Goltens was instructed to machine the crankshaft to -4mm and to evaluate the condition of the shaft. It was determined that the hard spots did not lessen — in fact, they became worse. All of the surface cracks were removed, with the exception of a few that could be locally ground and not exceed the -5mm target. Goltens was now confident that they could salvage the crankshaft at -5mm.

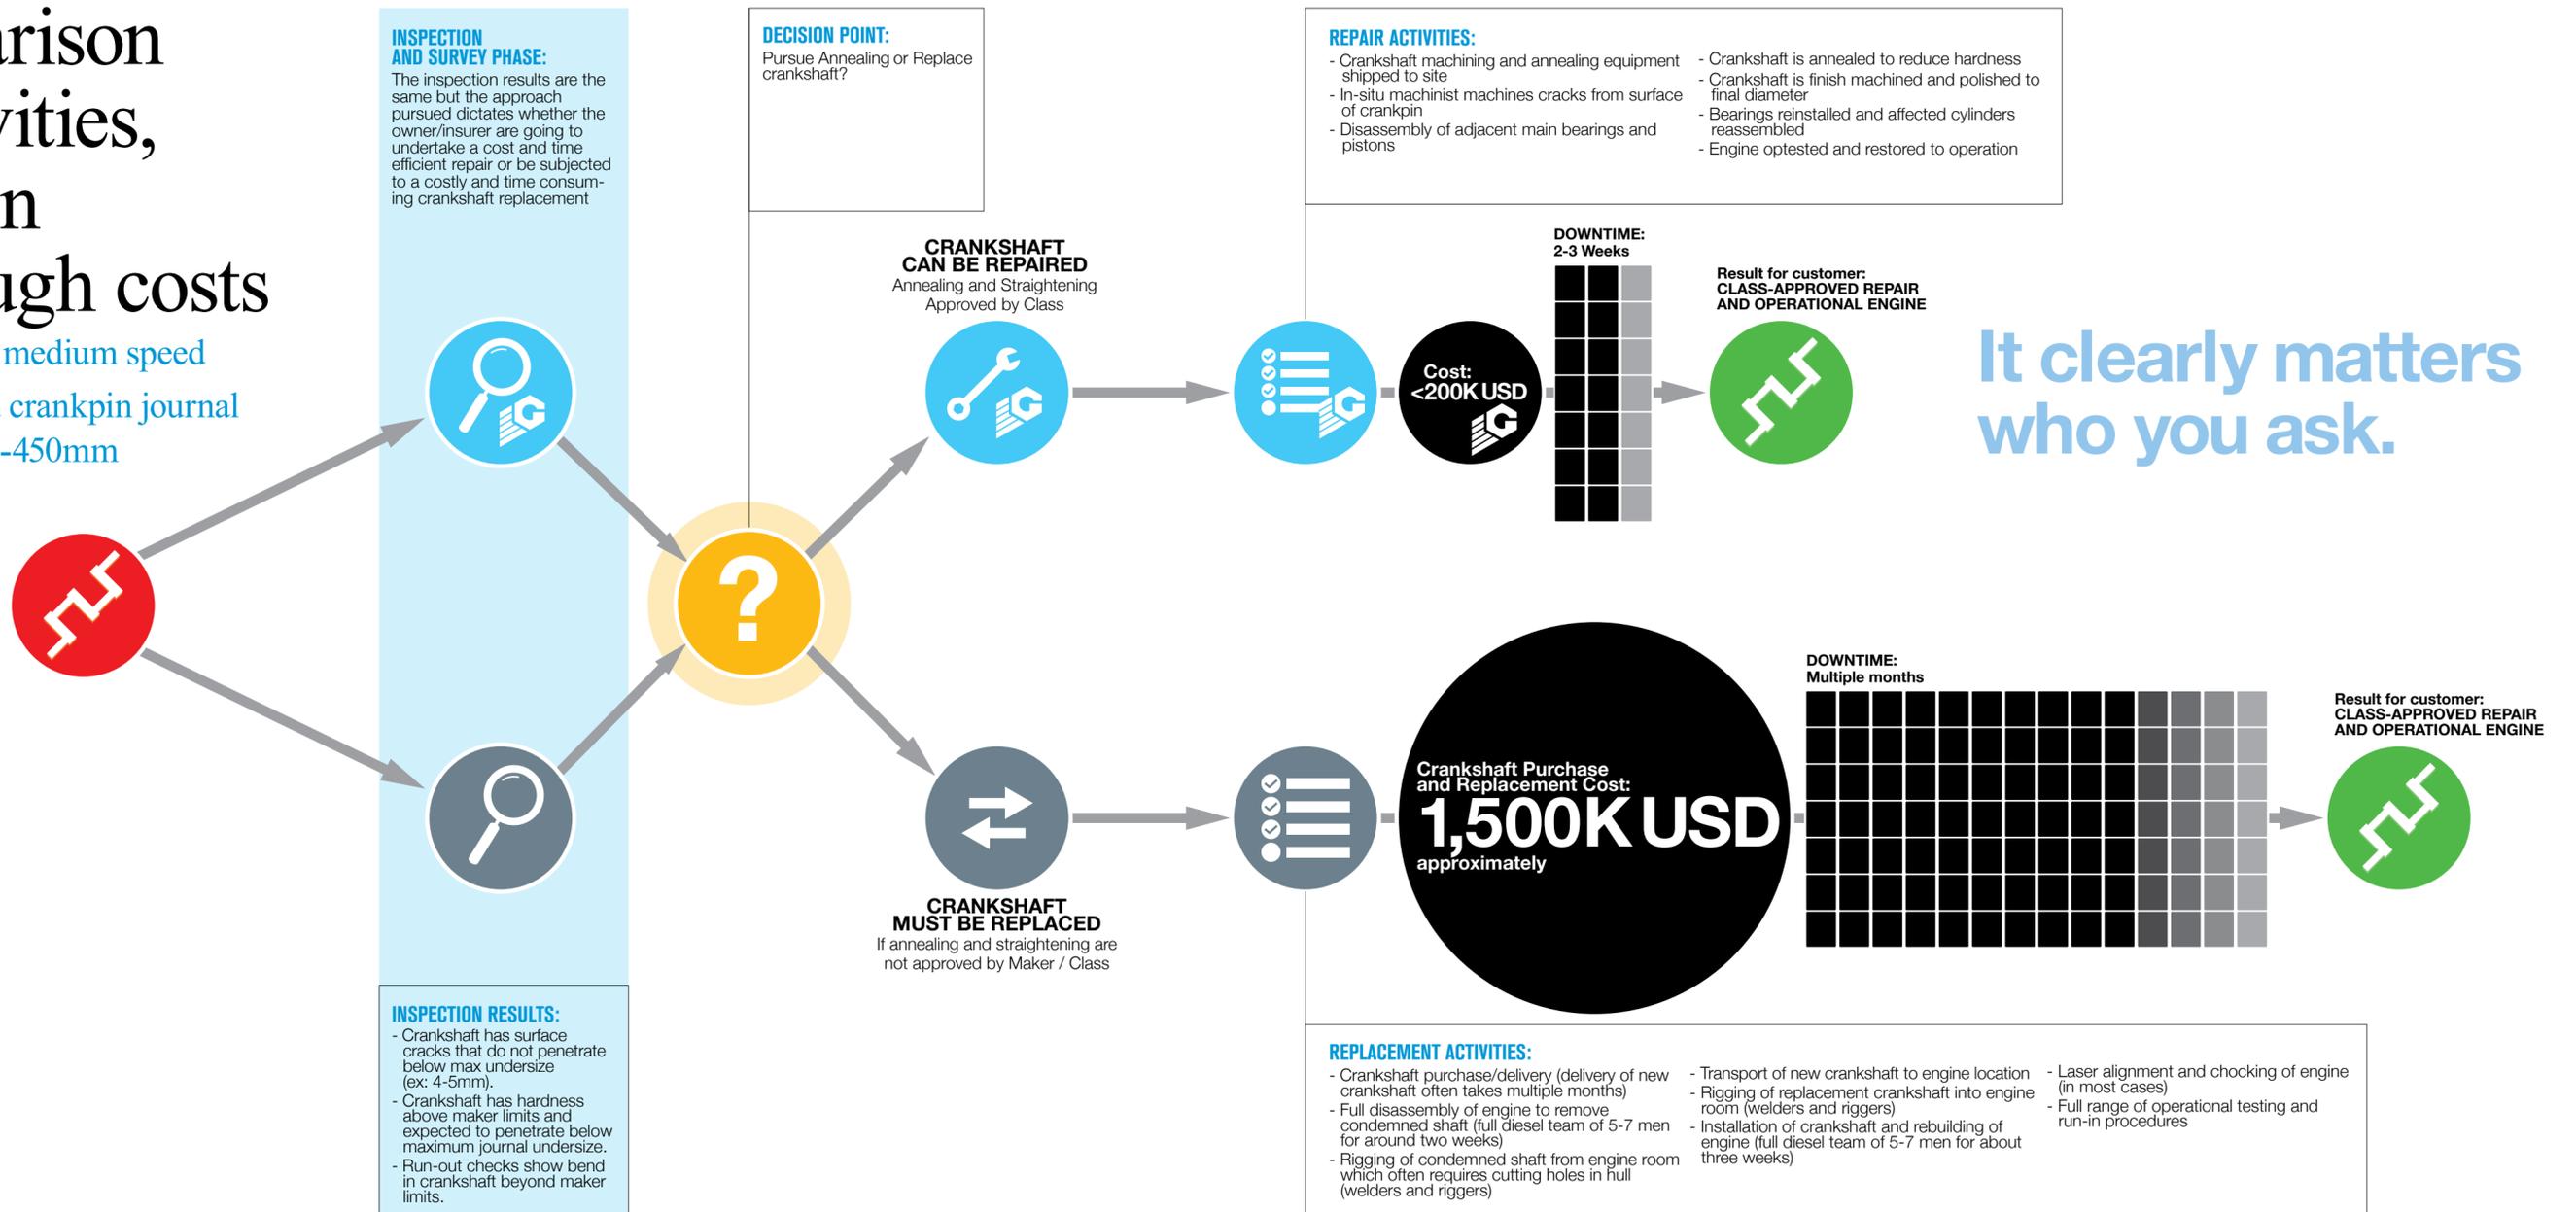
Comparison of activities, duration and rough costs

for a 6-cylinder medium speed with a damaged crankpin journal diameter of 400-450mm

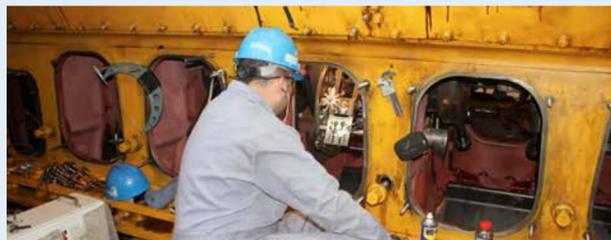
Post Annealing crankpin machining

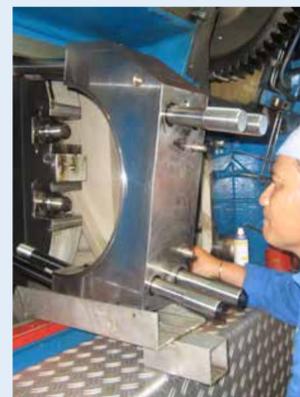
Removal of big end bearing housing

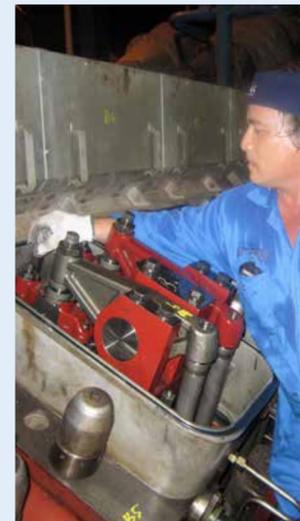
Installation of cylinder head

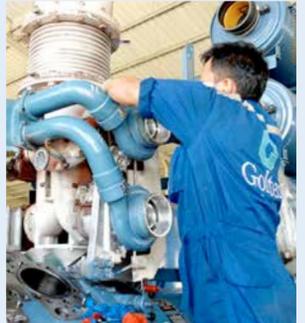
Securing turbocharger in place after overhaul

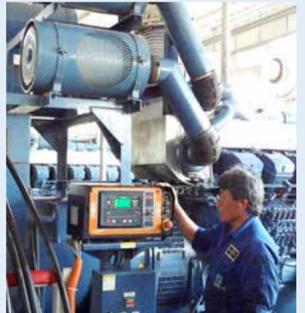
Test running/commissioning of engine

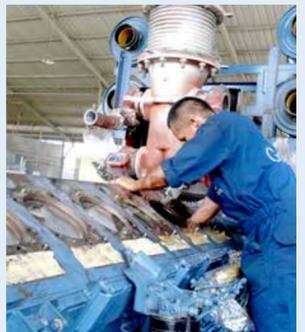
Cleaning of block liner bore

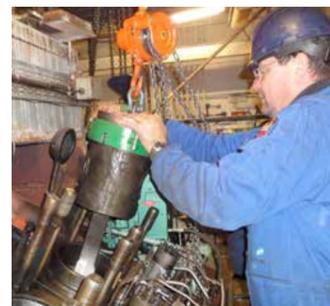
Reassembly of one of the overhauled pistons and connecting rods

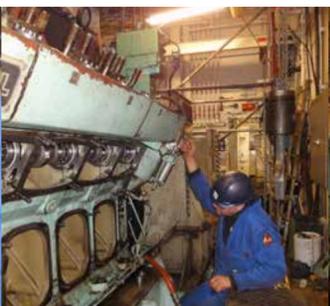
Rotating the engine to its correct position

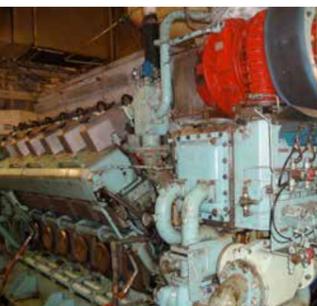
One of the completely overhauled and fully tested Wartsila engines type 12V22MD

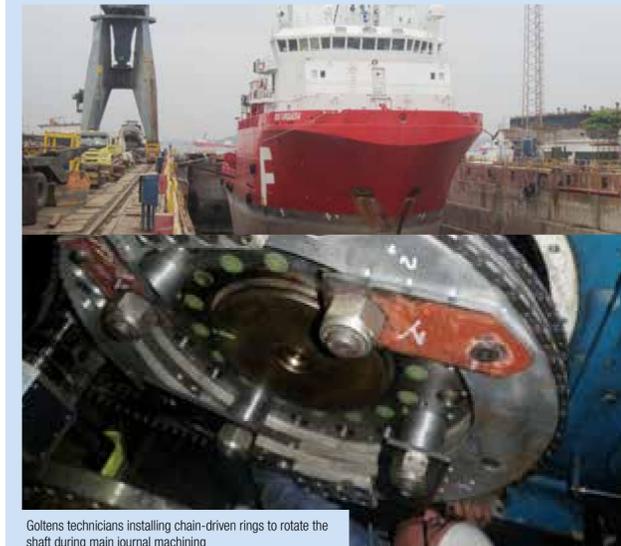
Goltens attended Farstad Shipping's offshore anchor handling supply vessel Bos Turquesa in Brazil to investigate and troubleshoot recurrent premature main bearing failures on its #1 and #4 Bergen B32:40 L6P main engines. The investigation revealed that a previous repair attempt by another company did not address the alignment issues and that the previous bearing repair on the main bearing was poorly performed. Goltens machined the main journal for use with an undersized bearing and realigned and chocked the engines, resolving the problem and returning the engine to service.

Goltens technicians installing chain-driven rings to rotate the shaft during main journal machining

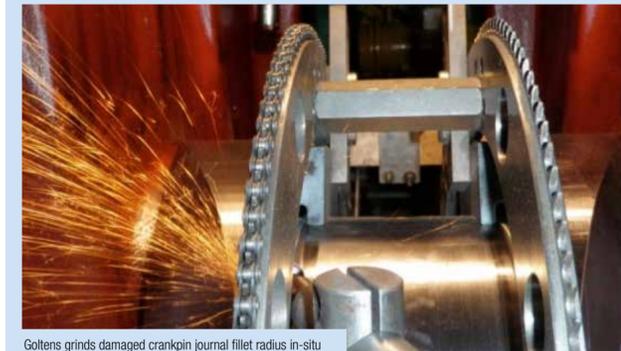
Goltens mobilized tools and technicians to inspect and repair a MaK 8M32C engine onboard an offshore vessel in South America. The vessel had experienced a casualty resulting in damage to all main journals and crankpins. Goltens deployed two teams of in-situ machinists to work around the clock to machine all of the crankpins and main journals and restore the offshore vessel's engine to service in the minimum amount of time.

Goltens grinds damaged crankpin journal fillet radius in-situ

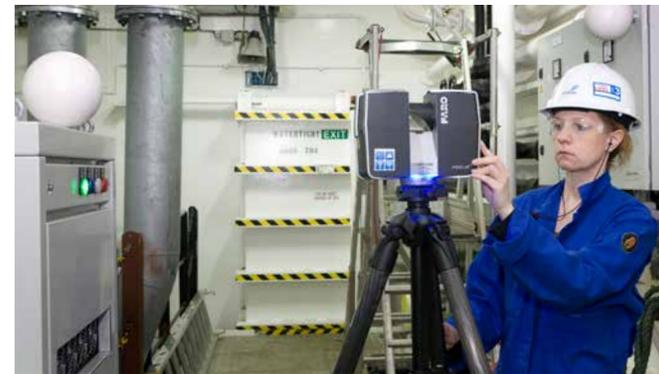
Performing 3D Laser scanning onboard vessel in Invergordon, Scotland

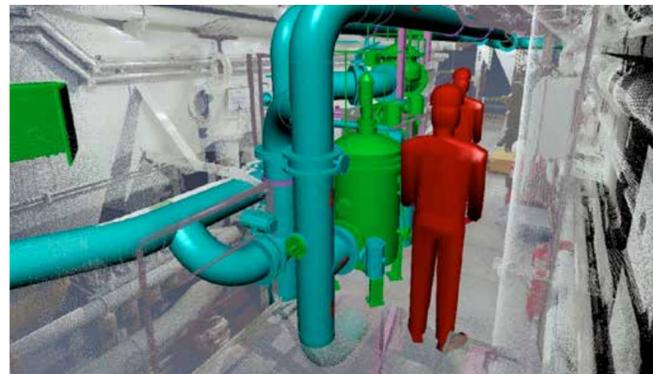
3D scanning results with Optimarin system overlay on scan

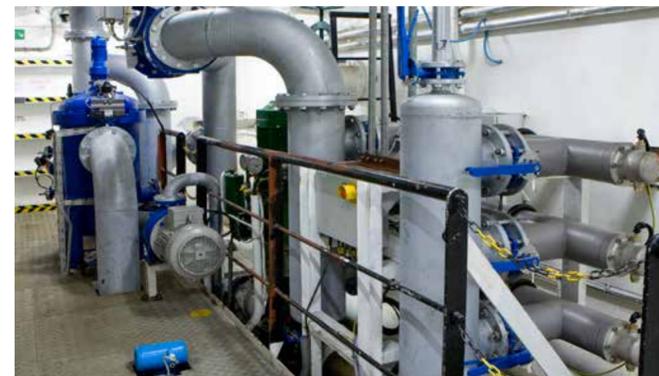
Optimarin System installed onboard

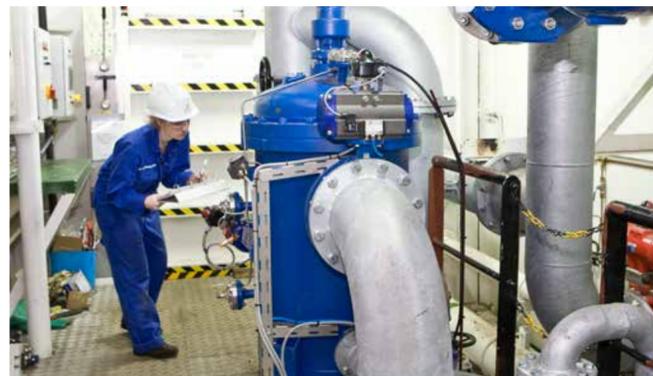
Performance of commissioning inspection by Goltens Green Technologies

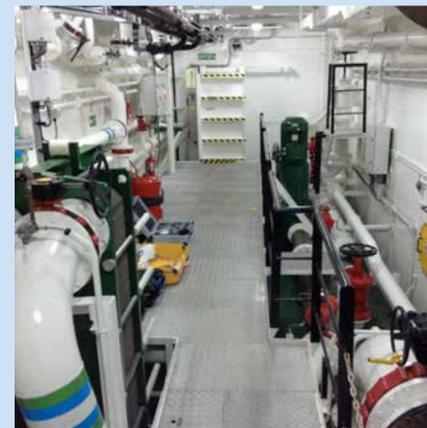
Photo of space scanned for installation

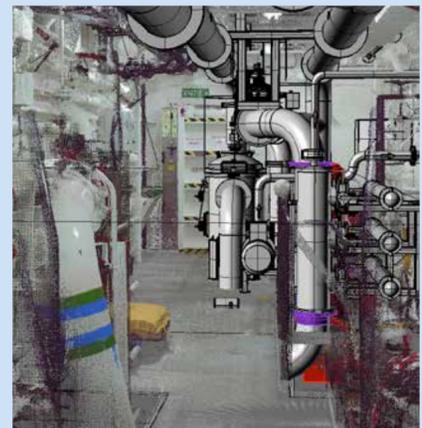
3D Scan output with overlay of Optimarin system layout

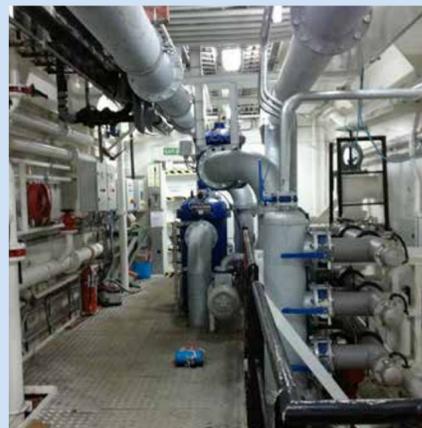
Optimarin System installed onboard

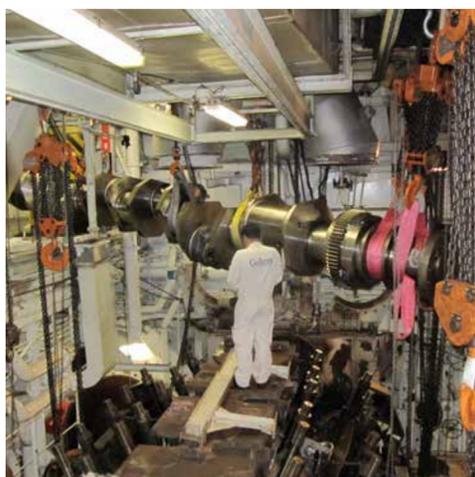
Rigging of condemned crankshaft from the engine room

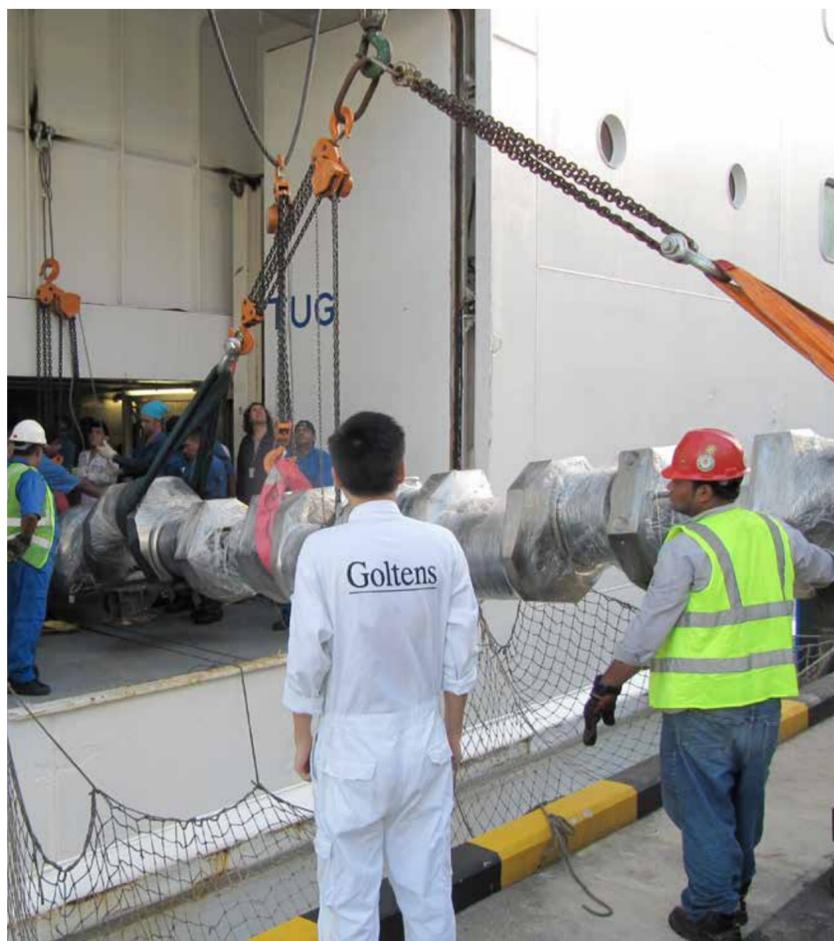
Rigging of replacement crankshaft onboard during port call in Singapore

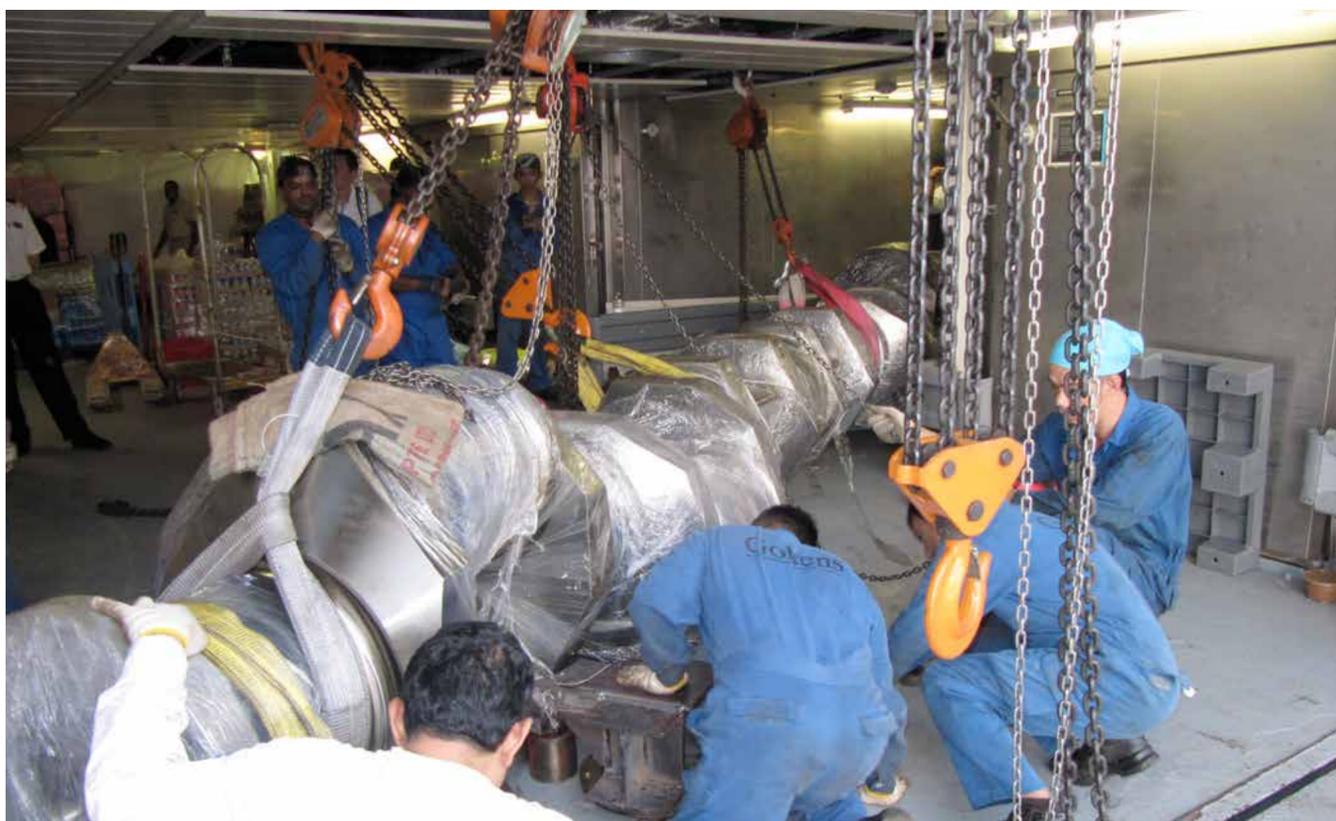
Preparing crankshaft for transport down passageway via skid

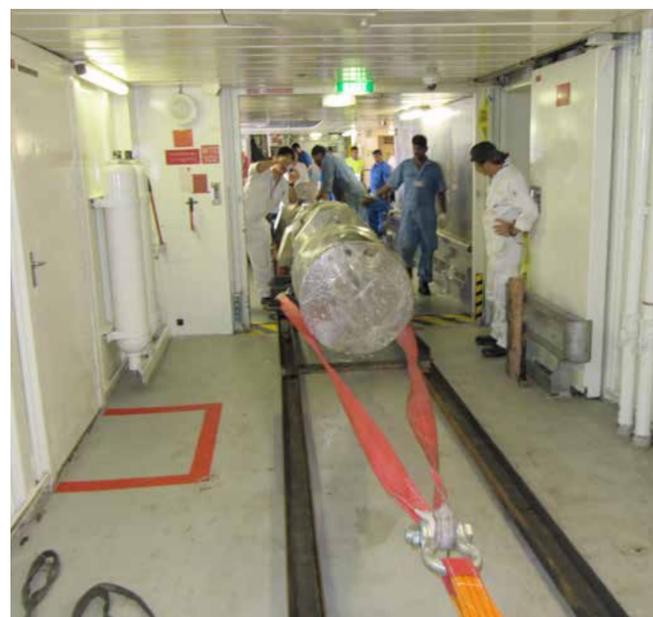
Transfer of replacement crankshaft down 80 meter passageway

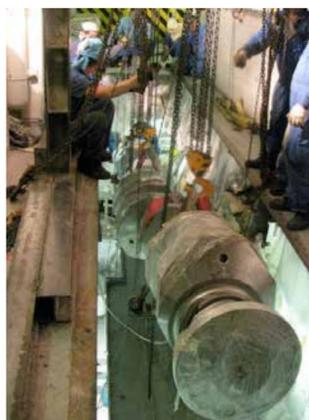
Rigging replacement shaft into engine room via hole cut in passageway floor

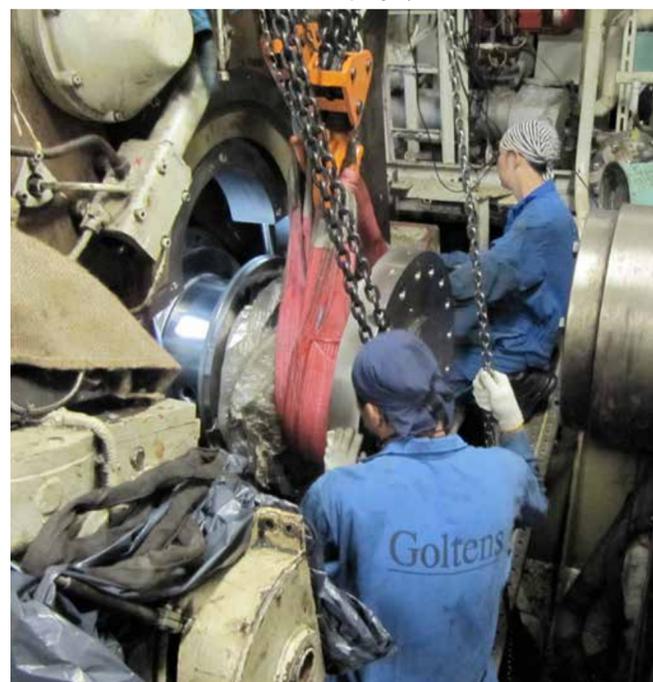
Maneuvering crankshaft into position

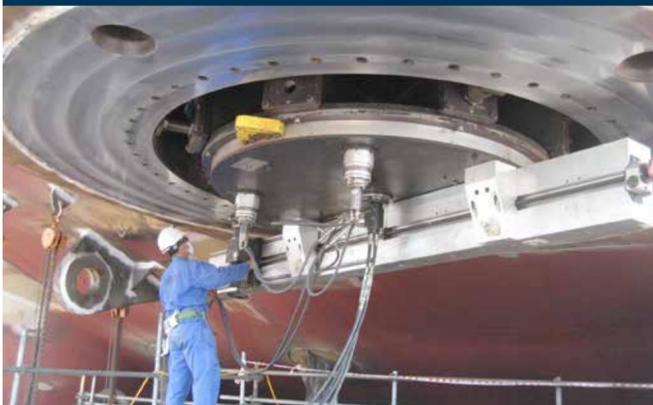
4.7M Thruster Flange Machining

Golten performed large scale flange facing on 2 - 6 Megawatt stern tube thrusters on the cable laying vessel, Lewek Constellation. The job was completed at the TriYard Shipyard in Vietnam. The job was completed ahead of time with a job process approved by class. The end result was within the tolerances set by the yard and the Thruster supplier.

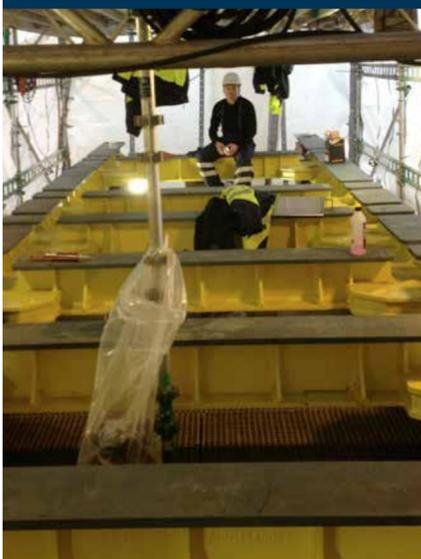
ITW Chockfast Foundation installation onboard Jackup Rig

Golten completed the design and fabrication of a 13,000mm X 400mm Skid foundation for a crane onboard a Norwegian Jack Up Oil Rig undergoing a refit in a shipyard on the west coast of Norway. The completed foundation was installed using ITW Chockfast and was capable of withstanding a total load of more than 100 Tons.

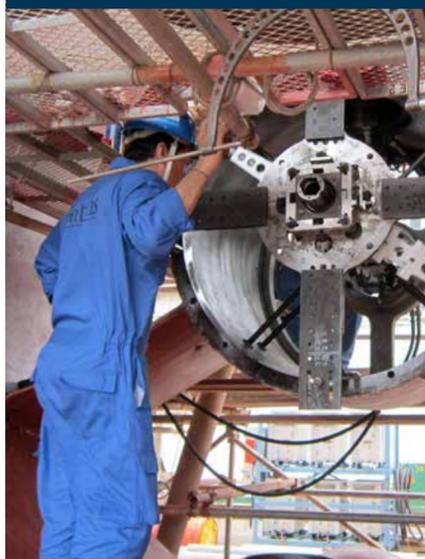
Line boring 1.27M Propeller Thruster Housings

Golten's In-Situ team was asked to complete line boring on 6 propeller thruster housings in Jurong to an oversize diameter of 1.27M. Golten modified its boring tools for the job and laser aligned the tooling to ensure the tight tolerances were achieved and accurate. The job was completed on time and within the specified tolerances to the full satisfaction of the customer.

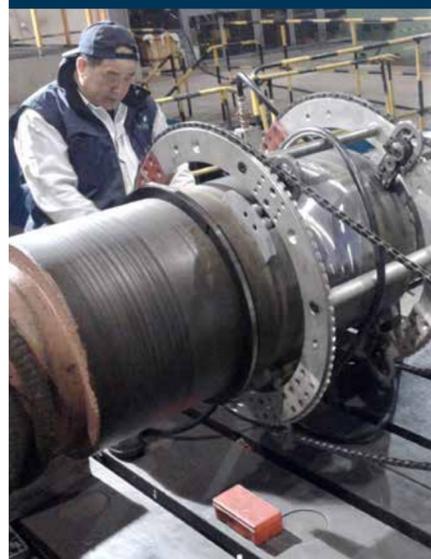
Emergent Repairs to a Damaged Rudder Stock

During a scheduled 5 year drydocking of the bulk carrier Lillian Z at Chengxi Shipyard, abnormal wear and scraping was observed on the 500mm diameter rudder stock. The damage required immediate repair to keep the drydocking schedule and Golten completed the emergent job in only 2 days to keep the shipyard schedule on track.
