## When Space is an Issue

Complete engine overhaul and line boring to support vessel conversion to livestock carrier

# Annealing With Class

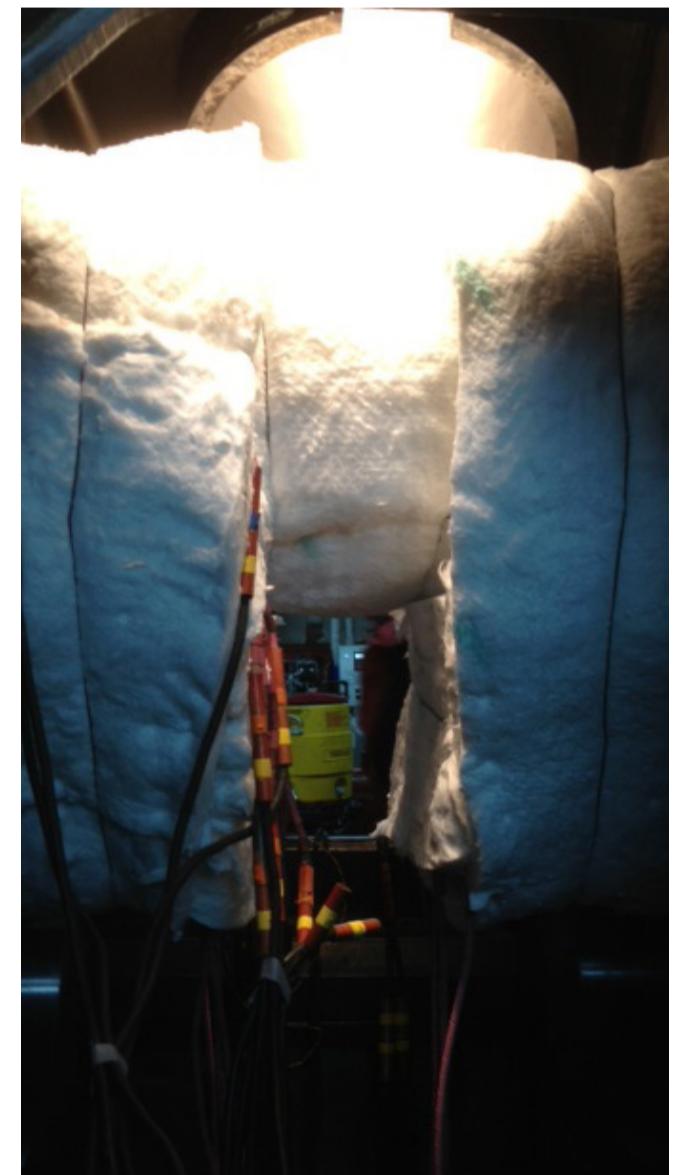
Annealing equipment installed and insulated on the damaged pin after machining to remove all surface cracks.

- Inspected the crankshaft, performing run-out, Magnaflux and hardness checks on the shaft
- Pre-annealing machining to -1.30mm to diameter 463.70mm to clear the crankpin of surface cracks
- Annealing of crankpin journal #5 with resulting hardness <300HB
- Final machining to -2.00mm undersize
- Machine polished the crankpin to a surface roughness of 0.4Ra
- Completed post-machining run-out and crack tests

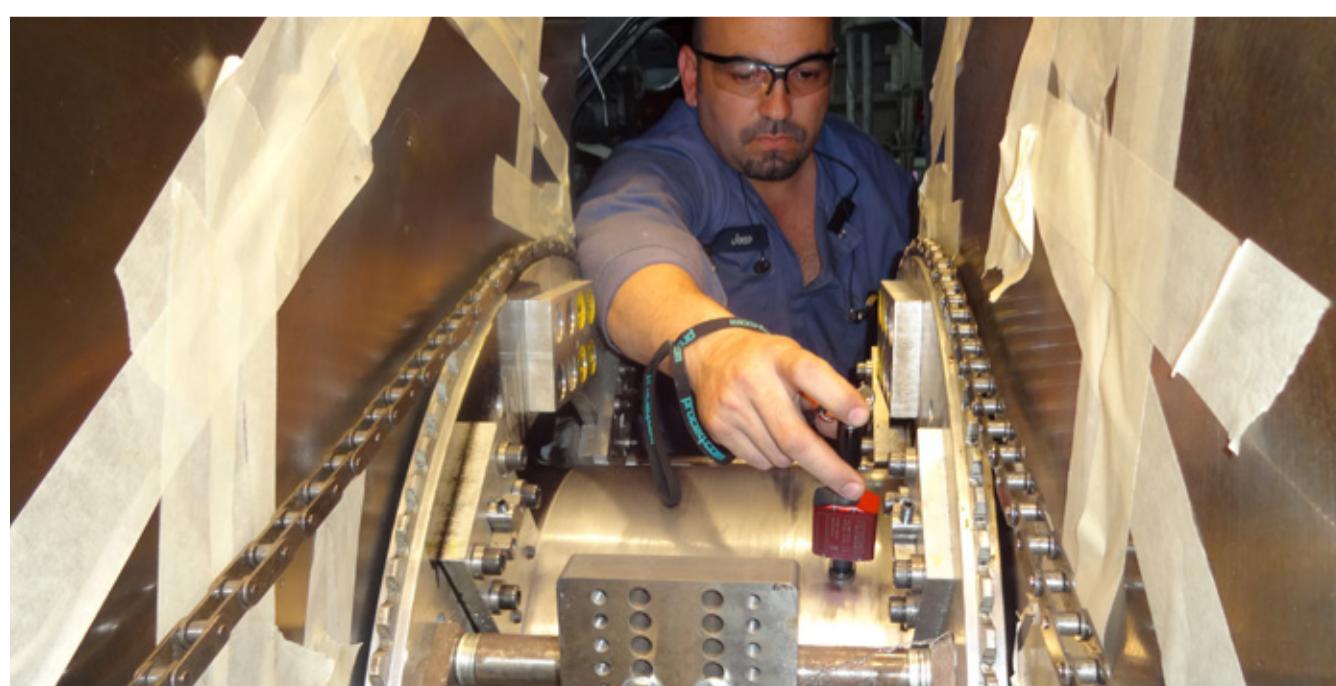
Checking journal hardness before annealing after machining 0.40mm from the damaged surface on the Rappahannock's PIELSTICK 10PC4.2V main engine.

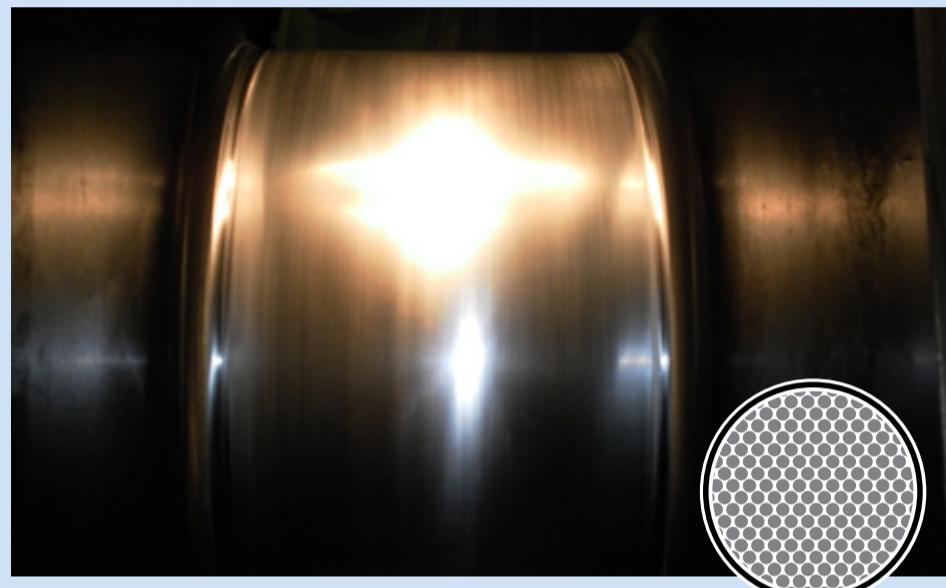
Unhardened crankshafts generally have a hardness in the range of 250-350HB (Hardness Brinell).

Homogenous grain structure with a hardness that provides desired strength, rigidity, resistance to wear, corrosion and impact.

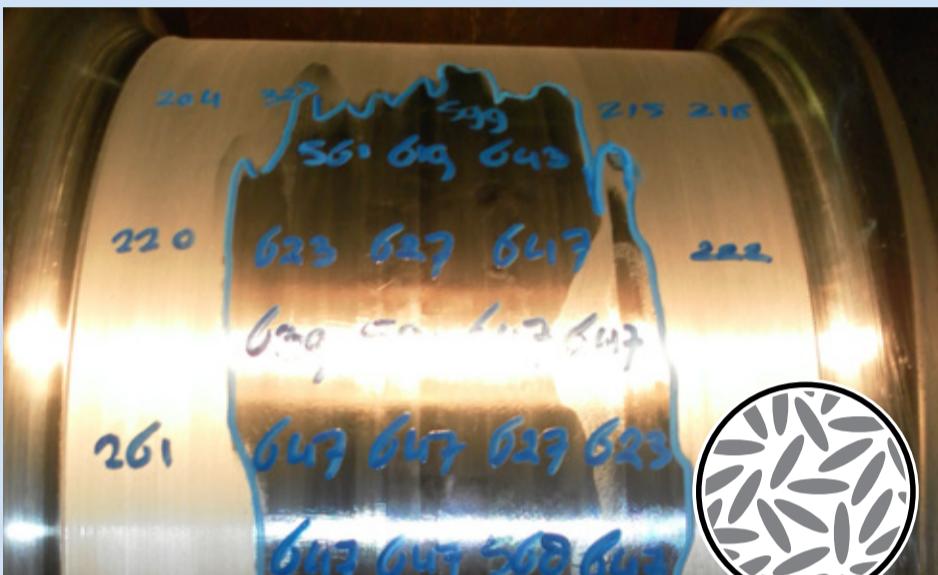
During a bearing failure, a crankshaft absorbs an incredible amount of heat. Emergency stopping of the engine introduces an uncontrolled cooling or quenching that often results in areas of excessive hardness in the range of 600 to 700+HB

Uneven grain structure with significant and visible differences in hardness create areas that are highly susceptible to cracking and potential shearing under force. Oftentimes, this hardness goes deep into the metal and without annealing would result in the condemnation of the crankshaft.

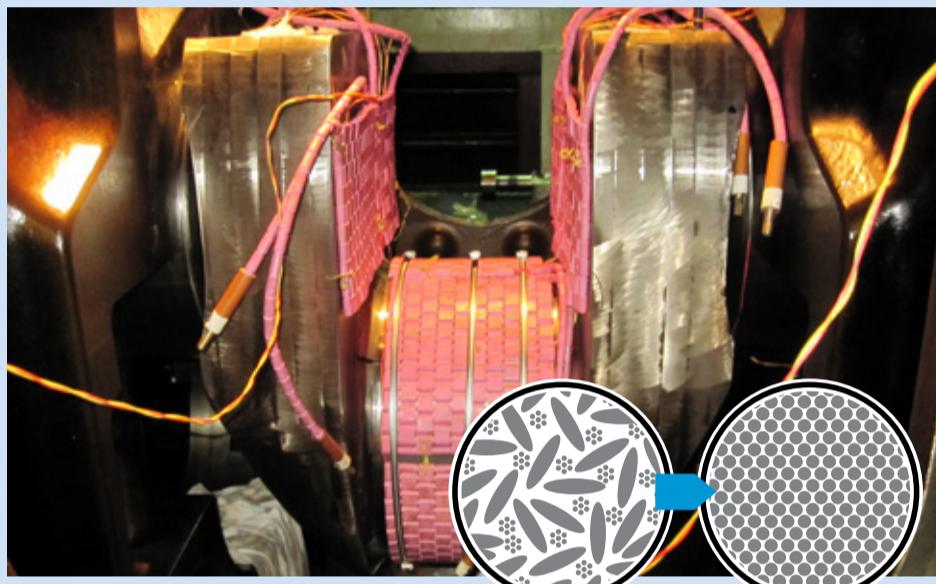
On a molecular level, when a metal such as steel cools down rapidly, the crystalline grains in the metal transform into a lenticular shape. This causes the metal to become harder but also more brittle in the process. Heating the metal to an appropriate temperature causes a homogenous growth of new crystals. The more heat is applied to the metal, the more its ductility increases and its hardness decreases.

Heat is applied to the shaft in a tightly controlled manner above its critical temperature but well below the austenite range where the crankshaft could be permanently damaged. This temperature is held for a time period related to shaft diameter and extent of damage before being cooled in an equally controlled manner.

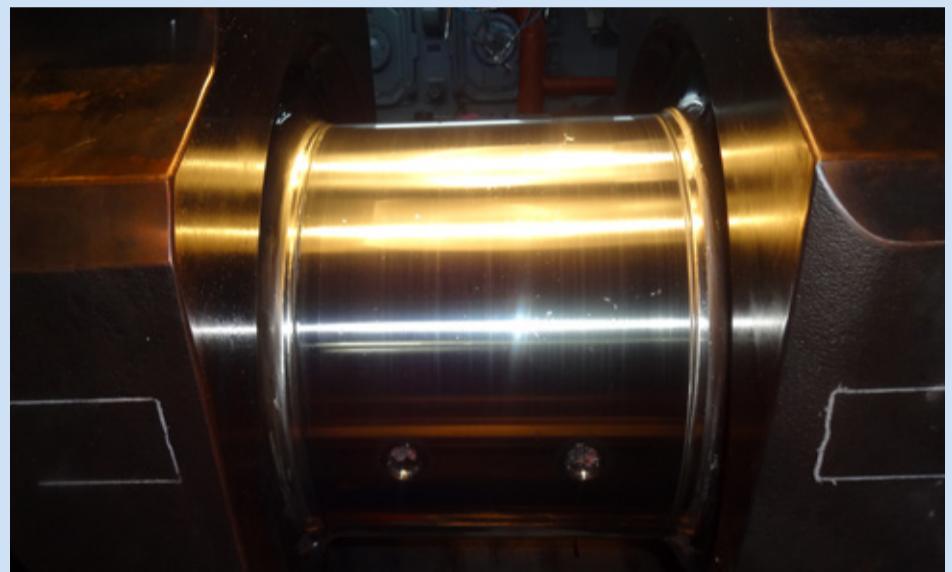
The journal now has an acceptable hardness across the entire surface of the pin and the surface has been polished to a finish generally of  $0.03R_a$  or better.

Once the shaft is cooled, the surface of the journal is rough with scale from oxidation of the metal during the annealing process. The shaft must then be machined to finish diameter and machine polished to the required finish.

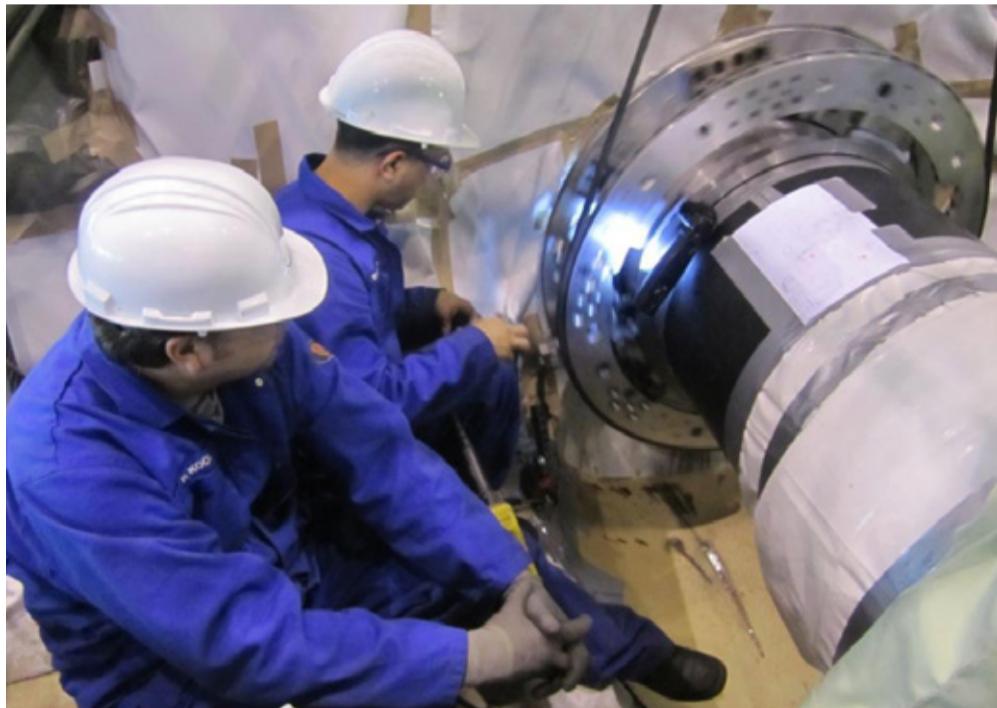
Goltens In-Situ machinists machining a 610mm diameter shaft on a newly installed Hitachi TC4F steam turbine journal that was damaged during operational testing at the Maasvlakte Electrabel Powerplant in the port of Rotterdam. Working closely with the manufacturer's technical representatives, Goltens removed 1.20mm from the shaft diameter and finished the journal surface to 0.12Ra.

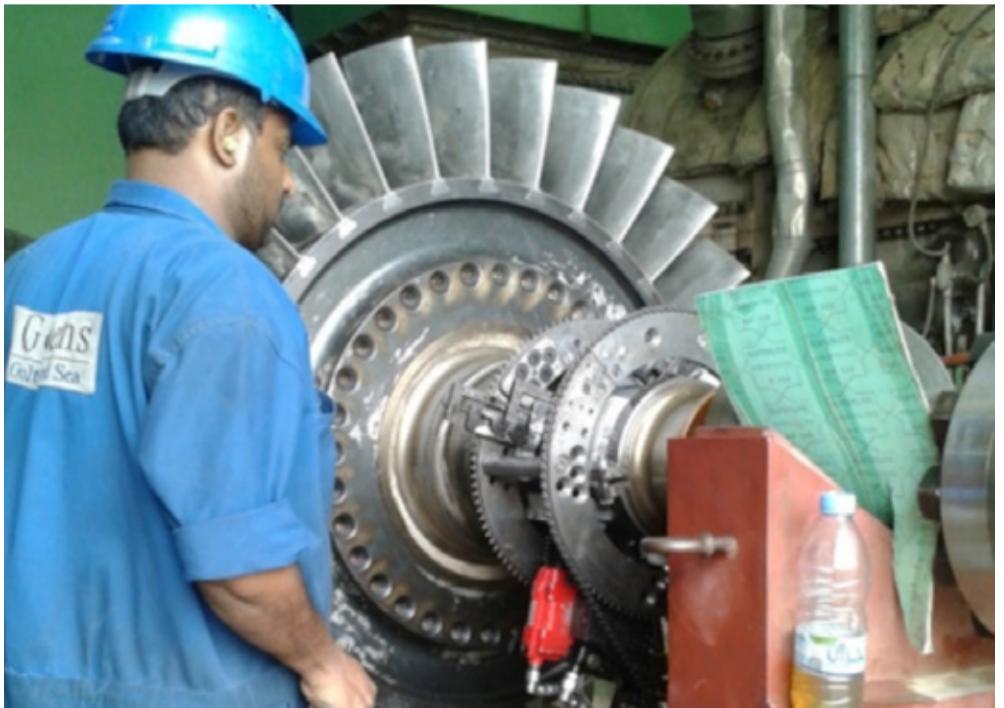
Saudi Electric Company (SEC) contacted Goltens Red Sea (Saudi) about damage to the shaft on a Fiat TG 20 B-7/8 Gas Turbine at their Narjan Power Plant. As the damage on the compressor bearing journal was more significant, Goltens' In-Situ machinists needed to perform fine grinding and honing on the journal to remove the heavy scoring. Goltens removed the scoring taking only 0.25mm from the shaft diameter. As the damage to the exhaust side was less severe, Goltens was able to remove the lighter scoring with only honing and machine polishing.

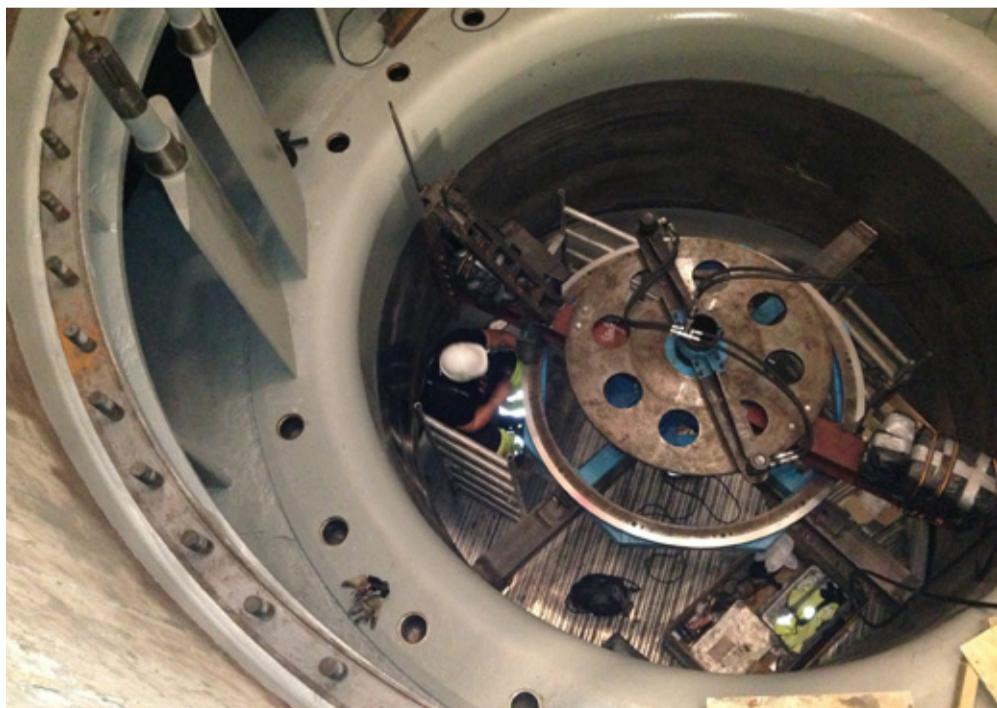
Andritz Hydro was contracted to produce a new impeller for a Kaplan hydro turbine at a plant in Hunsfoss in Southern Norway to increase the efficiency of the power plant. In order to accommodate the new impeller, Goltens was asked to machine an 800mm wide flat area and another 300mm wide oval surface on the 3.5m diameter turbine outlet. The challenging job was complicated by limitations on how Goltens' machinery could be mounted on the turbine housing. Three of Goltens In-Situ machinists completed the job in a period of 25 days, removing an average of 3.5mm from the radius.

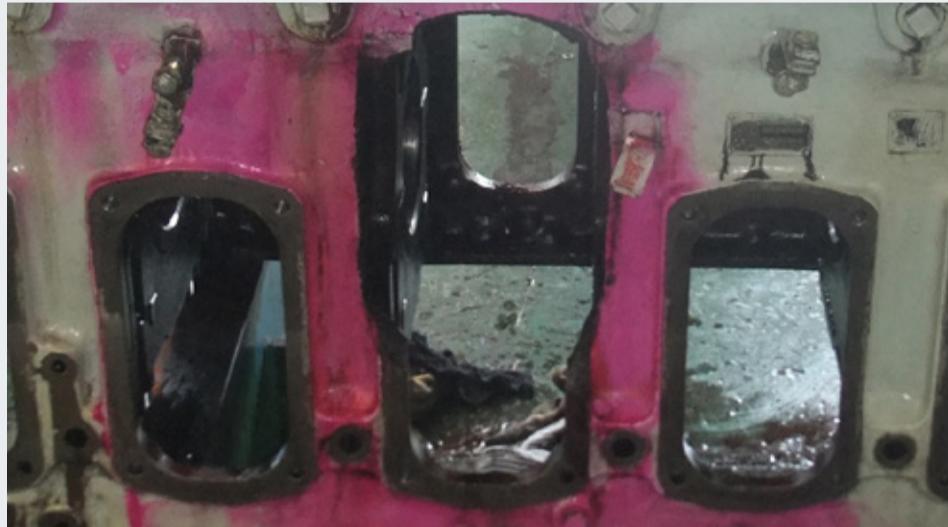
A bulk carrier's Yanmar 6N18-UN auxiliary engine suffered a broken connecting rod, resulting in serious damage to the engine block and crankshaft.

Badly damaged Yanmar 6N18-UN crankcase door resulting from a connecting rod failure.

The engine work consisted of complete cleaning and inspection of the engine block, repair of the badly damaged crankcase door by metal stitching, laser alignment checks and line boring of main bearing pockets, straightening of the crankshaft and bench grinding on all crankpin journals along with supply of seven sets of undersize bearings and polishing of all main journals.

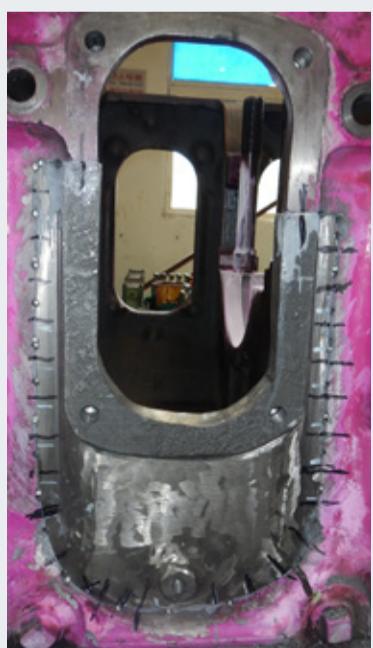
Pre-finish machining metal stitch repair.  
Full repair completed in only five days by Goltens Shanghai.

Being authorized by Yanmar and experienced in this type of repair, Goltens provided a class-approved repair procedure to repair the block by metal stitching as well as complete the rest of the required repairs on the engine during the vessel's dry docking in China. Goltens mobilized two teams to repair the engine block and complete the crankshaft grinding working on a two-shift basis in order to meet the vessel's schedule.

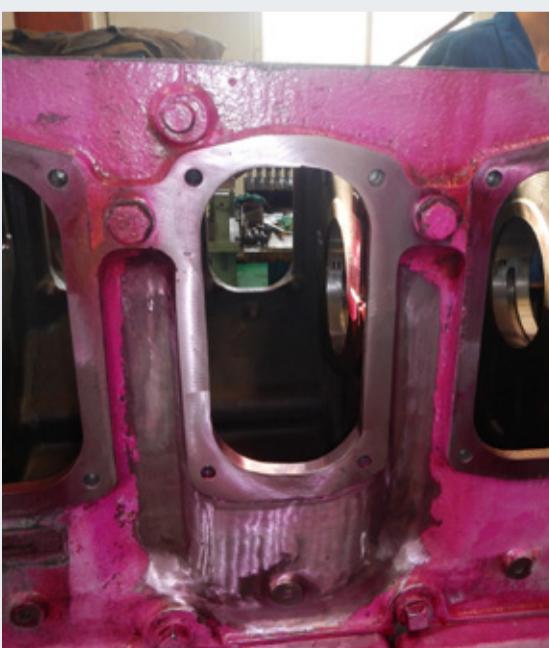
Dye penetrant crack check on the completed repair.

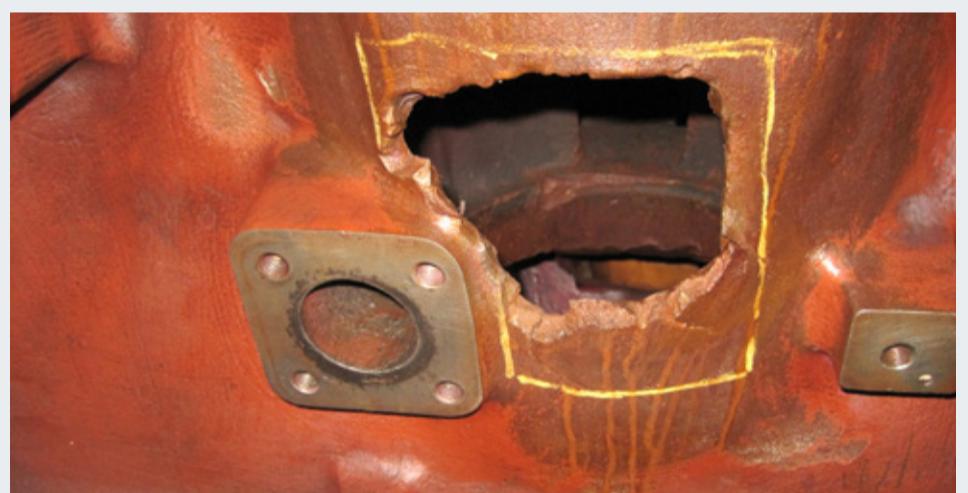
When a highly specialized offshore vessel in the U.S. Gulf suffered a catastrophic failure on one of its MaK 12M282 generators, the call went to Goltens. One of the generator's connecting rods had broken away from the crankshaft and tore through the block of the engine.

Damage resulting from a connecting rod failure on the vessel's MaK 12M282 engine.

The repairs on the damaged generator included the full inspection of the damaged block, removal of damaged portions of the block, cutting and fitting replacement pieces from condemned block to stitch into place, metal stitching replacement pieces into place, finish machining and stress relieving of seam surfaces and finally crack testing of the repairs.

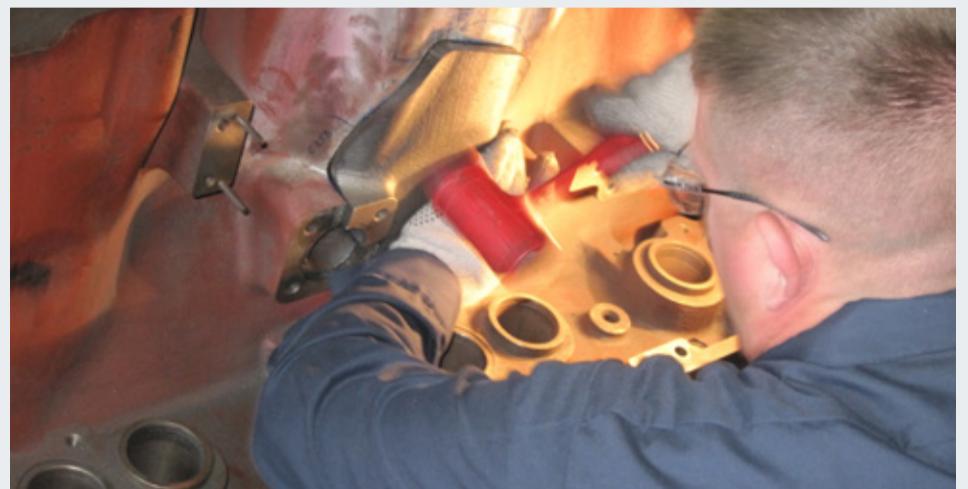
Machinist fitting replacement piece into place prior to metal stitching.

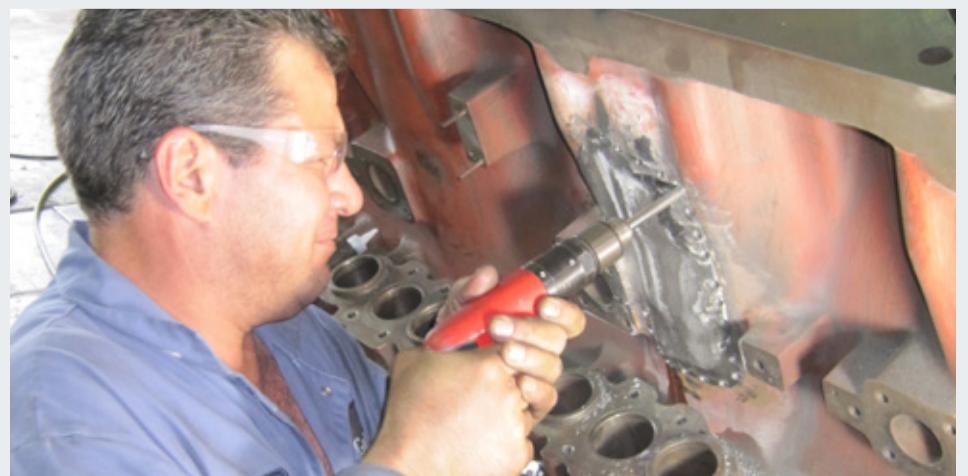
Goltens' machinist stitching replacement piece into place prior to installation of locks to complete the repair.

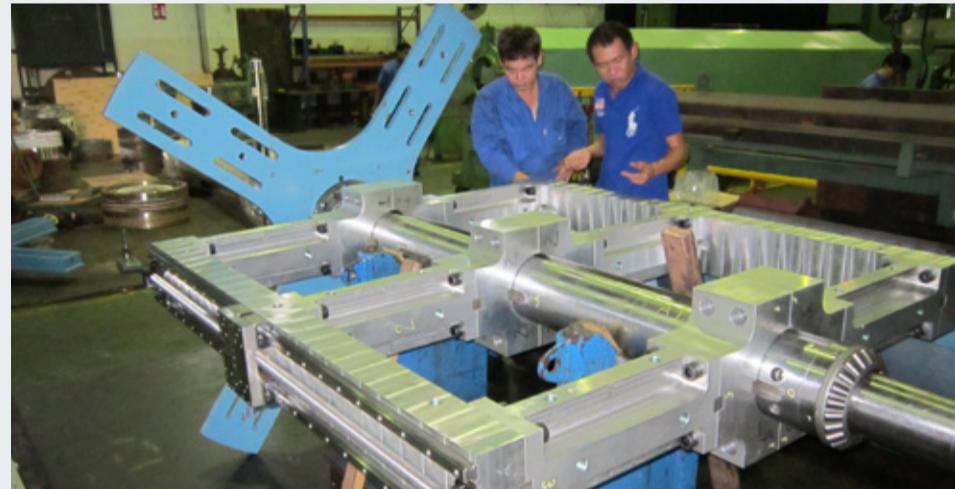
Goltens' G2000 boring machine during construction in Goltens Singapore workshop.

custom expandable boring tool, the G2000. The G2000 can handle larger diameters (up to 3 meters), tight tolerances and requirements for tapered boring. After successful completion of the Leewek Constellation job, Goltens received a follow-on order from Triyards to machine the inside diameter on a newbuild outer turret column on the *Bellinda FSO* project with an inside diameter of 2.9 meters.

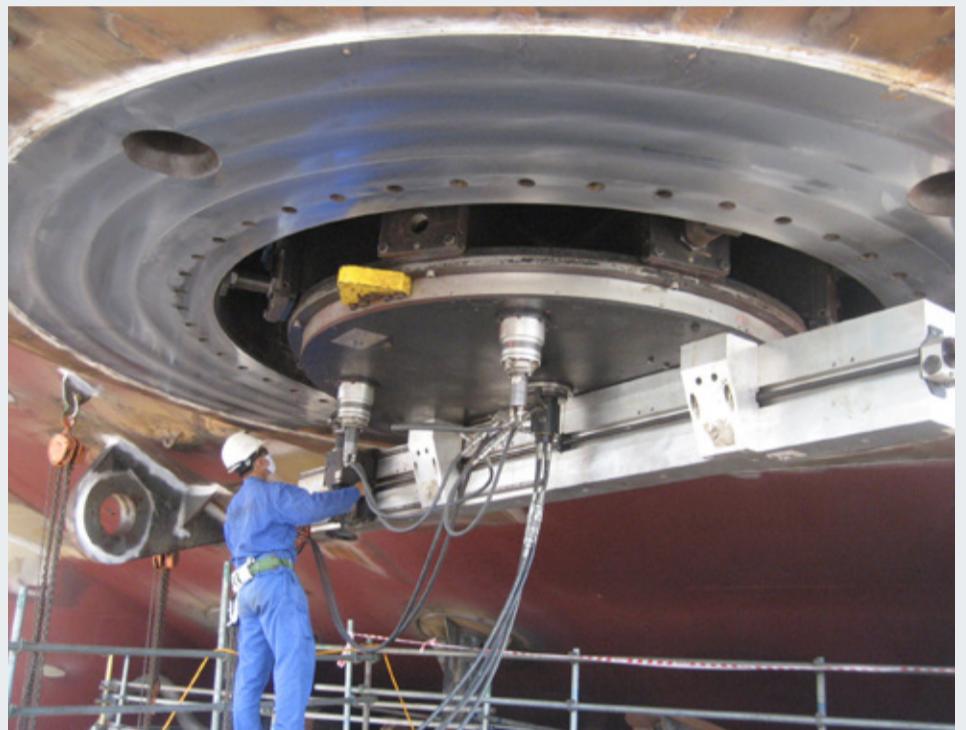
Goltens 6000i flange facing machine mounted on the 4.7m diameter flanges for the vessel's two 6MW Stern Thrusters. Machining was complicated by the inverted mounting of the machinery and the tight flatness tolerances of 0.15mm across the surface.

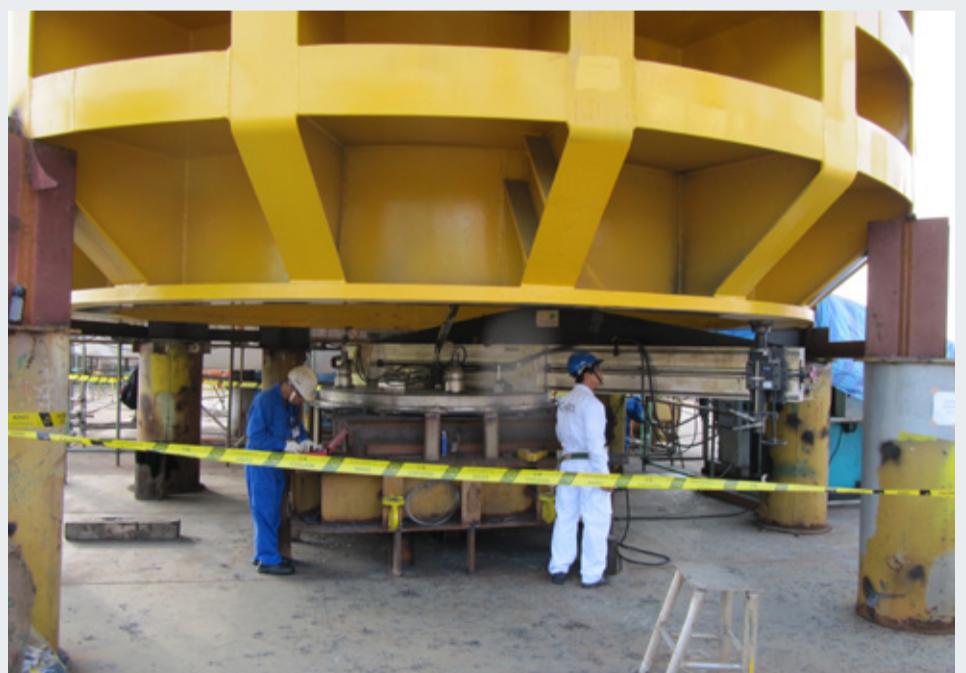
Flange facing of the underside of a turret head on an FPSO conversion project in Keppel Shipyard in Singapore (OD 5.99m/ID 5.58m)

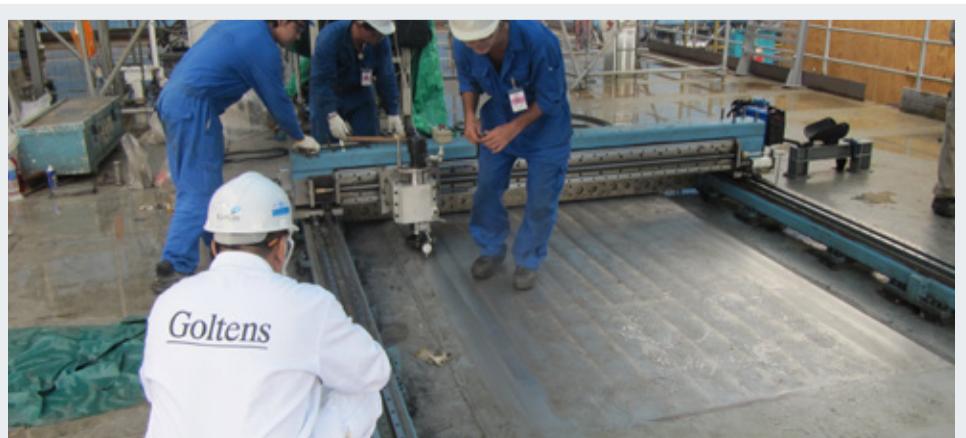
Goltens 6m diameter flange facer modified to handle the outside diameter machining on and inconel turret column on a newbuild vessel in Vietnam. Shop trials of the modified machinery underway in Goltens' workshop prior to shipment to Vietnam.

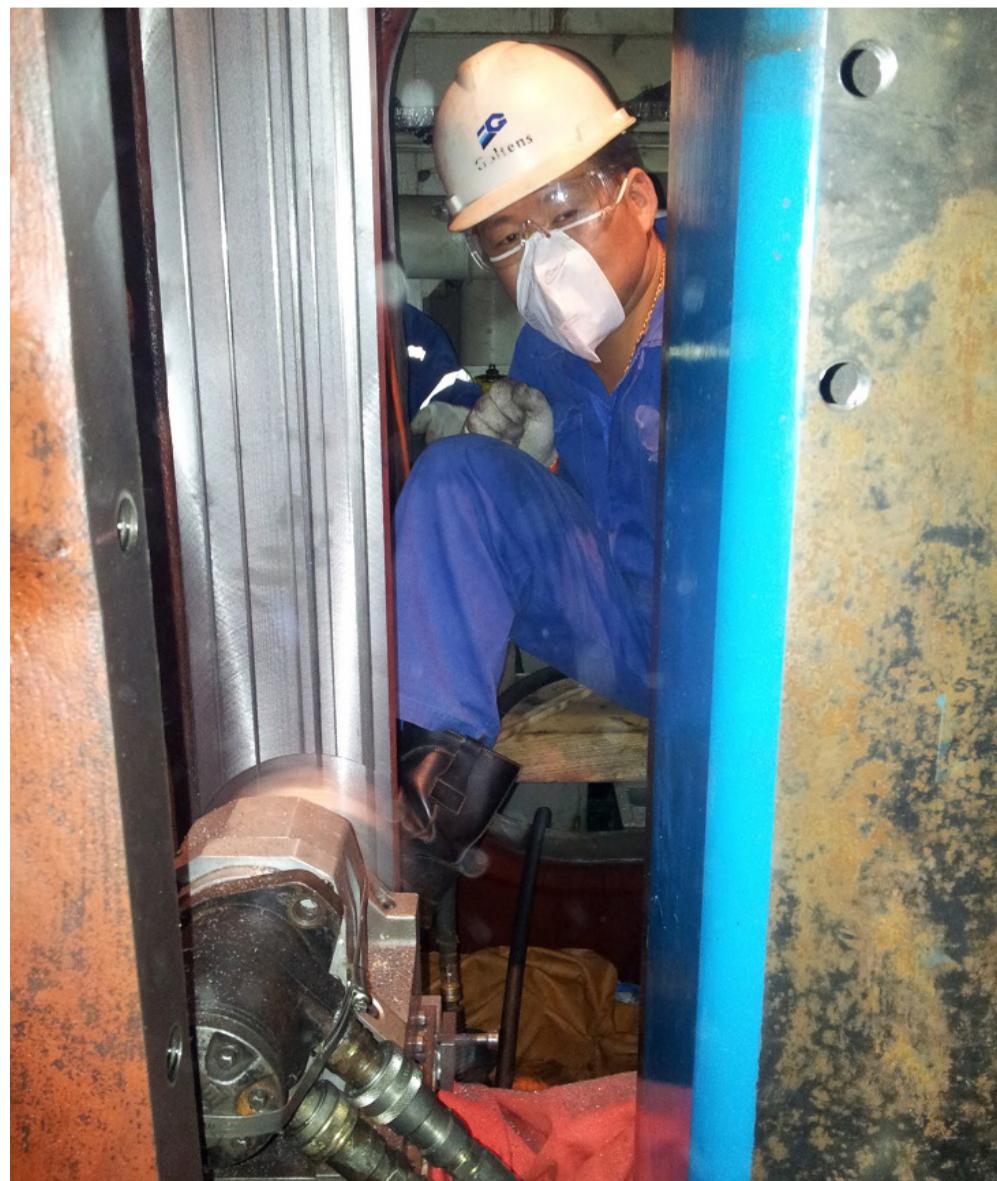
The ship manager requested Goltens, Mitsubishi's authorized service partner, to immediately dispatch their In-Situ Machining supervisor and technical manager to check the main engine guide shoe condition. Goltens' inspection revealed severe and deep scoring all along the length of the guide shoe support rails on three

cylinders as well as serious damage to the guide bearings.

Goltens' In-situ Machining technician monitoring the progress of the guide rail machining on damaged Mitsubishi 6UEC52LA. Note deep vertical scoring on rails.

Goltens' In-Situ specialists removed between 1.5 and 2.5mm from the badly damaged rails in

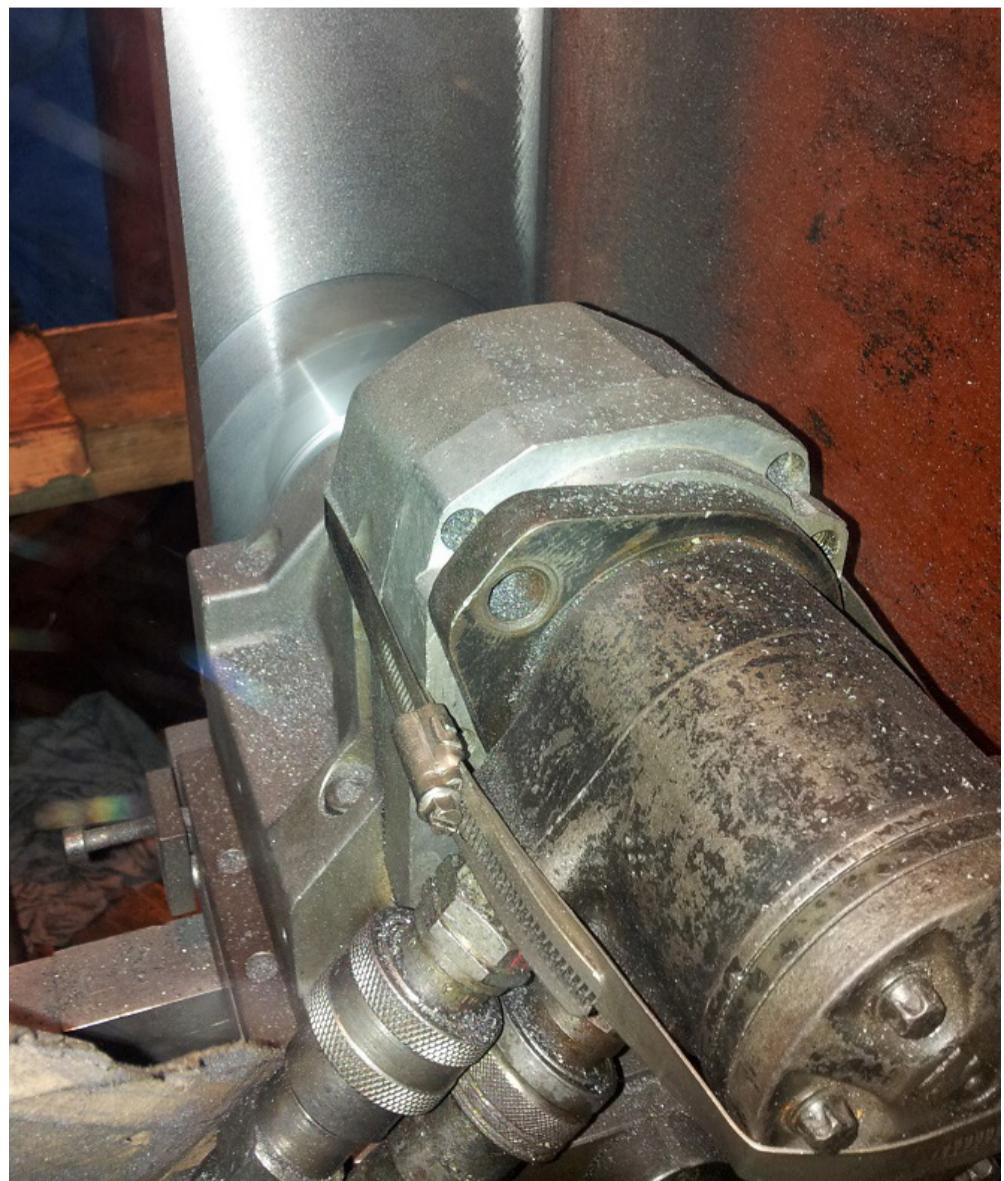
Machining near completion on one of the damaged guide rails. Deep scoring has been removed.

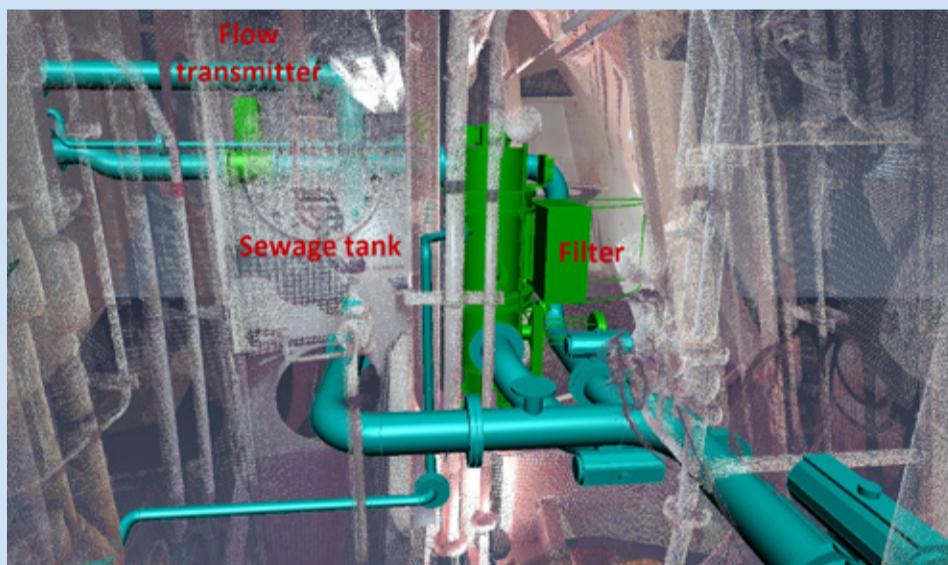
Proposed Alfa Laval Pure Ballast Filter location overlaid on 3D scan output.

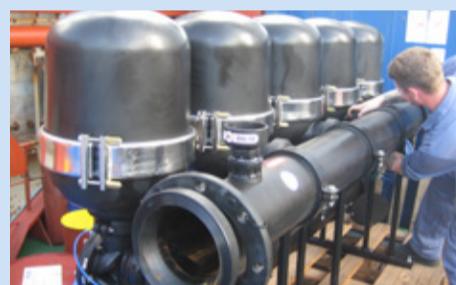
Goltens' technician preparing the Hyde Guardian filters for rigging into place in the engineering spaces.

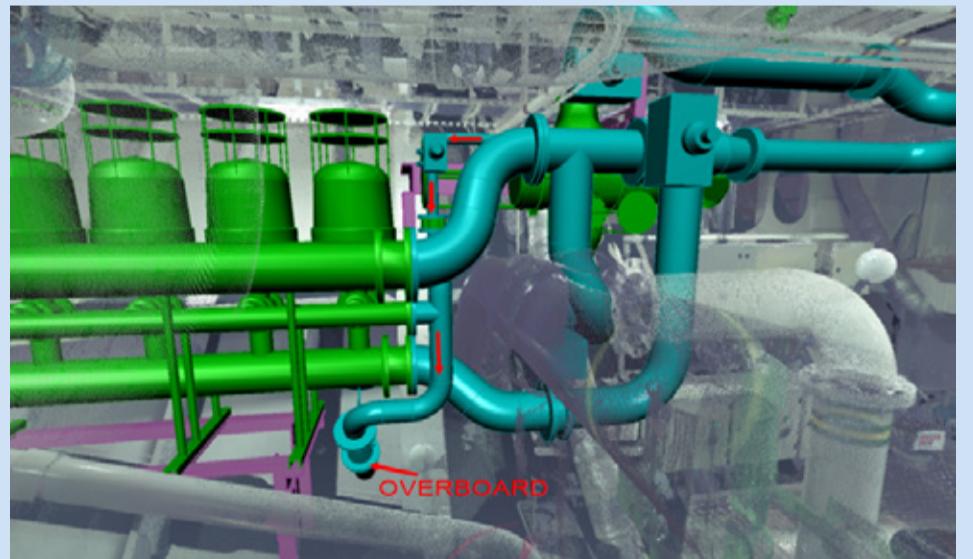
Overlay of the Hyde Guardian system on 3-D scan output showing location and connections to existing systems.

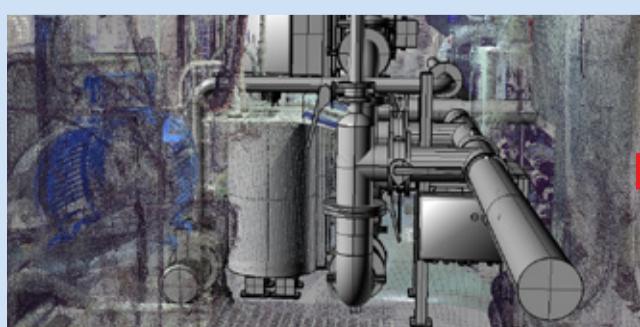
BWT System overlay on 3-D Scan results.

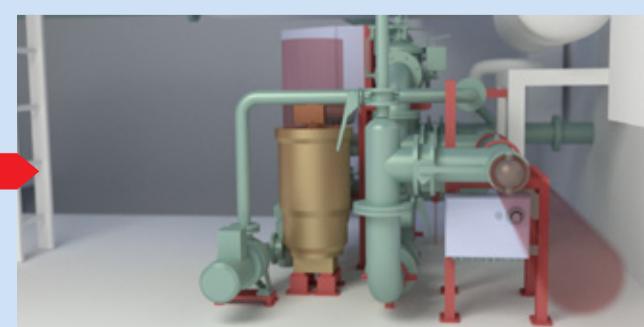
Rendering of the BWT System 3-D Model.

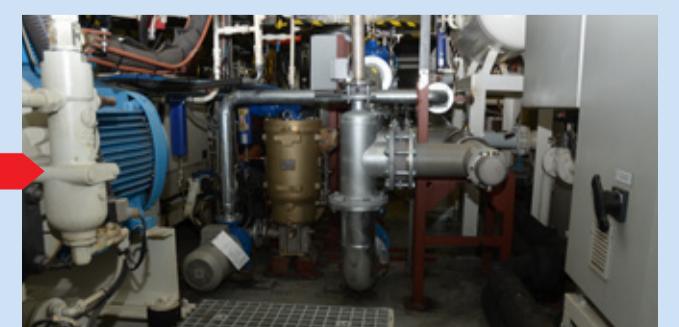
Installed Optimarin BWT system.

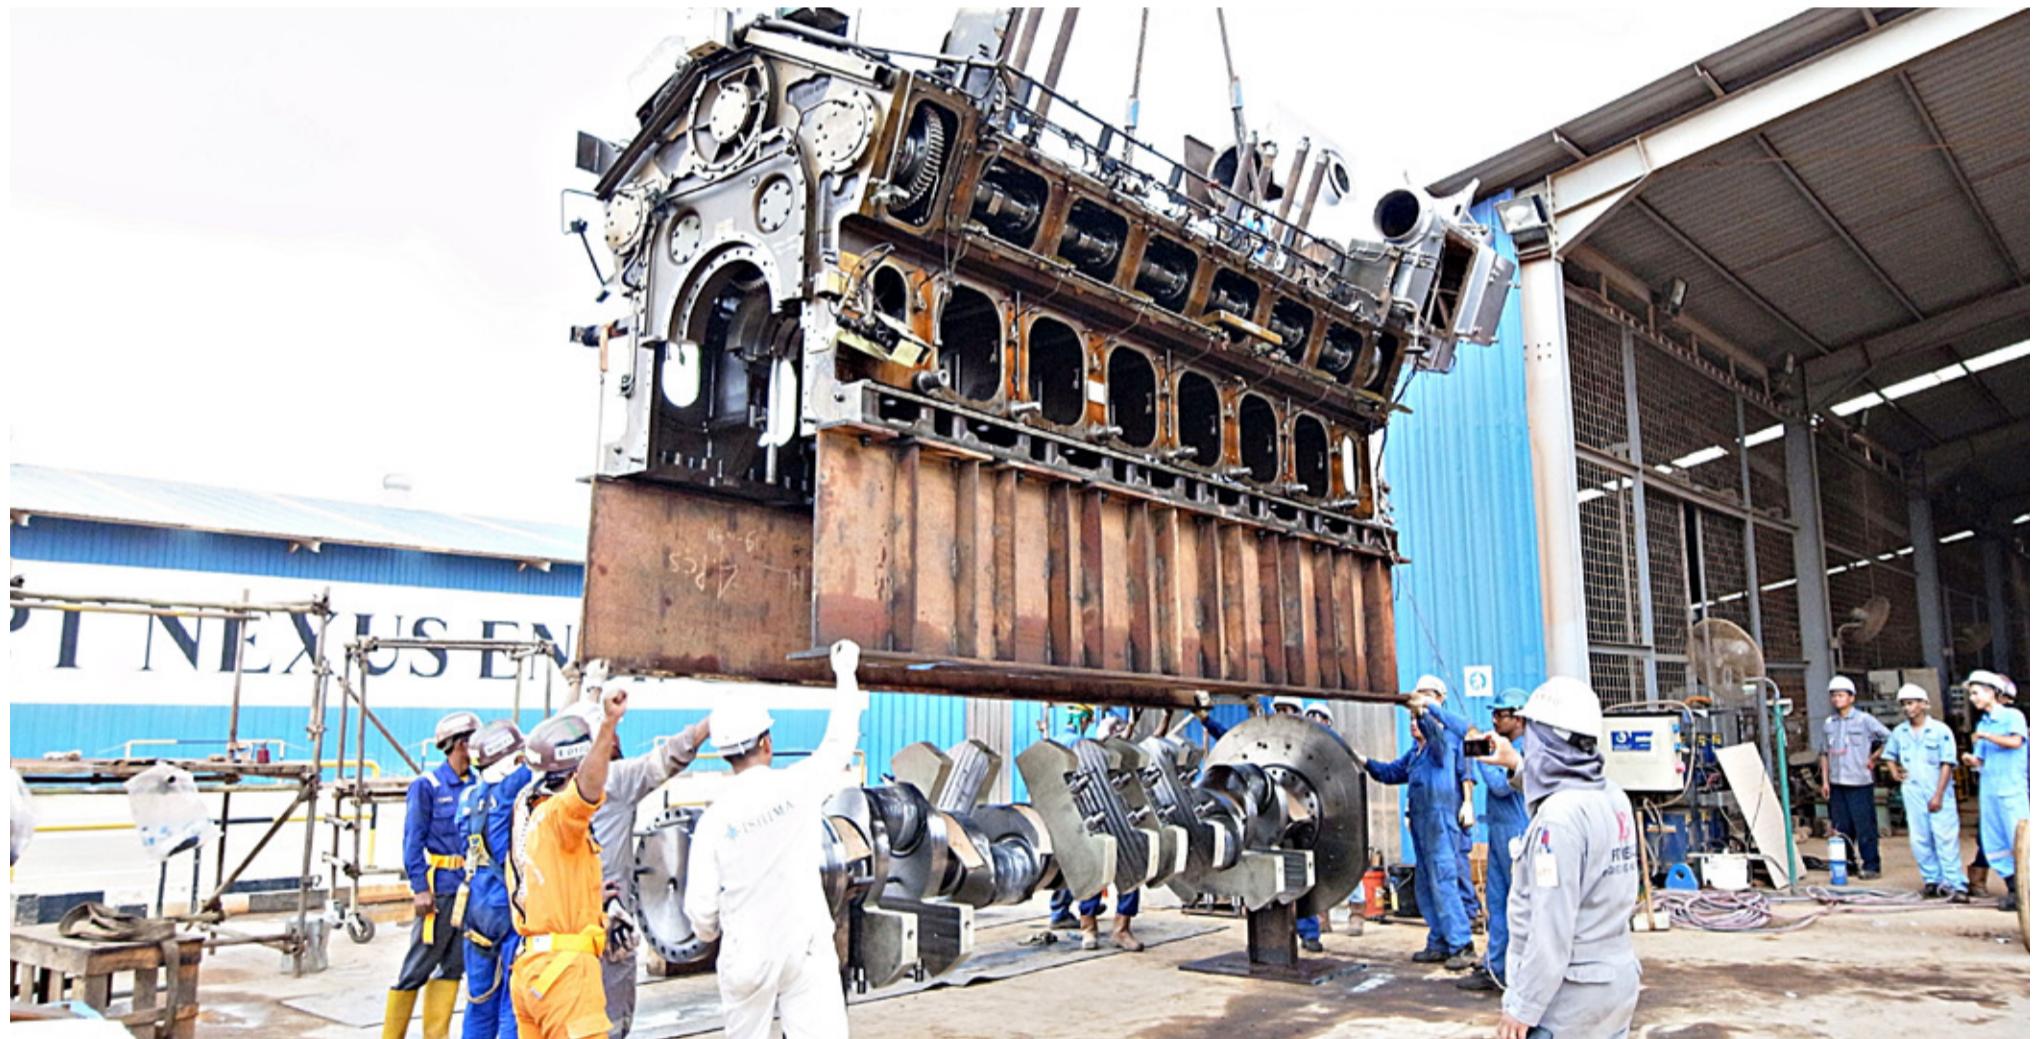
MAN B&W 12V32/40 engine block being rigged into place for the installation of the crankshaft after engine lineboring.

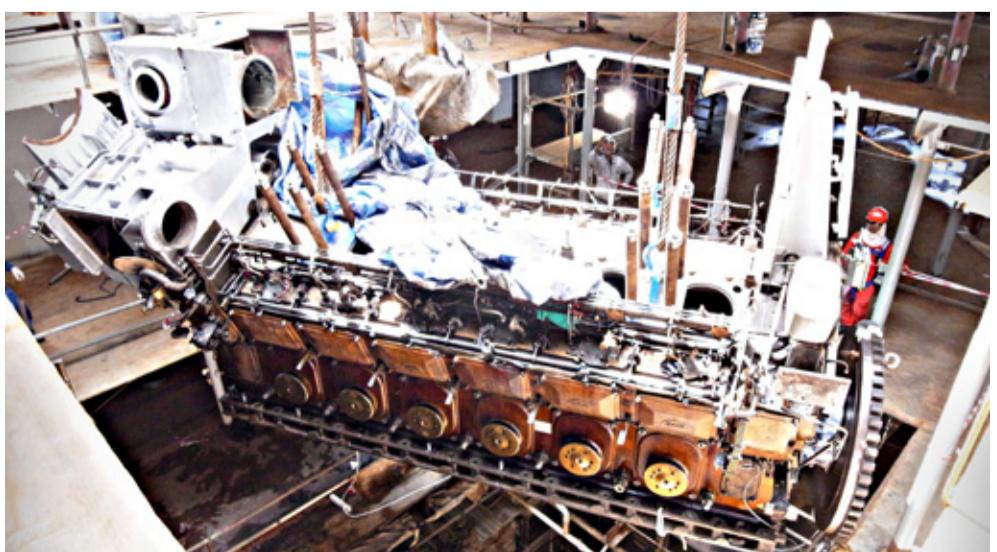
Rigging of the damaged MAN B&W 12V32/40 from the vessel for repairs.

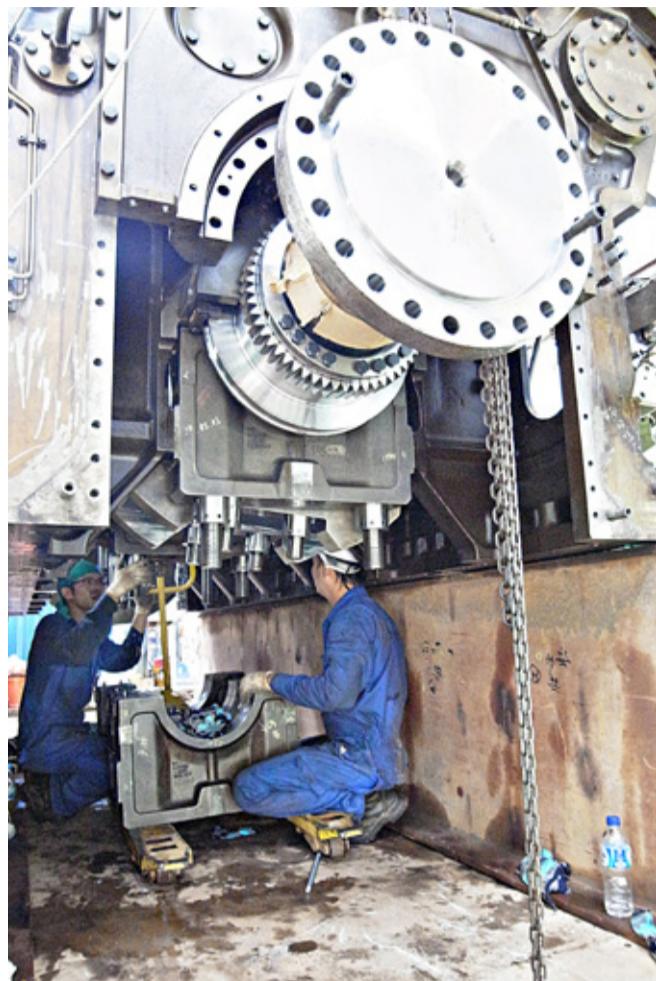
Installation of main bearings on the engine prior to rigging back on board.

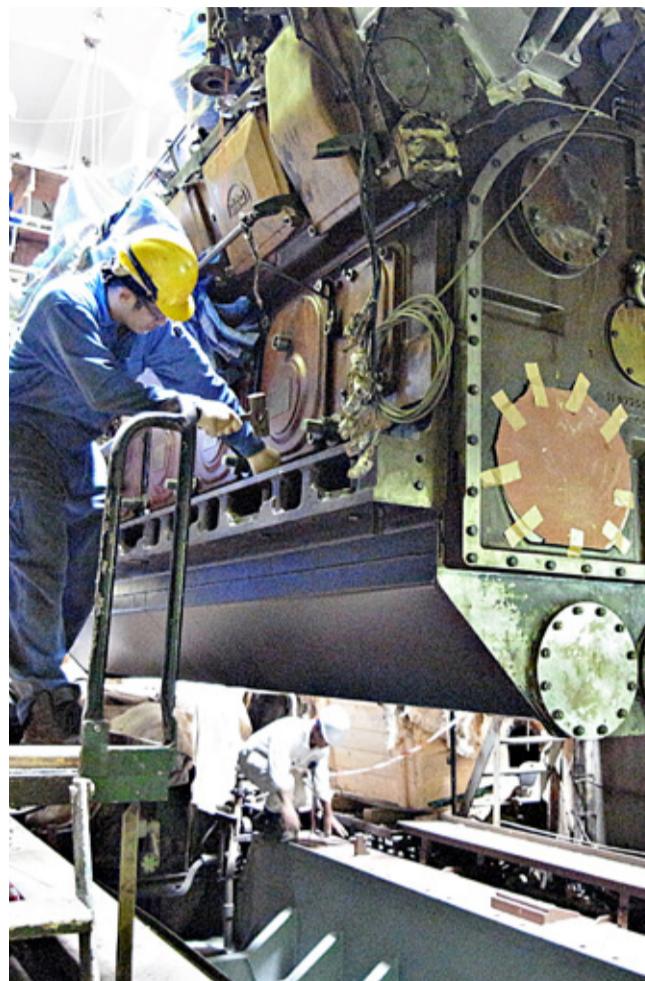
Lowering the repaired MAN B&W 12V32/40 engine into position in the engine room.

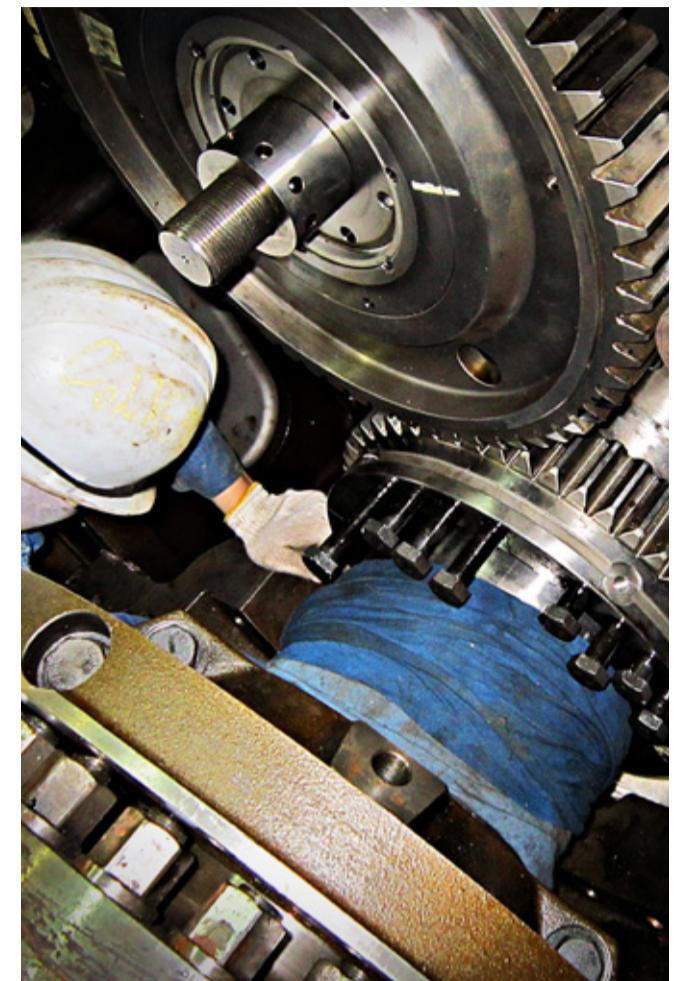
Goltens technicians adjusting timing on the overhauled engine.

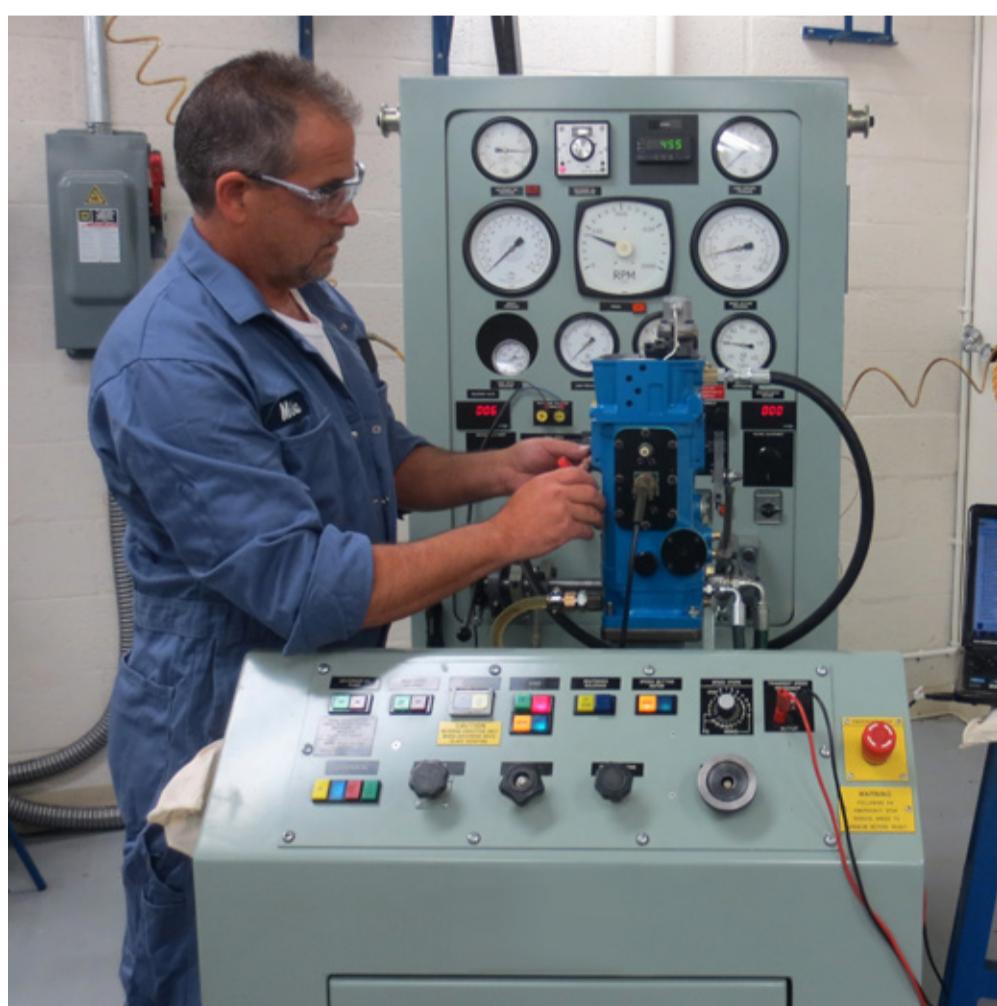
One of Goltens' governor specialists testing an overhauled governor on the test bench.
