## When Space is an Issue

Complete engine overhaul and line boring to support vessel conversion to livestock carrier

# Annealing With Class

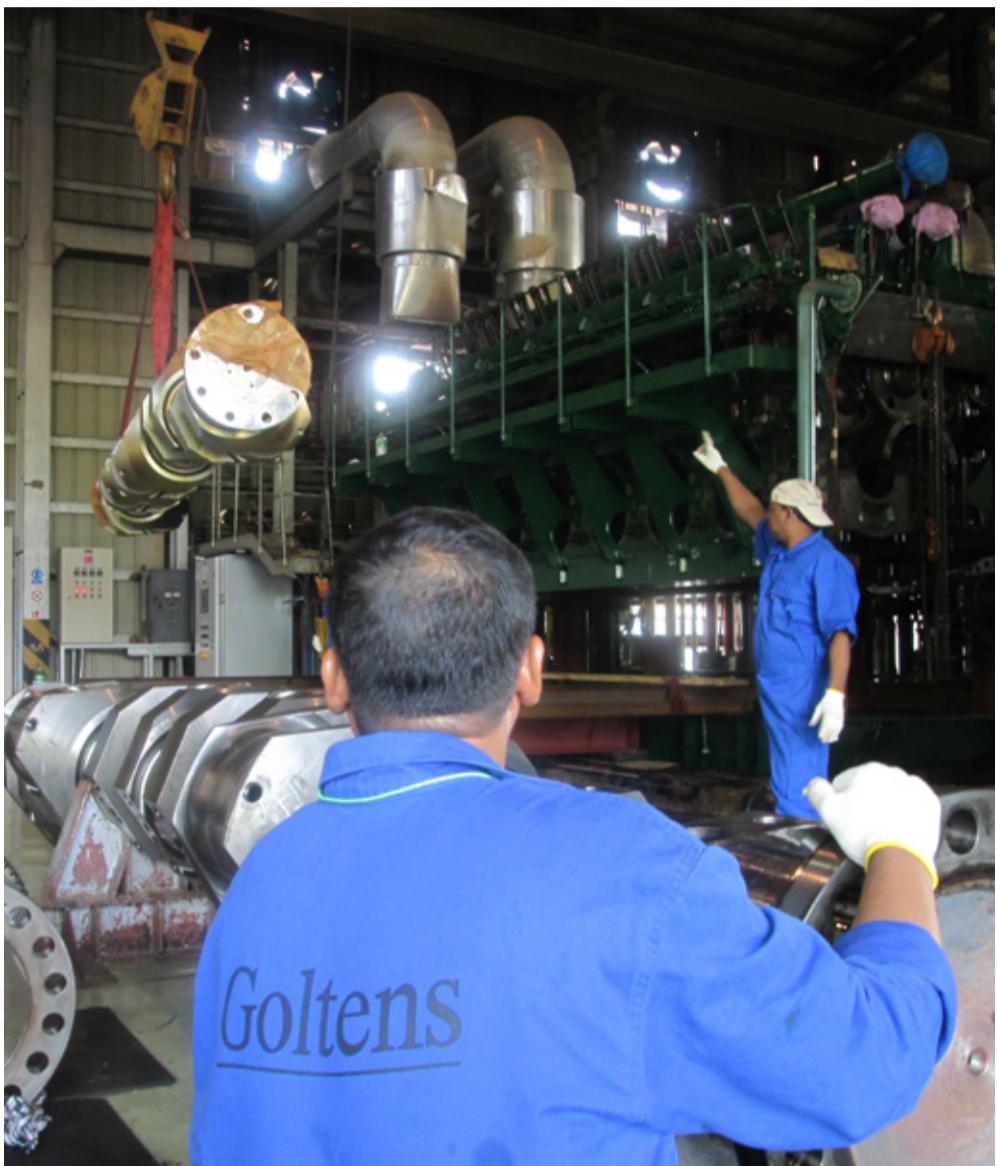
Goltens technicians rigging replacement Sulzer Z40/48 crankshaft into position at Tarlac Power.

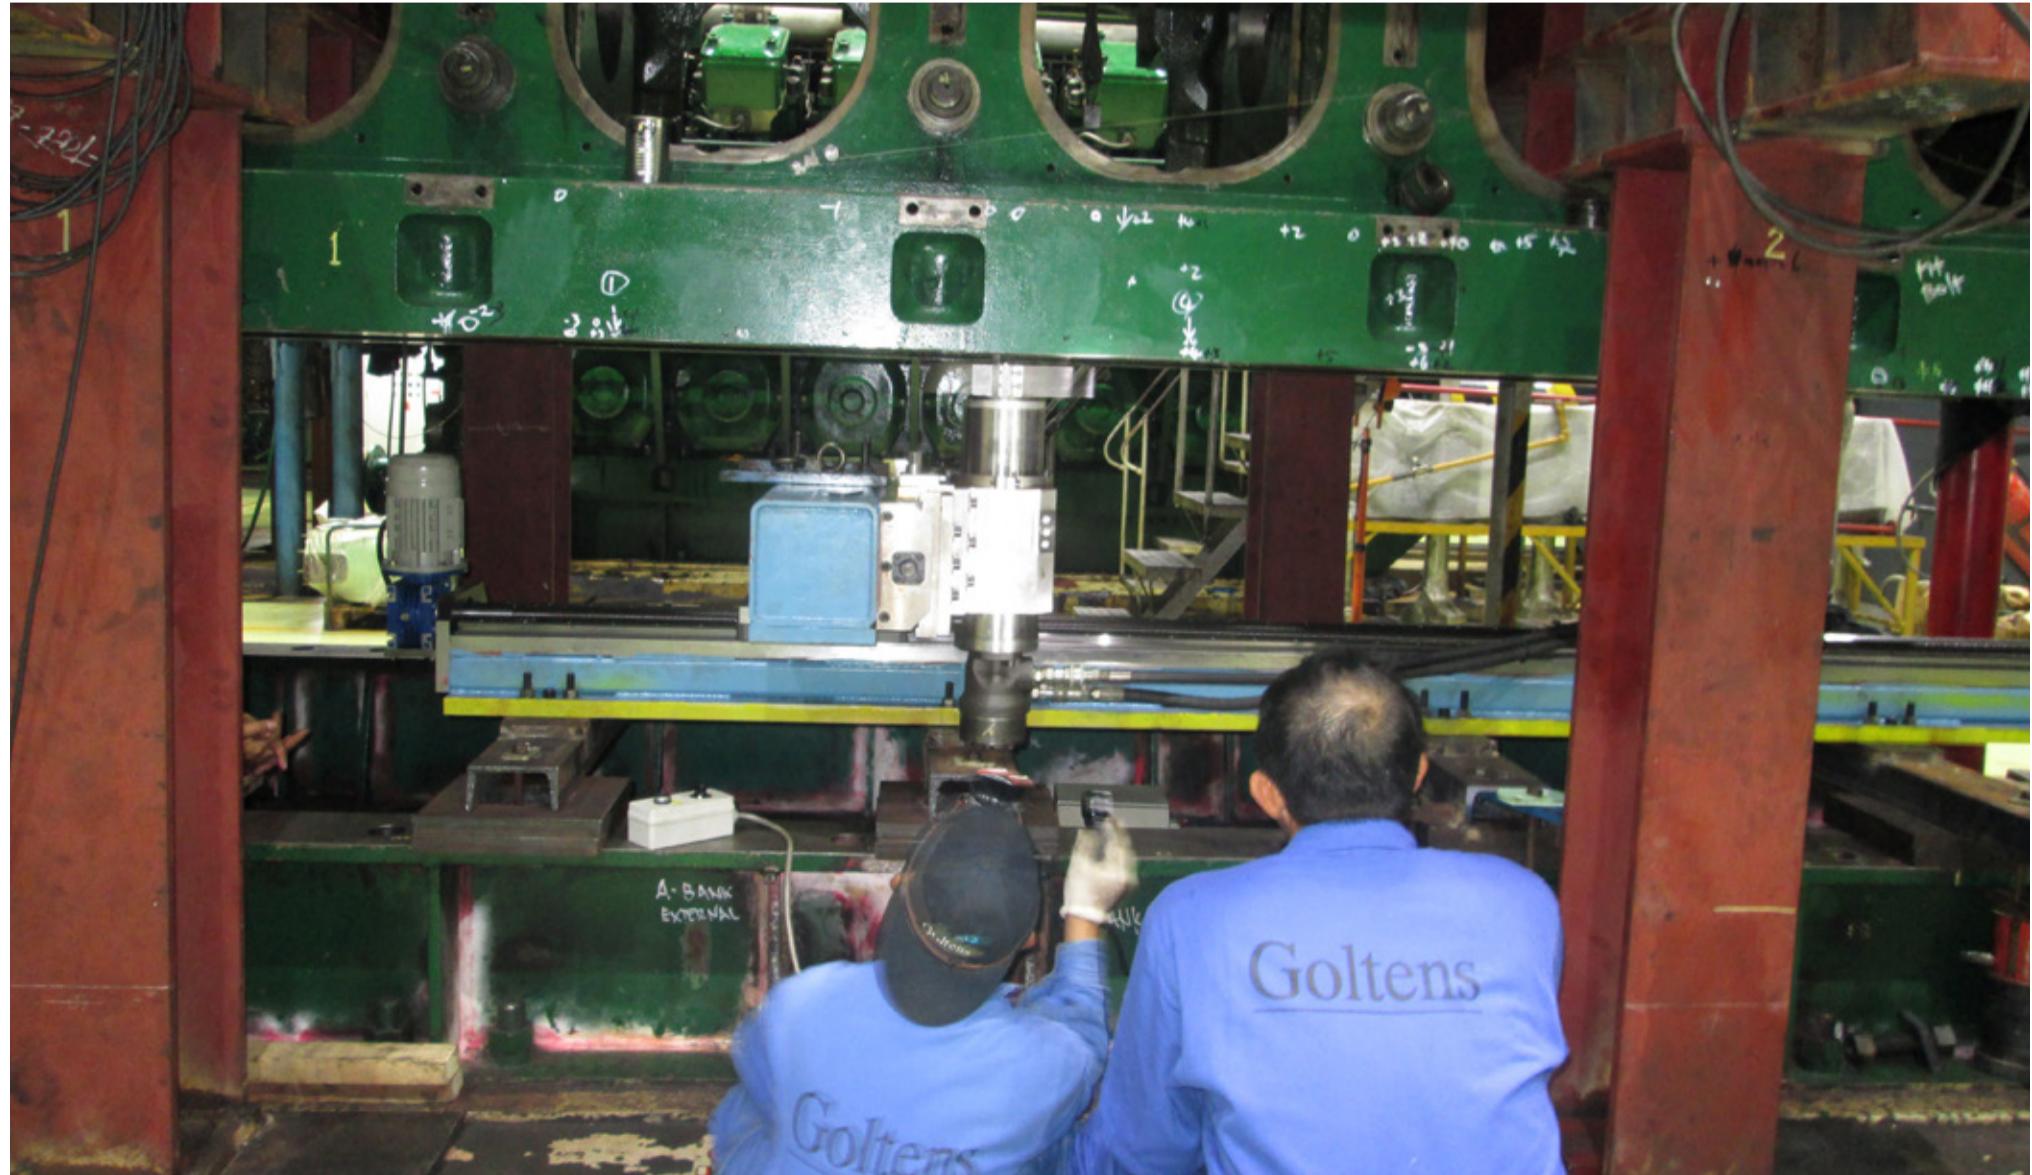
Goltens In-Situ machinists milling the underside mating surface of the Sulzer Z40/48 engine block to remove distortions.

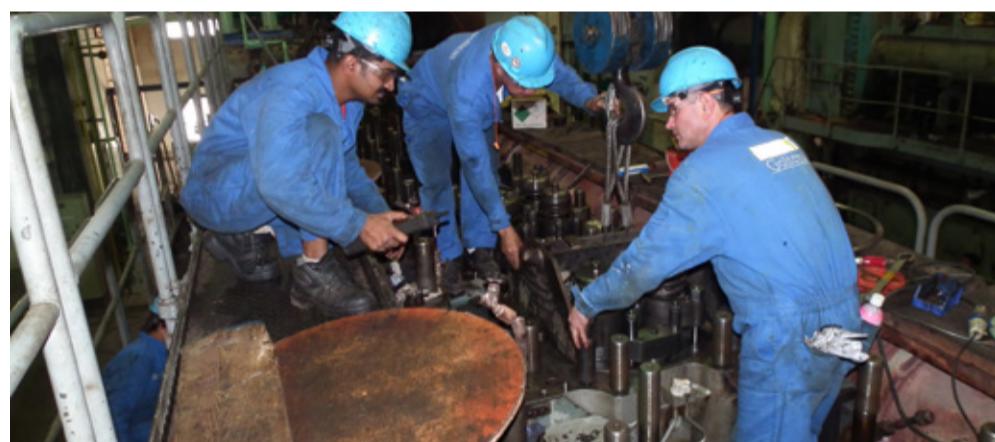
Goltens' Diesel Technicians fastening the lifting yoke to remove a cylinder head from one of the MAN B&W engines.

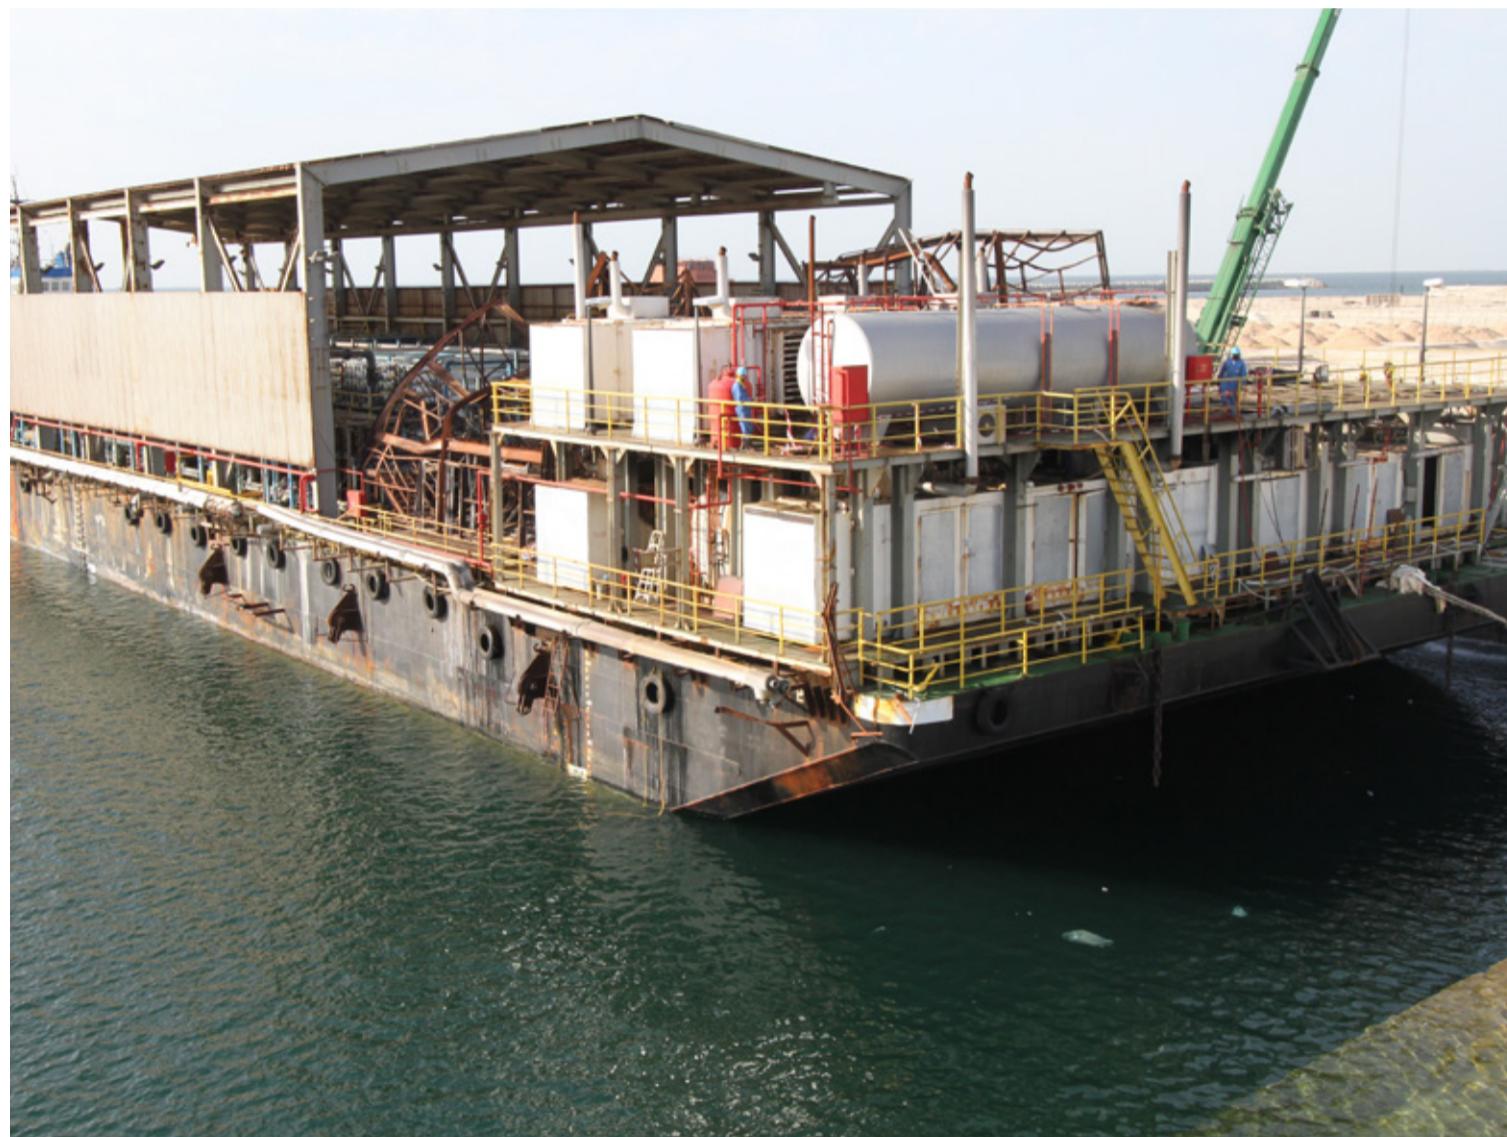
Bowarege 2 arrives in DMC end December 2013 with its Accommodation Block completely destroyed as well as serious damage to several containerized Gensets

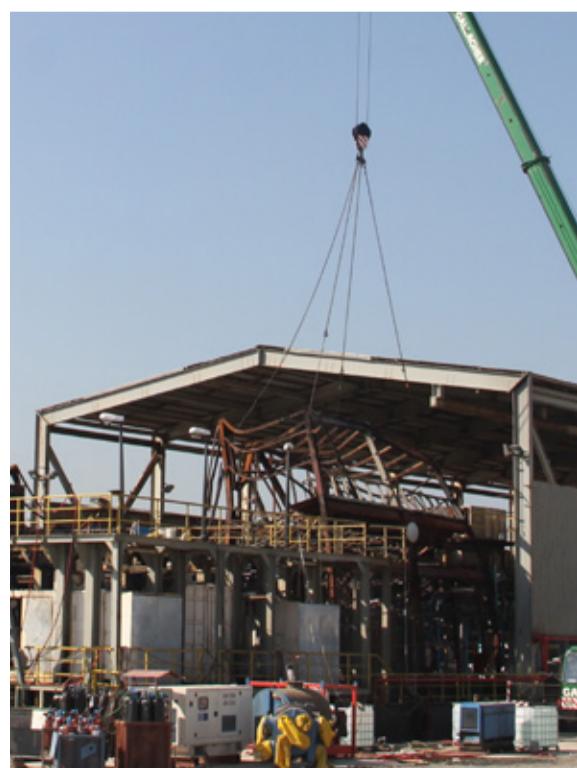
Work starts immediately to carefully remove the remnants of the burnt-out Accommodation Block, an exercise that took 3 weeks to safely complete before refurbishment work could progress.

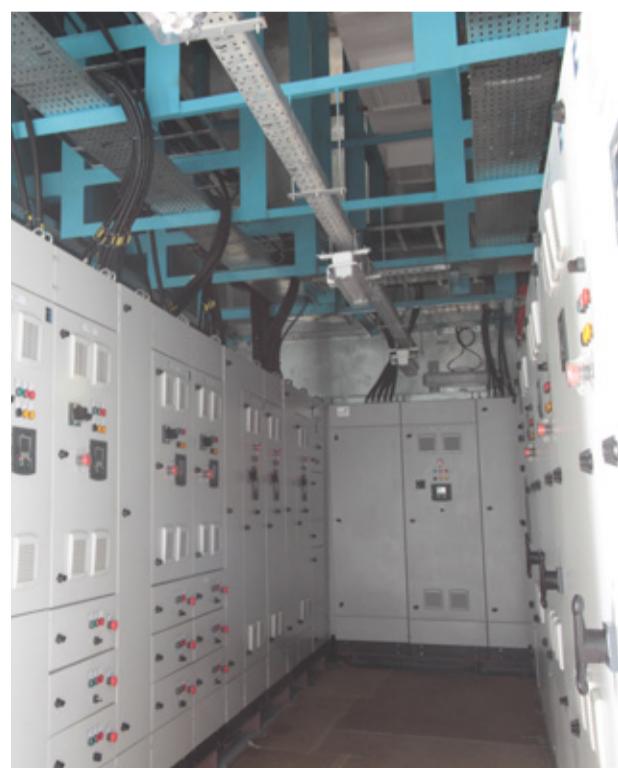
One of 6 MCC Panels in the MCC Room as part of a major electrical installation that also included PLC Cabinets, a SCADA System, and 32,000 metres of cable.

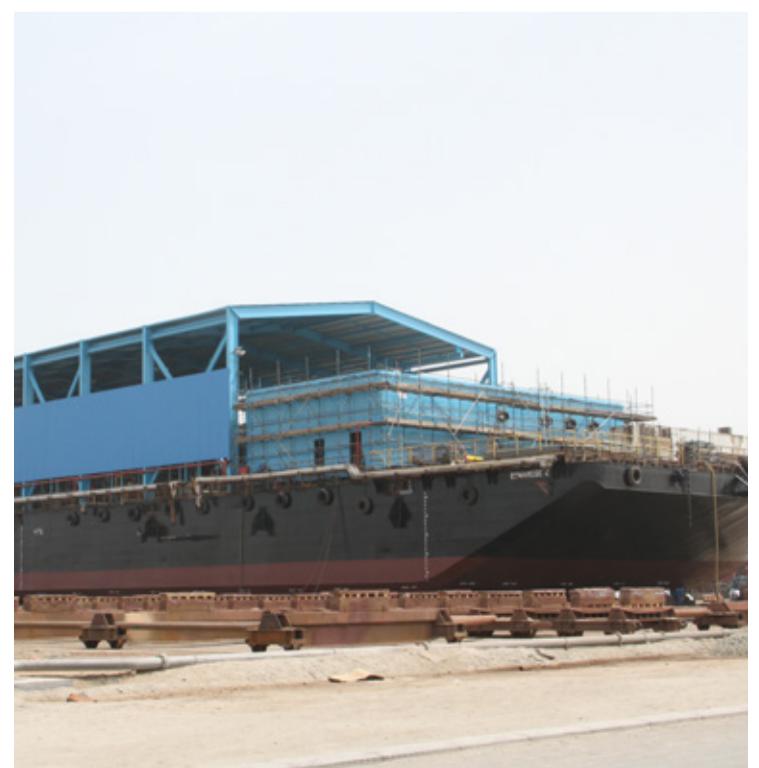
Docking scope is complete along with total refurbishment of the structure housing the desalination equipment.
