ANOTHER SUCCESSFUL REPAIR FOR ROYAL CARIBBEAN'S LEGEND OF THE SEAS

WARTSILA 12V46B CRANKSHAFT RENEWAL

PROJECT FACTS: CRANKSHAFT REPLACEMENT

Engine:	Wartsila 12V46B
Output:	15,635 HP
Vessel:	Legend of the Seas
Tonnage:	5,200 DWT

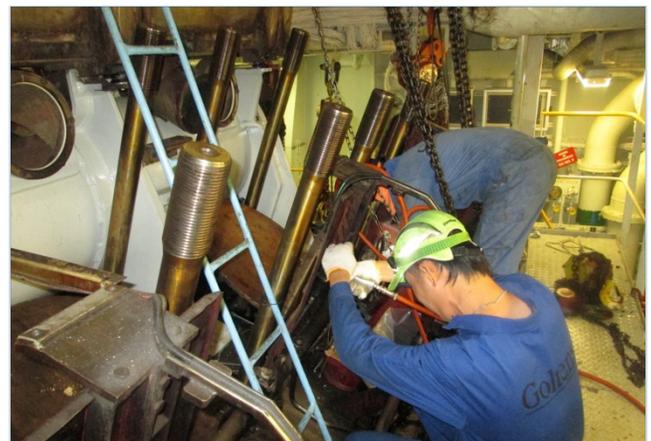
Disassembly of engine on voyage

Goltens technicians joined the vessel in Singapore and completed the dismantling of the engine on voyage to Navantia, Spain where the vessel was to dry-dock. The job was complicated by the limited space to store the dismantled components and rig the crankshafts. Goltens completed the replacement and rebuild of the engine to maker's specifications in dry-dock.

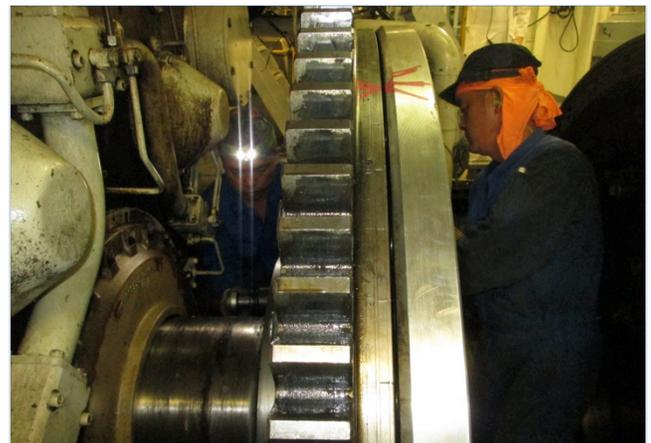
Dismantling of flywheel

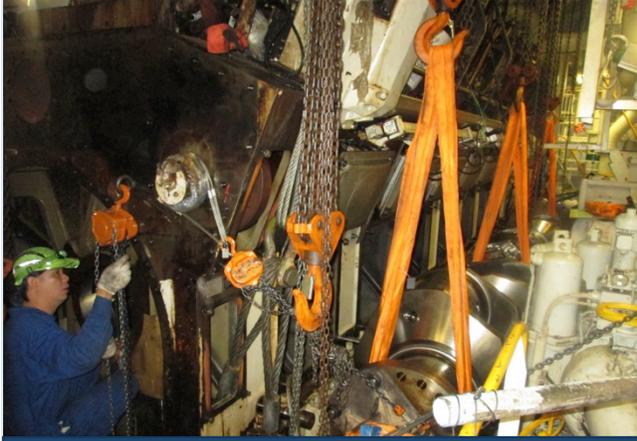
Rigging of condemned crankshaft from engine

Legend of the Seas was built in 1995 and was the most travelled cruise liner in the Royal Caribbean fleet before she was transferred to another cruise line in mid 2017. Prior to that transfer, however, a casualty on main engine #5 resulted in significant damage to one of the crankpins. Due to the depth of the crack in the crankpin, the crankshaft could not be salvaged by machining and would require replacement.

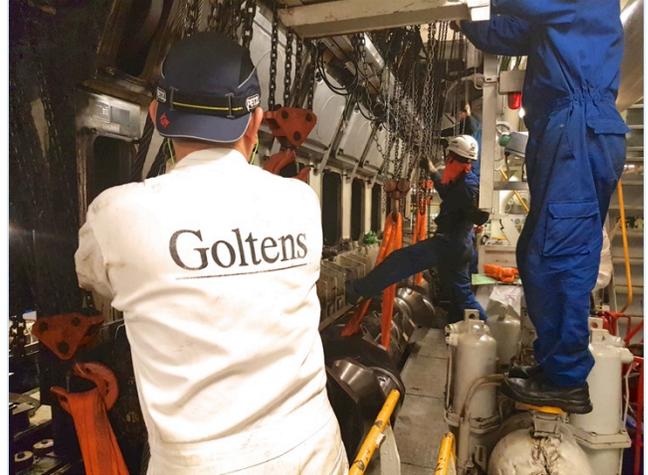
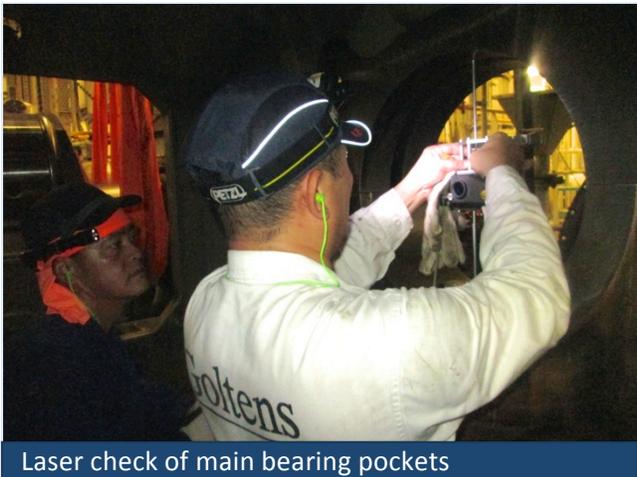
Laser check of main bearing pockets

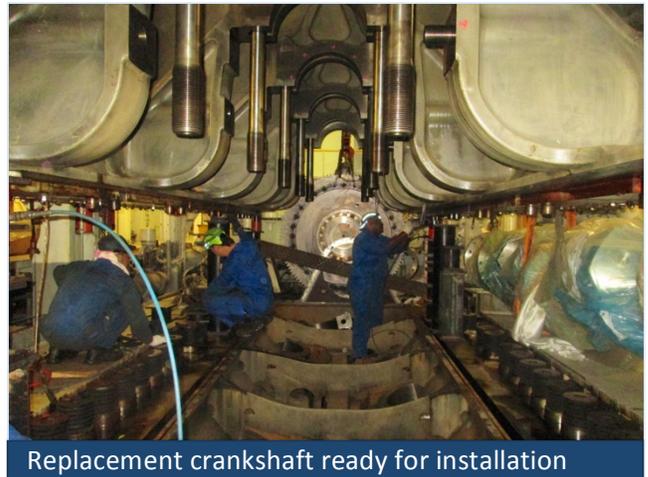
Replacement crankshaft ready for installation

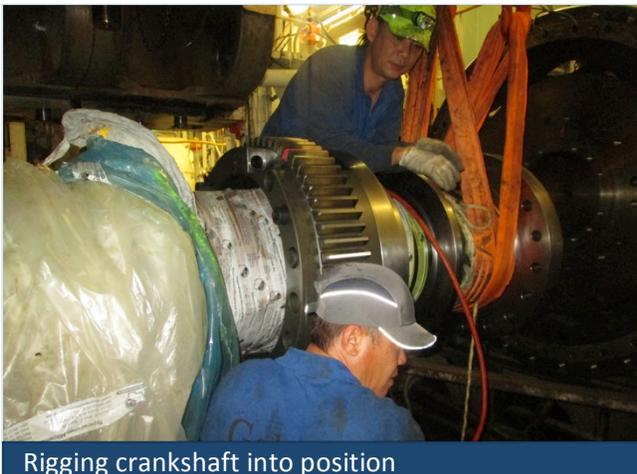
Rigging crankshaft into position

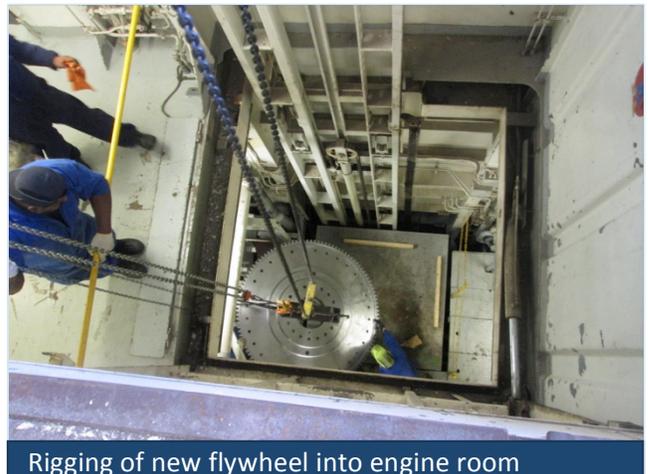
Rigging of new flywheel into engine room

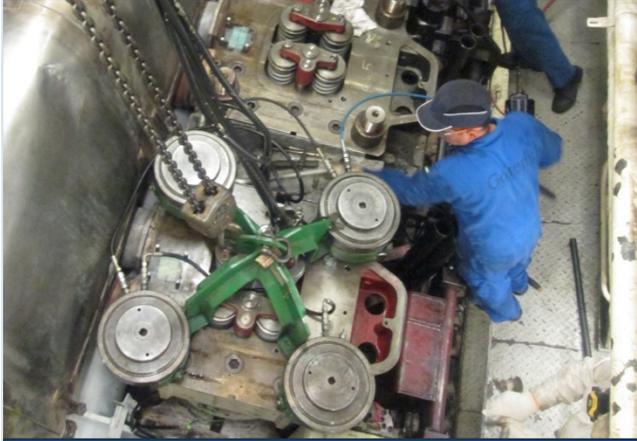
Installation of cylinder heads during rebuild

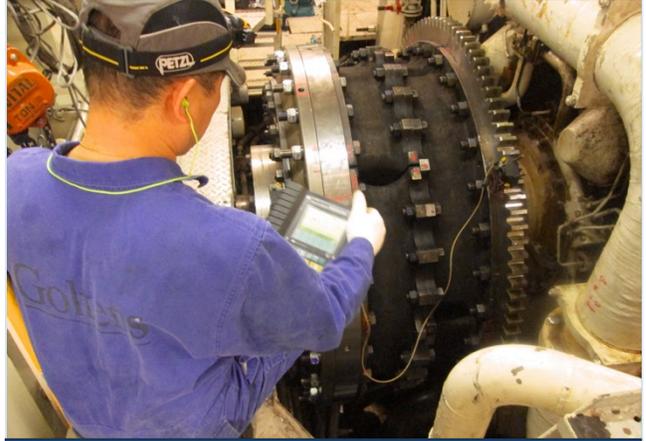
Laser alignment of coupling

Once the engine was rebuilt, Goltens laser aligned the engine and the generator and flushed the lube oil system to clear any debris. The prescribed running in procedures and operational testing were accomplished on voyage after the dry-dock. Lastly, load testing of the repaired engine was completed to the customer's satisfaction.

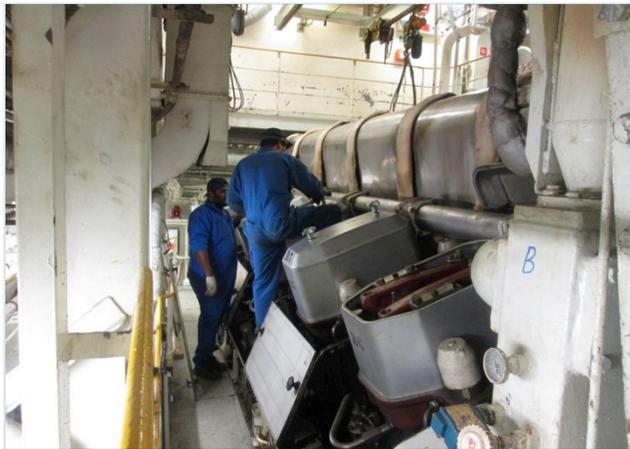
Inspection of engine during run in checks
