## The Independent Alternative

Across industries, Goltens' investments in advanced tooling, technical training and technologically advanced repair processes continue to save customers money and downtime all around the world

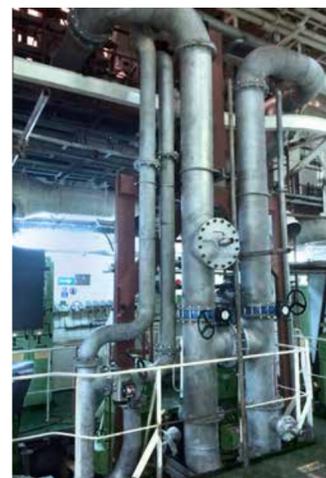
A portion of the BIO-UV Bio-Sea ballast water treatment system installed on a container ship

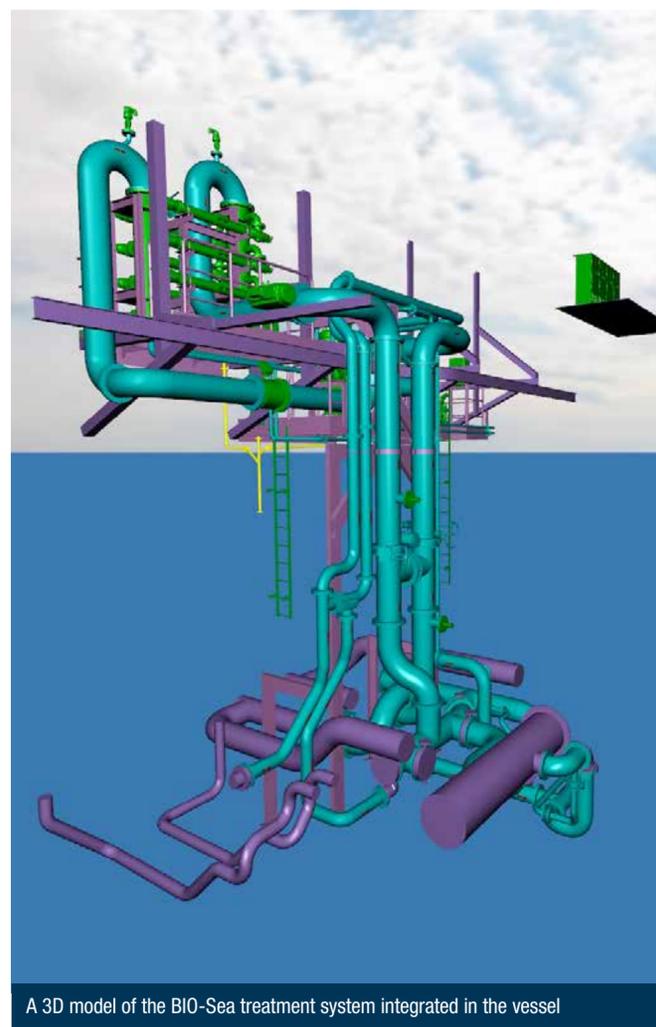
A 3D model of the BIO-Sea treatment system integrated in the vessel

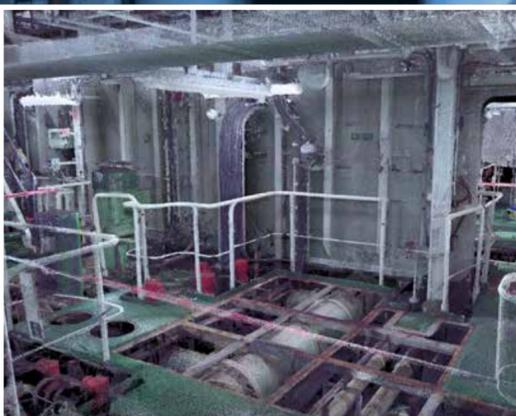
**1** Laser scanning is an incredibly accurate and efficient method to determine the feasibility, impact and potential conflicts when retrofitting BWTS and other large equipment into an existing space. Goltens personnel set up the laser scanner equipment in multiple locations of the room where the system will be installed. The process of scanning an entire room generally takes eight to ten hours on board, depending on its size. The scan does not disturb the vessel's operation and it is not even necessary for the crew to vacate the area during the procedure.

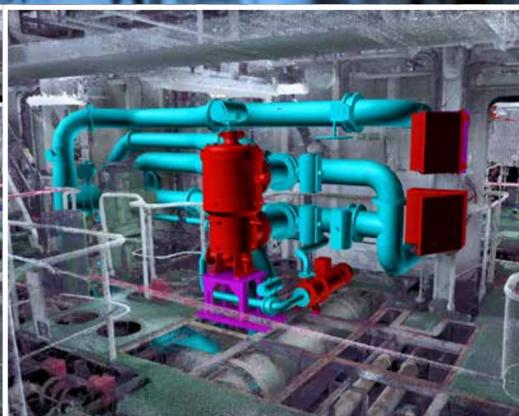
**2** The scan produces a point cloud of over ten million data points. For an average installation, 15 to 35 scans are made. These point clouds are stitched together and used by a 3D CAD program to create a fully three dimensional and highly accurate image of the area and all details inside it.

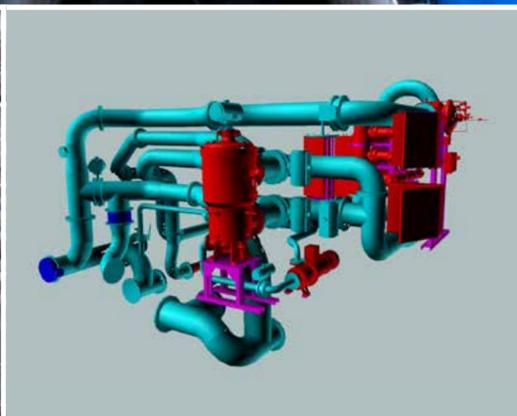
**3** The next step is to model the BWTS into the rendered room. At this point, it becomes possible to see exactly how the system would fit, evaluate rigging restrictions, locate power supplies and determine whether there will be sufficient space to walk around the system and service it.

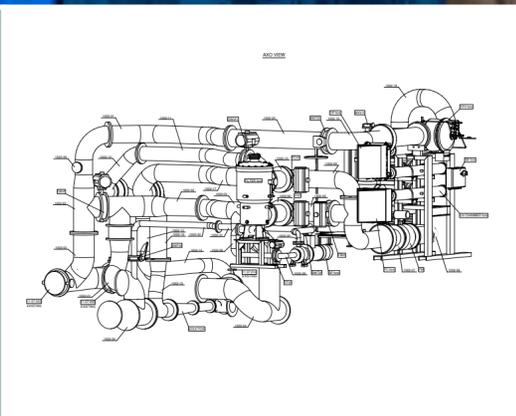
**4** Several systems can be modeled to show which one would fit best. The ship owner and crew can provide feedback and suggestions, and Goltens Green Technologies experts will look into the options for implementing their requests. After the concept is agreed upon, detailed engineering can begin. Detailed production drawings are prepared for all piping, supports and foundations.

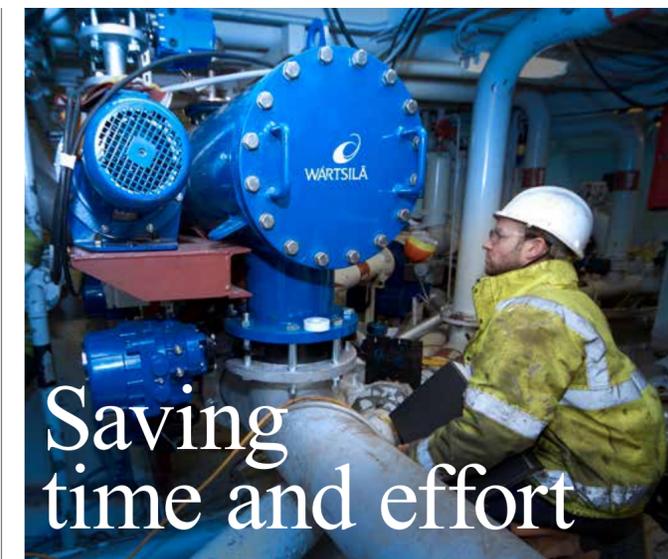
**5** The accuracy of the process allows for the prefabrication of a complete kit, ready for installation. Piping (including its pre-galvanizing), connections and foundations can also be precisely prefabricated, which eliminates the time-consuming, on-site pipe fitting process. This process is particularly attractive for sister vessel retrofits. Because the design can be re-used on sister vessels, overall costs will decrease for each vessel beyond the first.

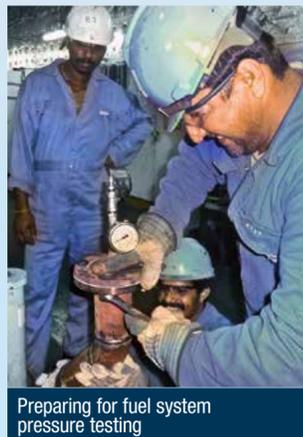
Preparing for fuel system pressure testing

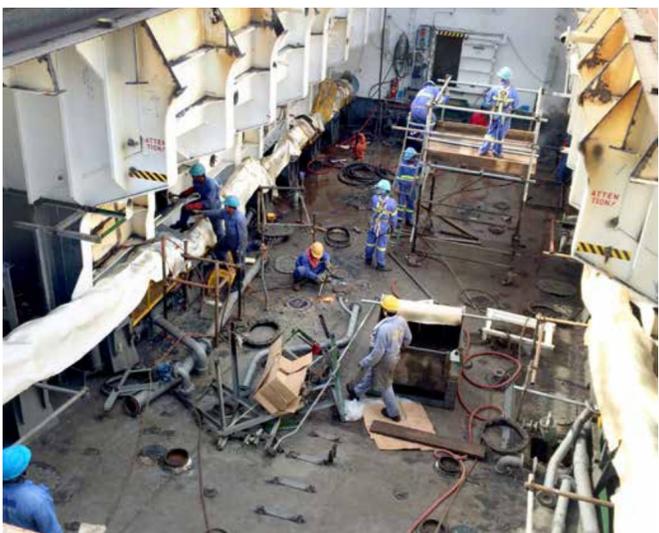
Deck plate and tanks removed

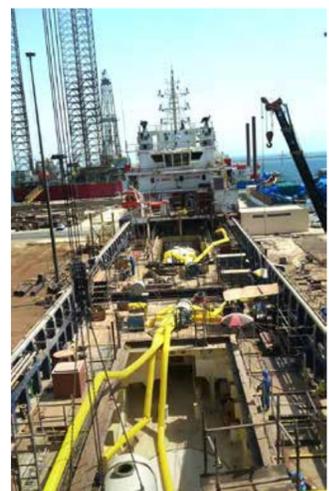
Tank install in process after compartment sealed with acid resistant coating

As the newly modified compartments held the carbon and stainless steel acid tanks and associated piping for the vessels' operation, the compartments needed to be fully coated in a special acid resistant paint to ensure the acid would not corrode the steel.

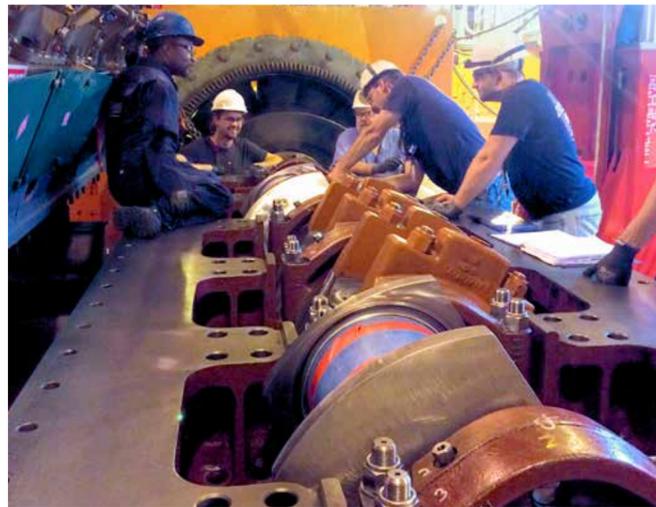
A nuclear power plant in the Midwestern US experienced a bearing failure on one of its four Worthington SWB-VEE-12 backup diesel generators. The plant reported that the 3.5MW engine suffered crankpin journal damage to the #4 crankpin. There was concern that the high heat caused by the failure may have introduced excessive hardness to the shaft. Goltens was requested to inspect the crankshaft and advise on repair or replacement strategies if the shaft could not be saved.

Replacement of bearing caps to check line bore

As the plant had a replacement crankshaft in storage, Goltens mobilized teams to work around the clock to get the crankshaft replaced and the engine operational as soon as possible.

The two teams consisted of a project manager, two service engineers and five technicians each. They worked in day and night shifts to complete the disassembly, remove the crankshaft, perform bore inspections, install the replacement crankshaft and rebuild and operationally test the engine.

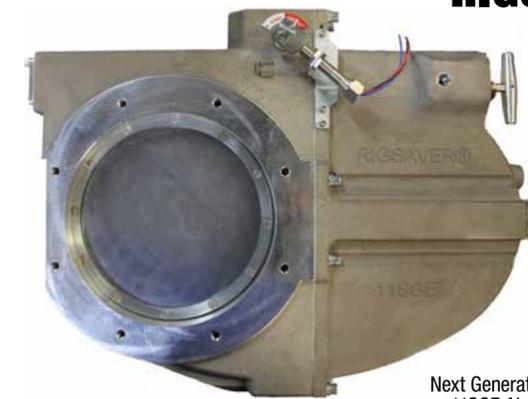
Rigsaver® valves can be manually or automatically controlled to help prevent diesel engine overspeed by cutting off the air supply to the engine. Rigsaver® is a swing gate, spring-operated air shutoff device mounted in the air intake system that stops the airflow into the cylinders and positively immobilizes the engine, safeguarding personnel and equipment. It can be manually or automatically controlled, responding to a variety of fault or hazard conditions.

Next Generation Rigsaver® 11SGE Air Shut-Off Valve

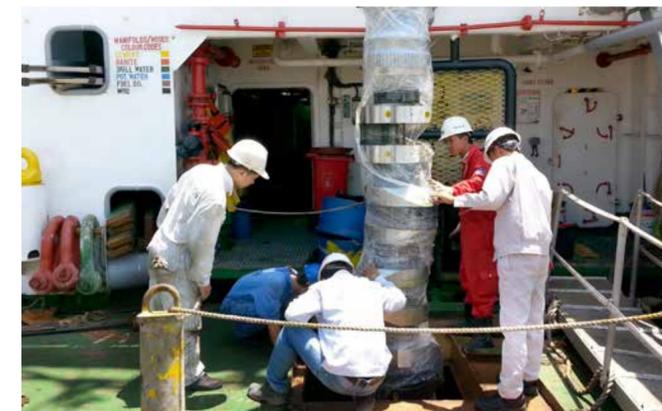
Replacement crankshaft being rigged onto the vessel for installation

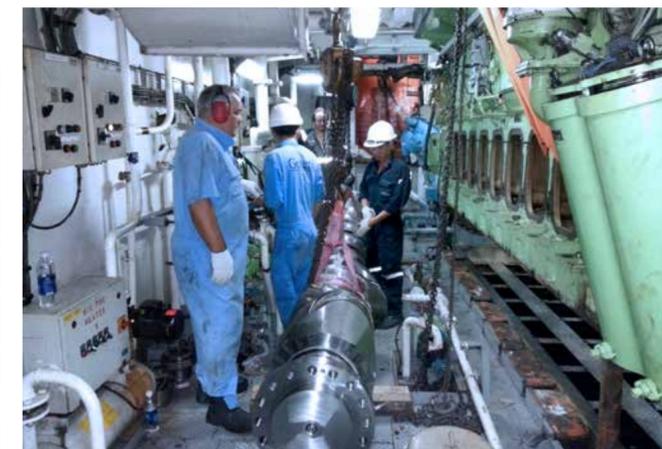
Block lifted with new crankshaft on deck ready for installation

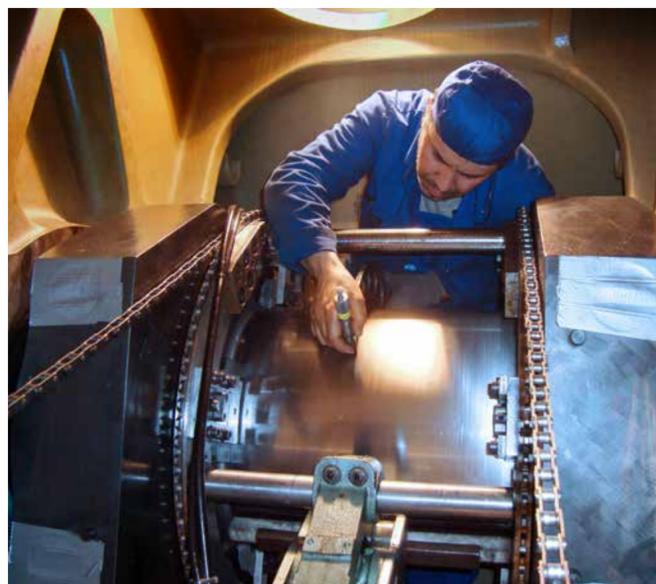
Checking journal diameter during finish machining

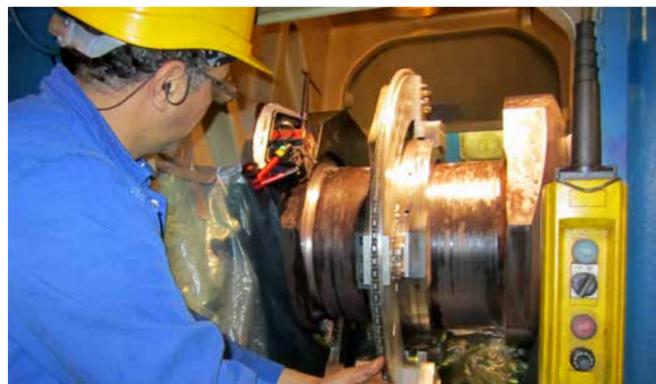
Machining the radius post annealing

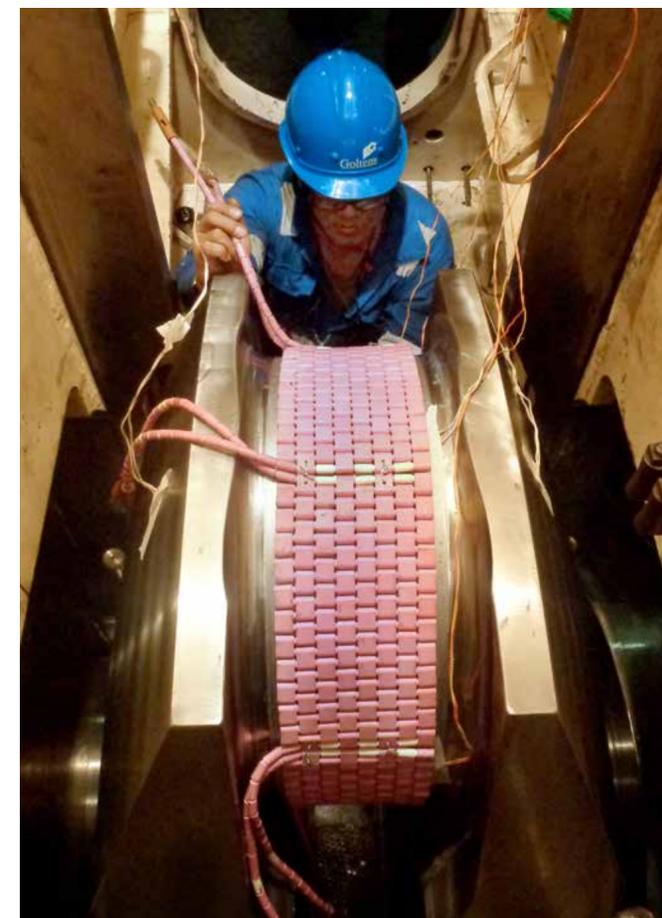
Installation of the annealing tiles on the damaged journal

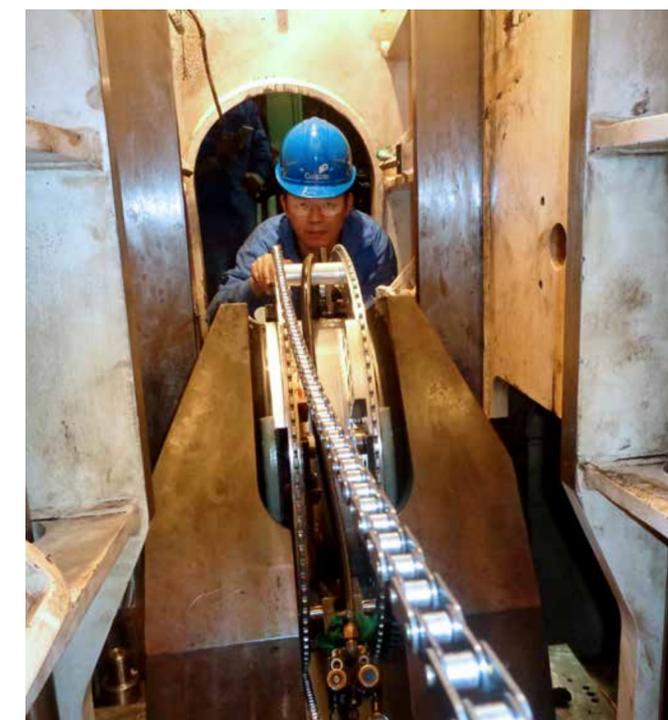
Finishing the machining of journal to -6.00mm

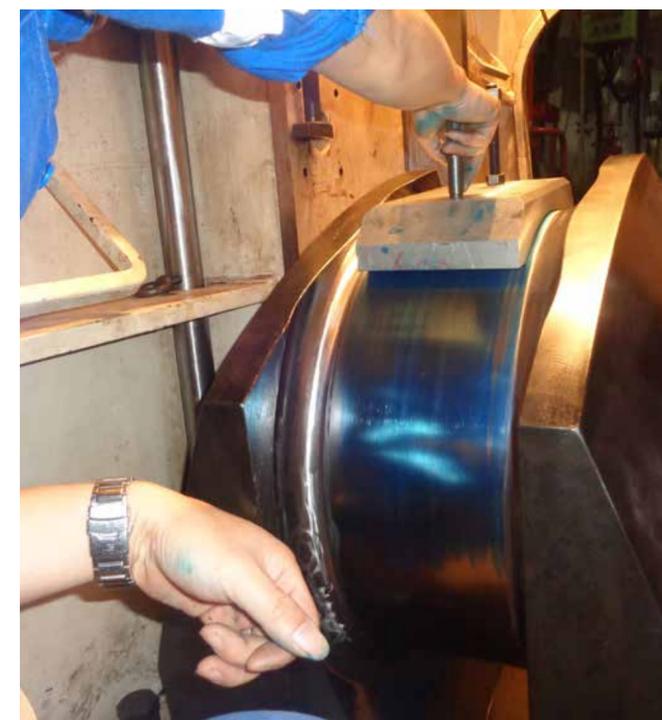
Final blue fitting of the repaired journal

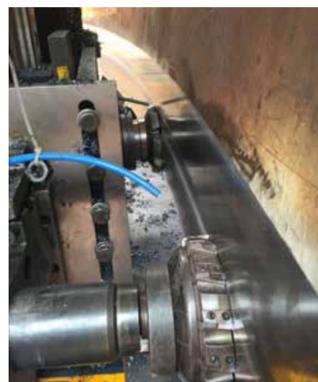
Two milling heads working at same time to maximize material removal

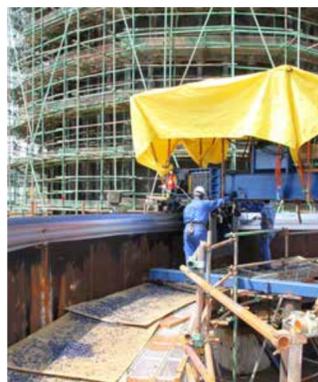
Machining top inside diameter at 5.2°

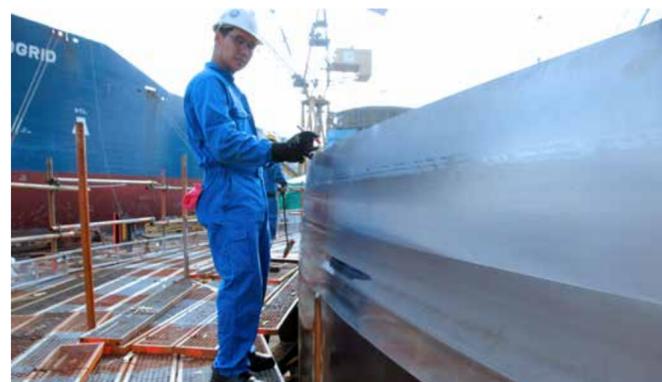
Quality checks on top OD machining

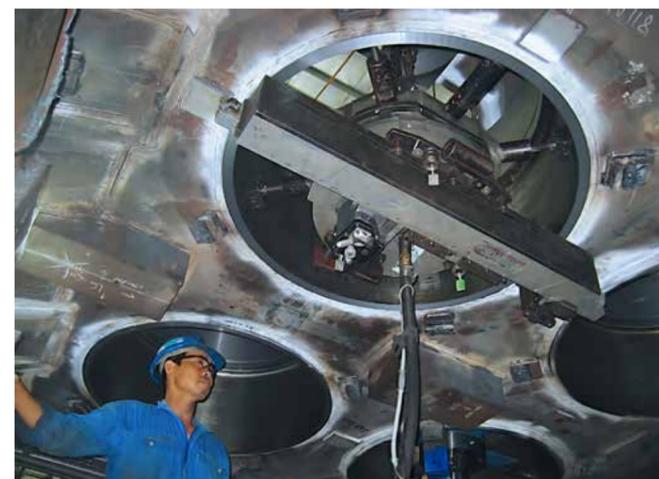
Flange facing in process on one of the 925mm lower gear box bores

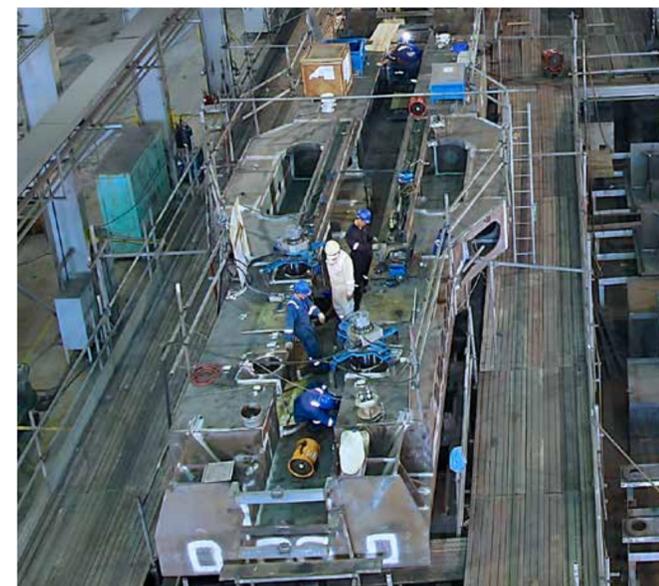
Boring equipment installed one of the six jack case structures for TAM DAO 5

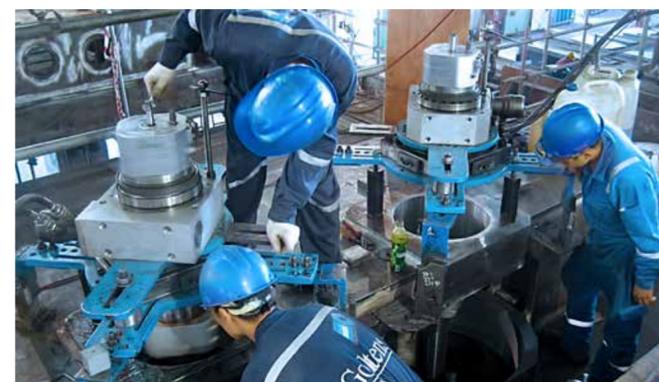
Multiple sets of boring equipment were used to speed the machining of the 36 925mm and 440mm top and bottom gear casing bores

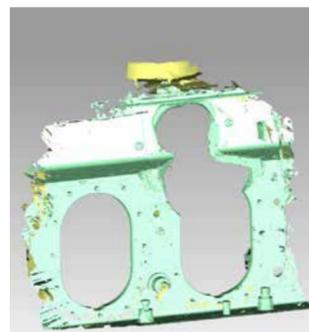
3D laser scan of the damaged portion

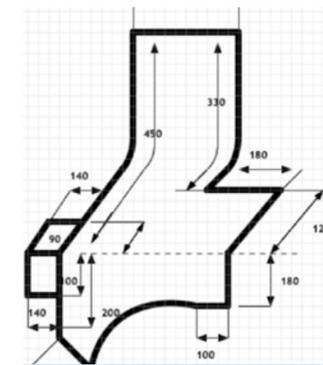
Design for cast insert and crankcase cropping

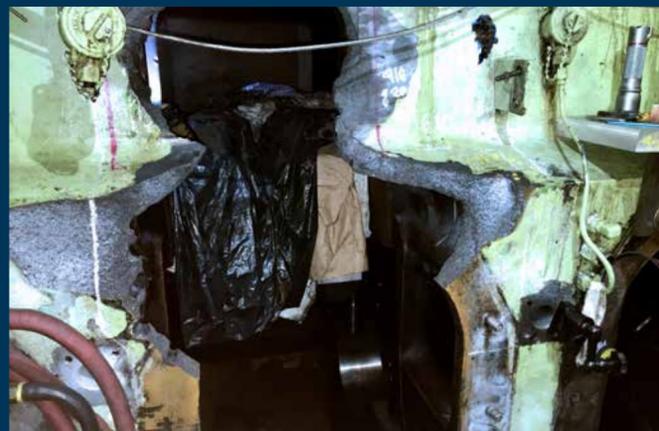
Crankcase exterior damage

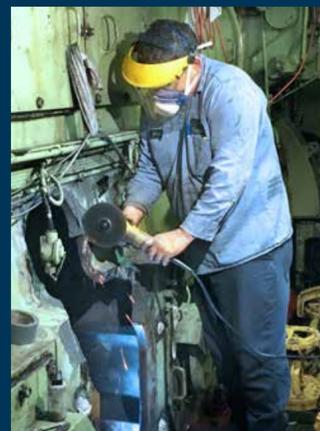
Cropping damaged section from crankcase

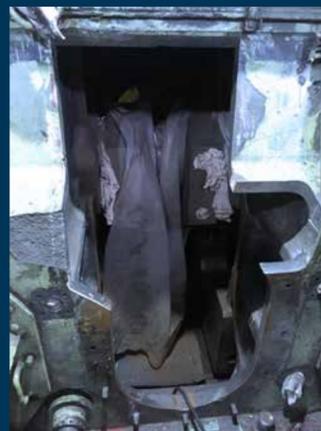
Crankcase damage cropped to insert dimensions

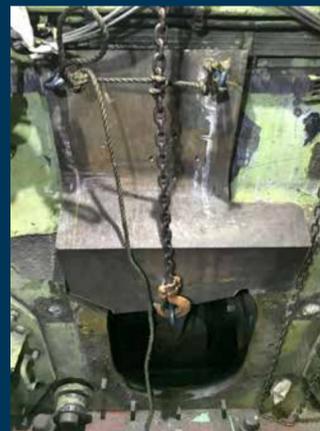
Cast and milled insert rigged into position

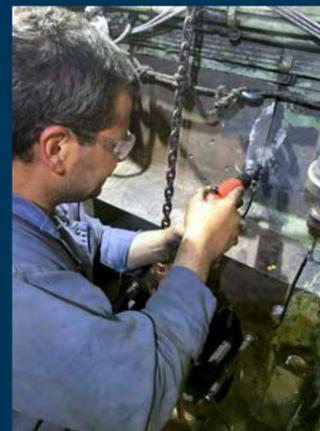
Drilling holes for stitch inserts along seam

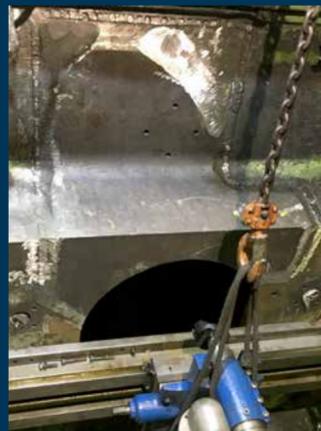
Stitching complete ahead of lock insertion and finish machining

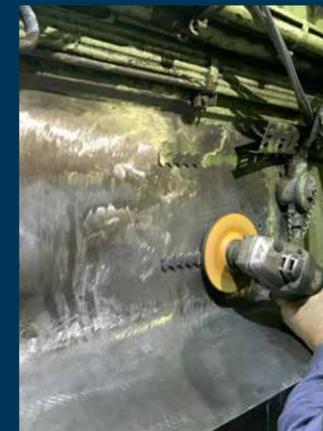
Final machining of crankcase surface after locks have been inserted

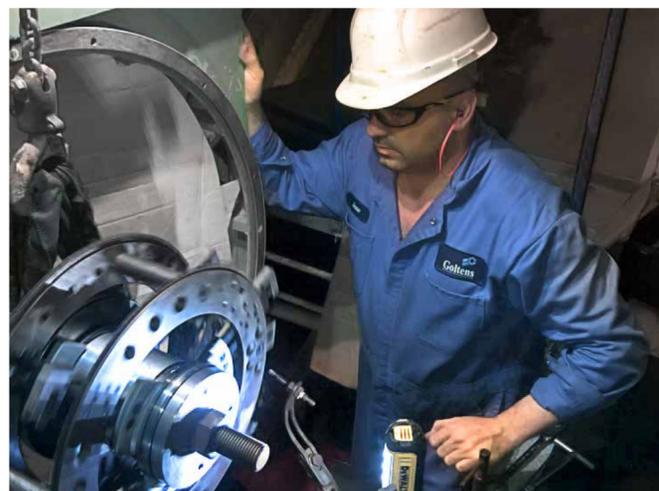
Goltens' new small range cutting tools in action on a 140mm diameter alternator shaft with 130mm between the rings. The shaft was machined to 130.00mm and a sleeve insert was installed to oversize at 141.00. Shaft was then finish machined to 140.00mm. The job was completed in only five days.

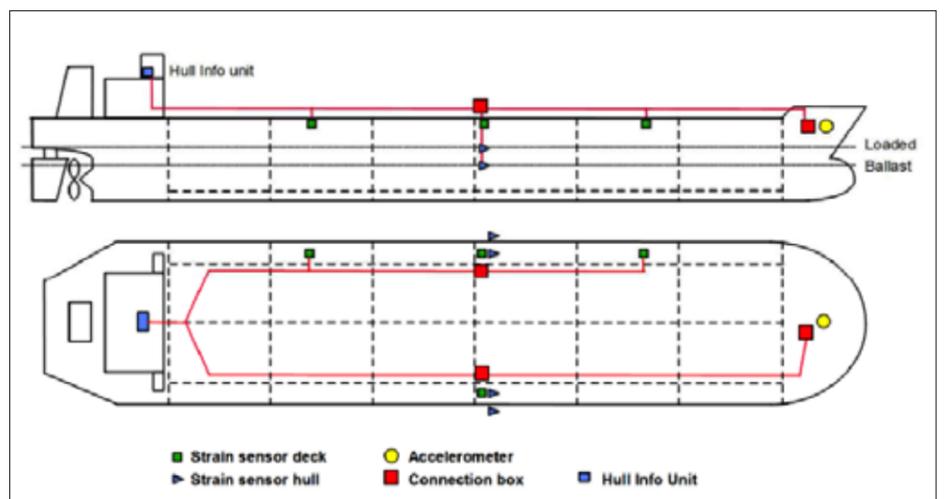
Representative component placement for hull condition monitoring components
