FOUR WARTSILA 12V50DF OVERHAULS IN ONLY 14 DAYS

TIGHT OVERHAUL SCHEDULE MET FOR LNG TANKER IN SINGAPORE

PROJECT FACTS: DUAL FUEL ENGINE OHAUL

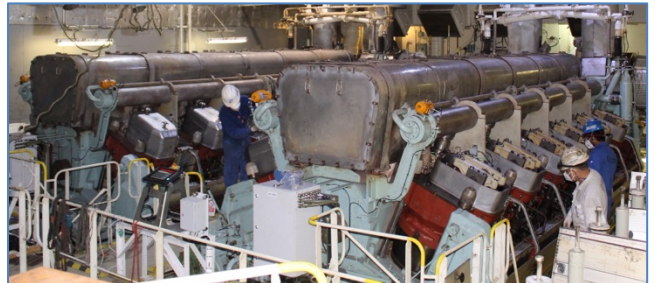
Figure 1: Goltens technicians disassembling one of the 12V50DFs

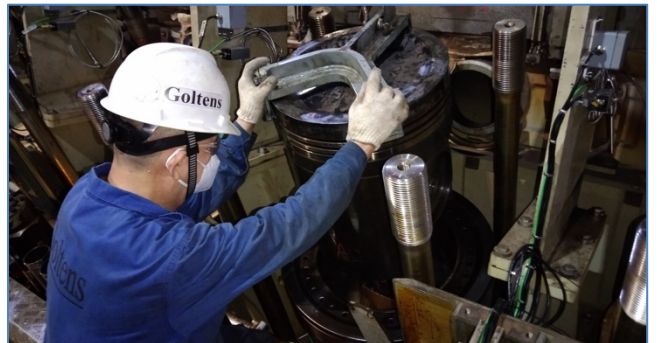
Figure 2: Goltens Engineer removing Piston

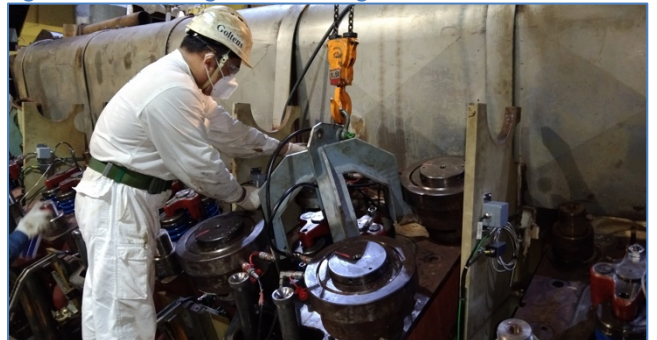
Figure 3: Slacking of Cylinder head nuts

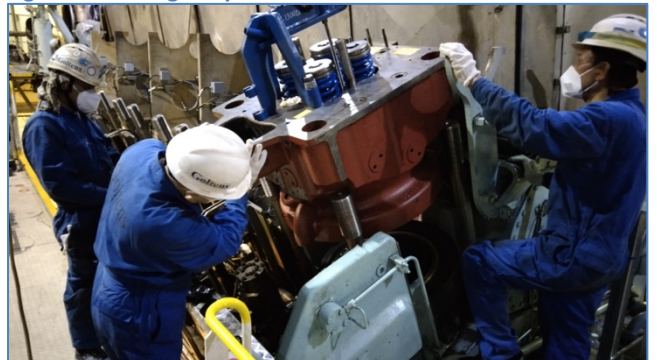
Figure 4: Cylinder Head installation

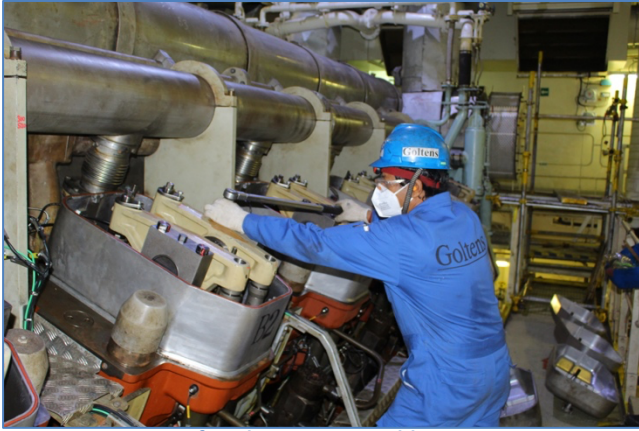
Figure 5: Torquing of Rocker Arm Assemblies
