50 TON DECK CRANE JOURNAL MACHINING

PROJECT STATS: DECK CRANE JOURNALS

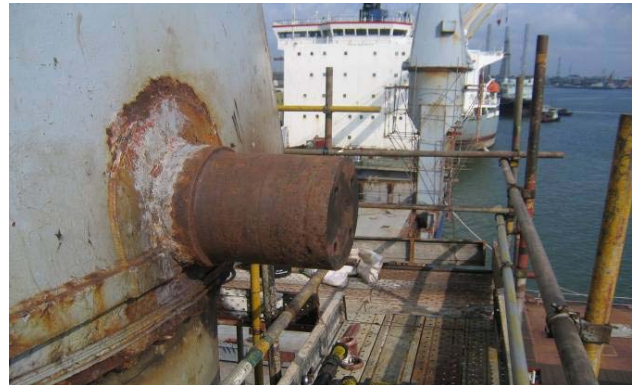
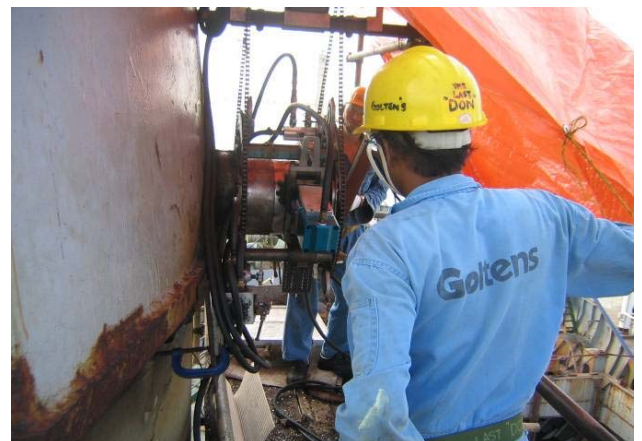
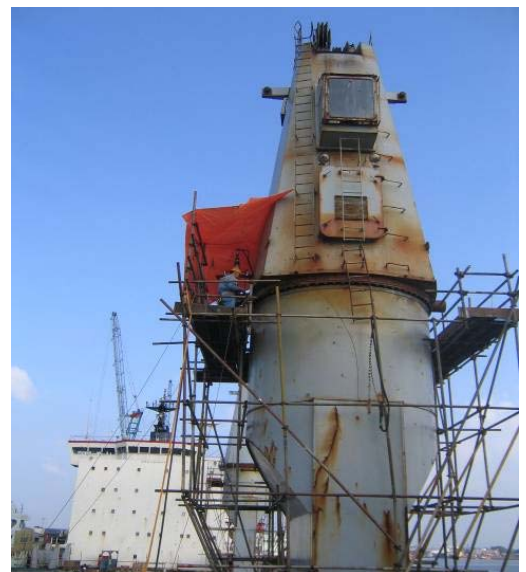
Both crane boom hinge pin journals were machined to 10mm undersize in diameter and new bronze bearings were machined to suit the new undersized dimensions of the pins.

SWL of deck crane:	50 tons
Crane boom hinge pin diameter:	285 mm
Machined Length:	350mm
Number of hinge pin:	2 per crane

- Calibration and NDT performed on both crane boom hinge pins.
- Modification of our equipment to suit space constraints onboard.
- Alignment taken between PORT & STBD hinge pins
- In-situ machining both pins to 10mm undersize in diameter.
- Machined new bushes in our workshop.
- Installation of new bearings on the machined pins.
- Final inspection.
