ALIGNMENT & INSTALLATION OF TWO MAK 8M32C ENGINES

PRECISION ENGINE ALIGNMENT FOR FERRY OPERATOR IN GREEK SHIPYARD

PROJECT FACTS: ENGINE INSTALLATION/ALIGNMENT

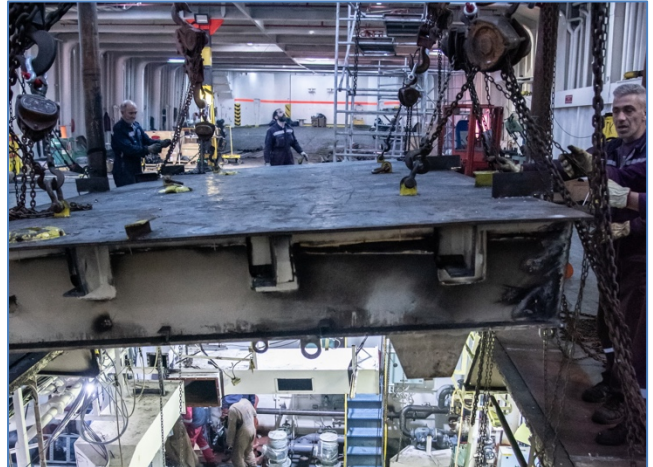
Figure 1: Removal of the deck to allow for engine rigging

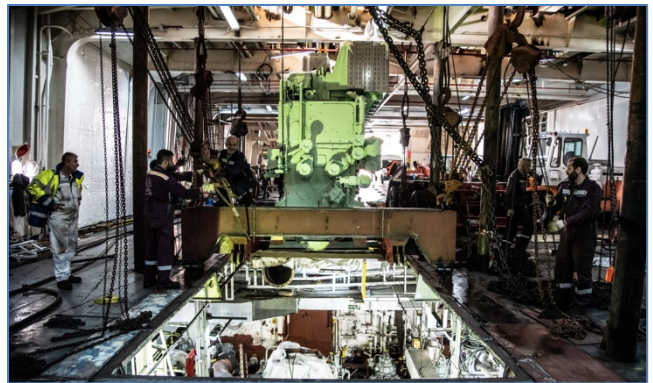
Figure 2: MaK 8M32C being slid into position on skid

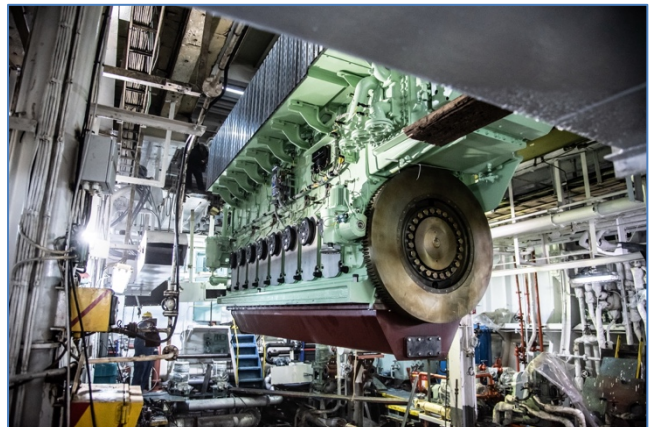
Figure 3: Lowering the engine into position above foundation

Goltens prepared the detailed installation and chocking plan for class submittal and deployed a team to the site. Upon arrival, the port engine had already been lowered into position and Goltens proceeded to weld the jacking plates in place and move the engine to set the correct axial alignment distance for the Vulkan coupling. During this time the starboard engine was lowered into position and work on the engines began in parallel.

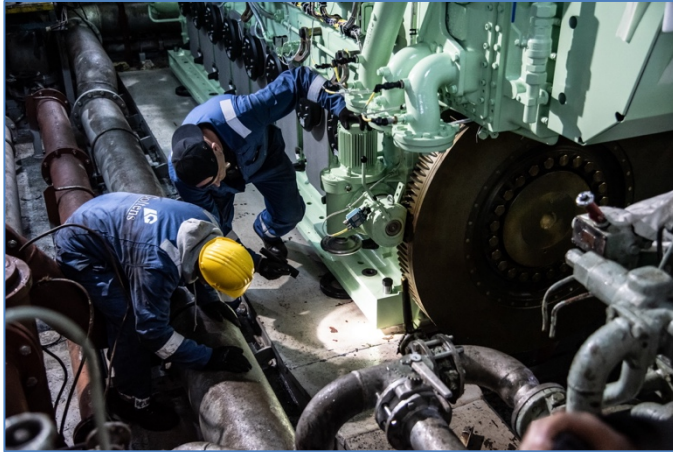
Figure 4: Inspection of engine placement on large metal washers

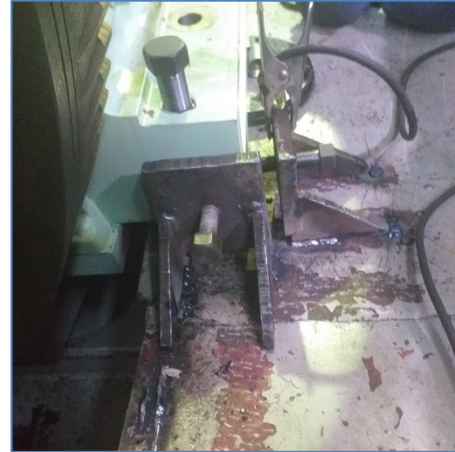
Figure 5: Jacking bolts installed

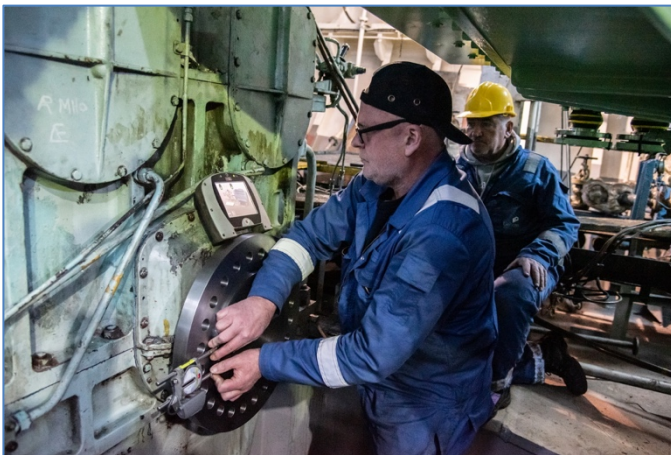
Figure 6: Laser alignment checks on engine and gear box

Once Goltens completed the thermal growth calculations, the team performed laser alignment to move the engine into the final position. The team then drilled all foundation bolt and fitted bolt holes and welded the prefabricated collision chock brackets in place. The final alignment checks, including crankshaft deflections, were then taken prior to chocking the engine. The damming material was then installed, and the chocking material was poured.

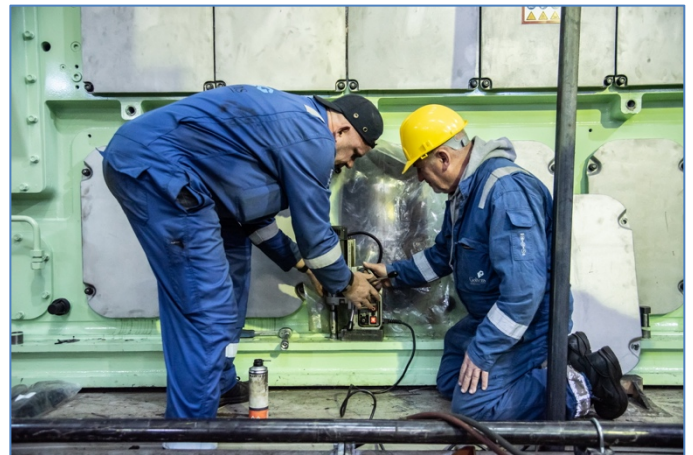
Figure 7: Preparing drill for foundation bolt drilling

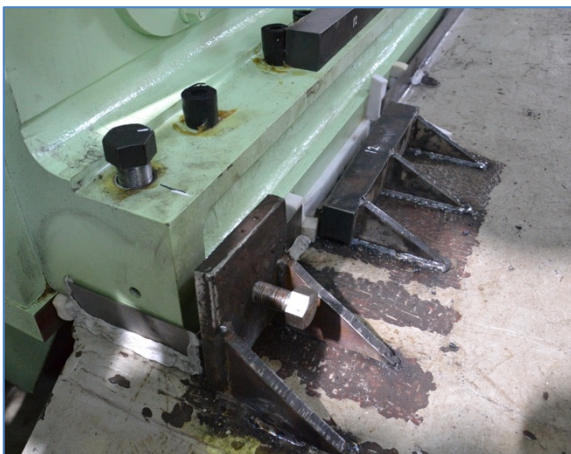
Figure 8: Damming and collision chock bracket installed prior to chocking

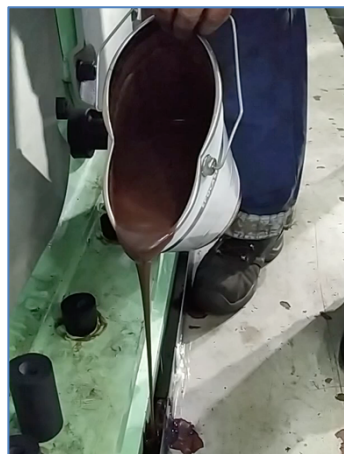
Figure 9: Chocking the engine

After curing of the chocking compound, the foundation bolts were installed, the fitted bolt holes were reamed to their final dimension and fitted bolts were final machined and installed. Once all bolts were installed, they were tensioned to spec. and final alignment confirmed. The team finalized the job with the installation of the Vulkan flexible couplings and fitted the collision chock wedges.

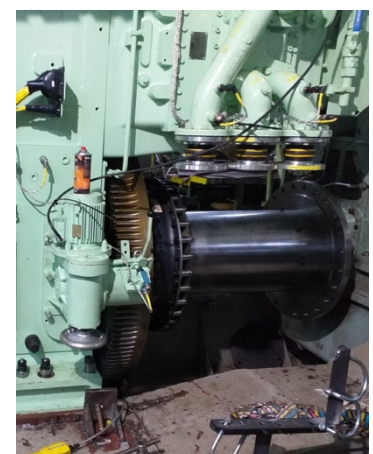
Figure 10: Vulkan coupling installed
