## IN-SITU MACHINING RETURNS ORE CARRIER TO SERVICE

### MITSUBISHI 6UECE85LS-II CRANKSHAFT

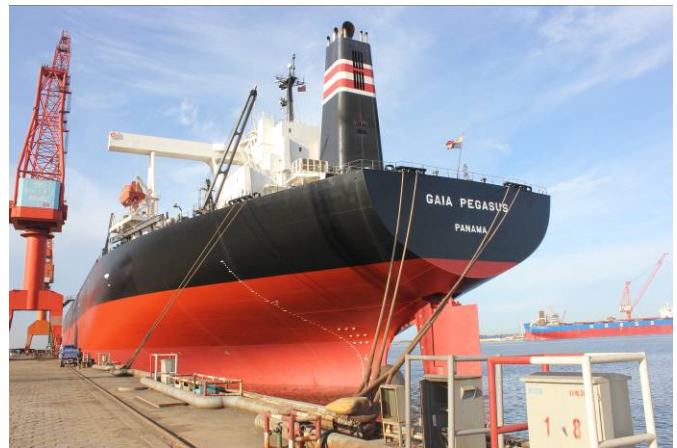
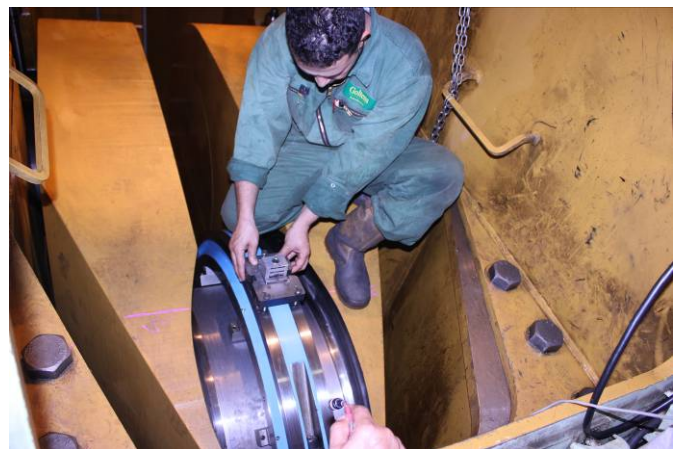
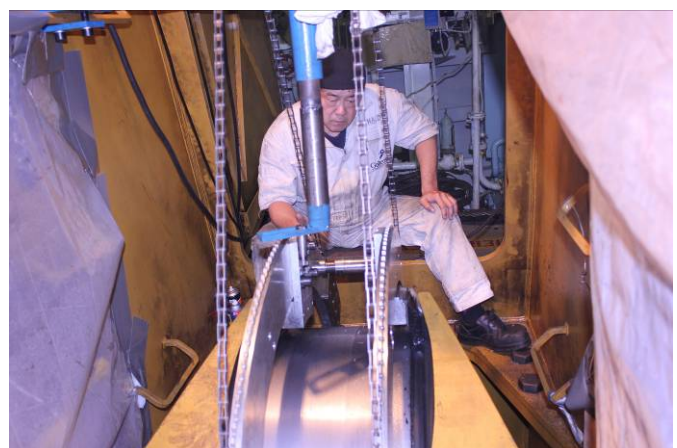
After completing inspection of the crankshaft, it was determined that the fillet radii were damaged and needed to be machined and that crankshaft damage was significant and would require 8-10mm to be machined from the crankpin surface to restore the engine to operation. Detailed repair procedures and work scopes were drafted by Goltens and approved by the customer's superintendent engineer.

- Hardness check and crack test via Magnaflux on No.1 crankpin journal
- Machining crankpin fillet radii
- Machining M/E crankpin journal to undersize -10.00mm (Final OD: Ø940.00mm)
- Fabrication of dummy bearing for blue oil checking
- Finish polishing of crankpin journal
- Final inspection of crankpin journal

Goltens technicians performed the complete cutting and polishing job within 7 days using Goltens' proprietary crankshaft/journal machining tooling. The use of the cutting tools reduced the repair time by as much as 30 days when compared to traditional crankshaft grinding, saving the vessel owner significant downtime and lost operational costs.
