## DAIHATSU CRANKSHAFT REPLACEMENT FOR CEMENT CARRIER

### GOLTENS SPECIALISTS REPLACE DAIHATSU 8DKM28 CRANKSHAFT AND OVERHAUL ENGINE

#### PROJECT FACTS: CRANKSHAFT REPLACEMENT

Engine Make/Model:	Daihatsu 8DKM28
Location:	Rhode Island, USA
Vessel Type:	Cement Carrier
Year of Build:	2011

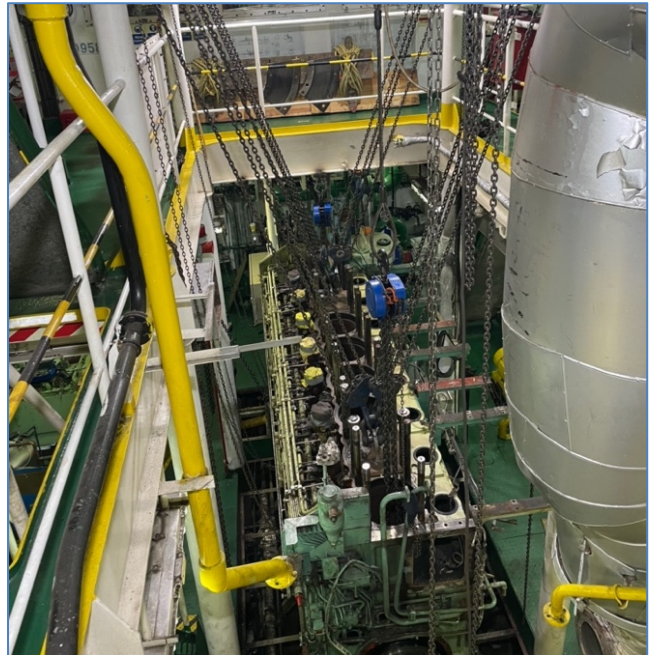
Figure 1: Engine stripped with rigging equipment attached to crankshaft for lowering

Goltens inspected the space and designed a rigging plan to safely lift the block and rig the condemned crankshaft out and the new crankshaft in. Goltens got to work welding the required pad eyes and made other preparations such as removing the counterweights, bearing caps and other components prior to commencing the rigging operations.

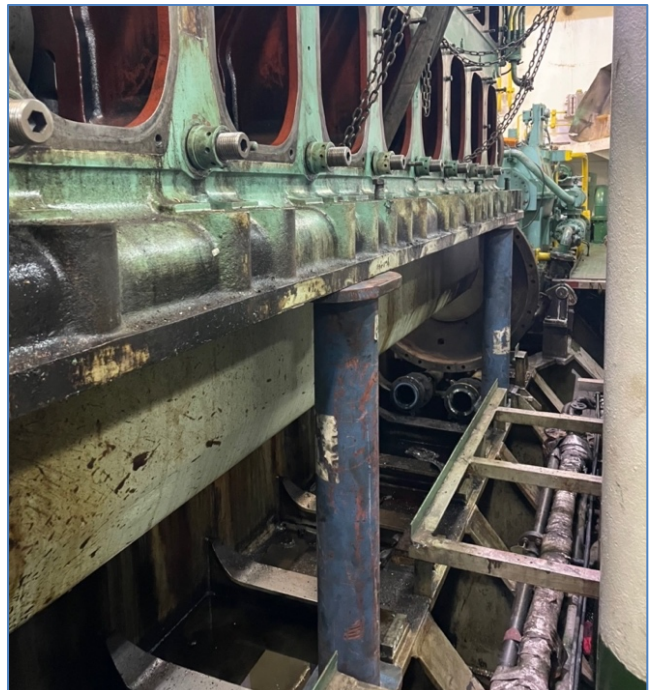
Figure 2: Engine block lifted and braced for crankshaft removal

The engine block was lifted and braced in a safe position for rigging of the crankshaft. The crankshaft was then removed and rigged to the engine room deck, where it was then rigged ashore. To thoroughly inspect the engine, the engine was thoroughly cleaned and NDT conducted on all bearing saddles and all surfaces on the engine block. Bearing saddles were reinstalled and torqued, with laser inspection and internal bore checks completed satisfactorily.

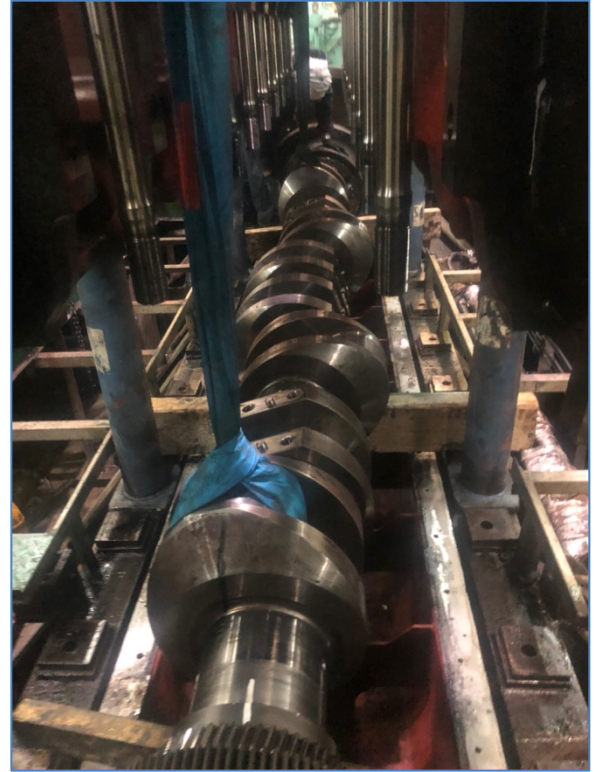
Figure 3: Crankshaft lowered from block

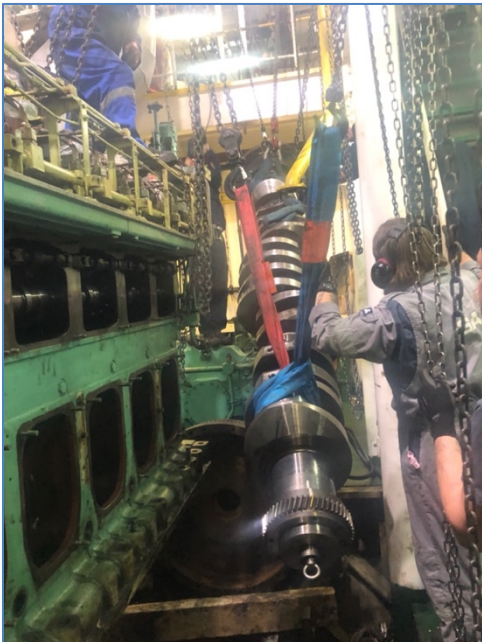
Figure 4: Crankshaft rigged from underneath block

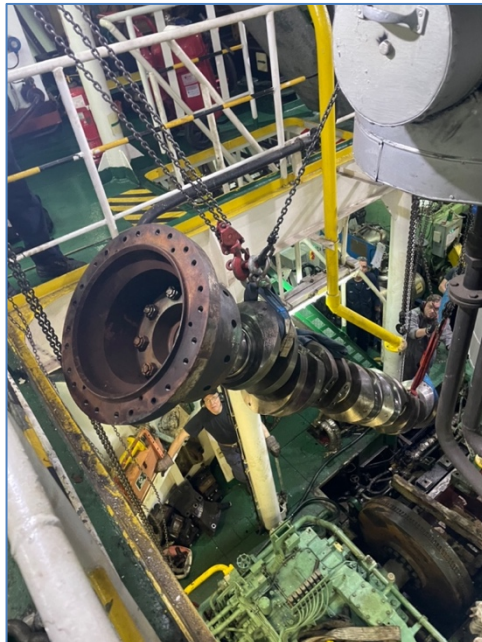
Figure 5: Rigging condemned shaft out of the engine room

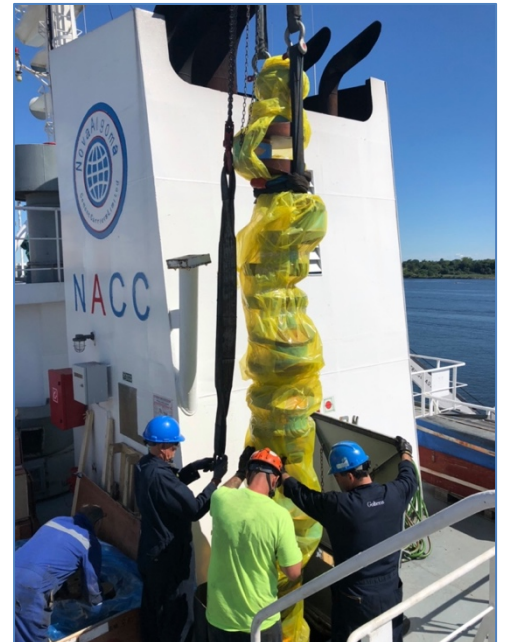
Figure 6: Lowering replacement crankshaft into the engine room with shore crane

With all inspections completed, the new crankshaft was lowered into the engine room by shore crane and rigged into place with new upper bearings. Main bearing saddles were then installed with new lower bearings, and the block was lowered. Engine was then reassembled, with use of the overhauled and replacement engine components.

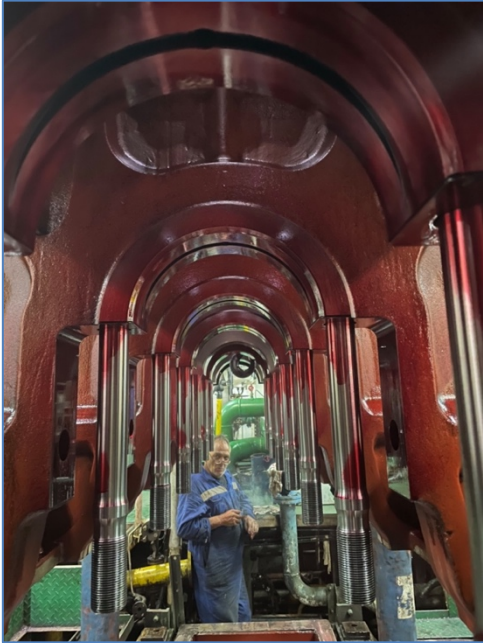
Figure 7: Non-Destructive crack testing on block prior to new crankshaft installation

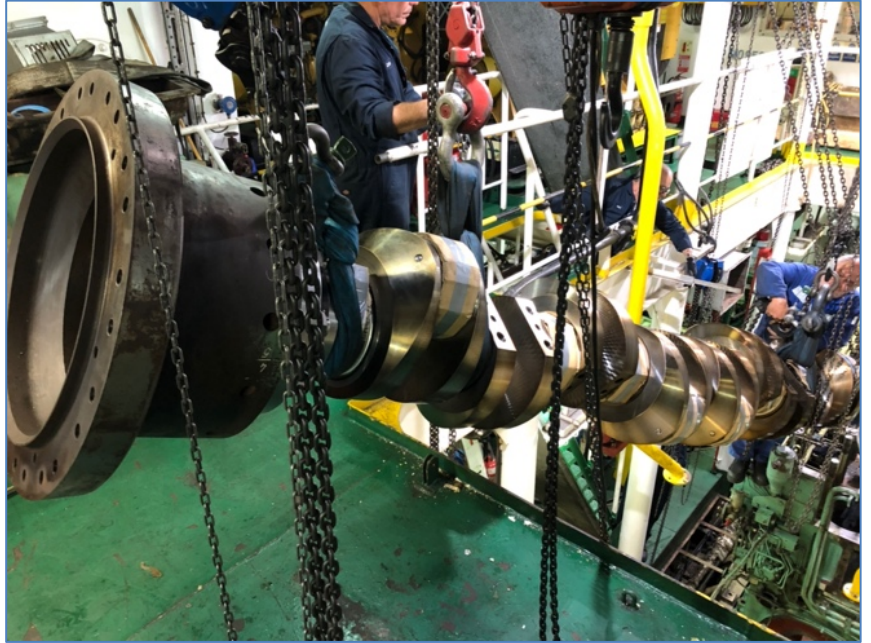
Figure 8: Goltens technicians rigging new crankshaft to lower engine room deck

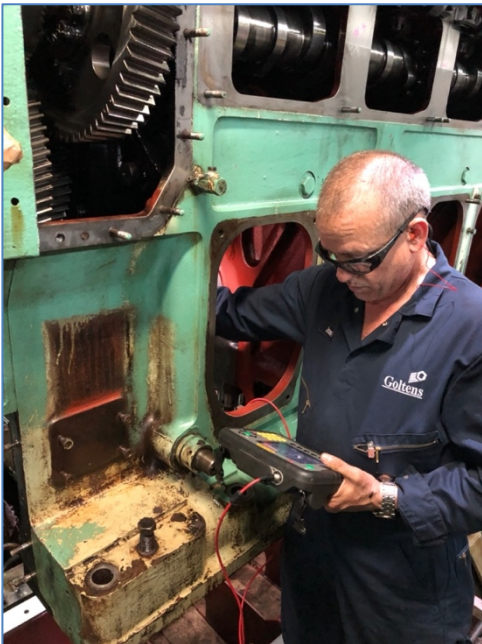
Figure 9: Laser check of block bore

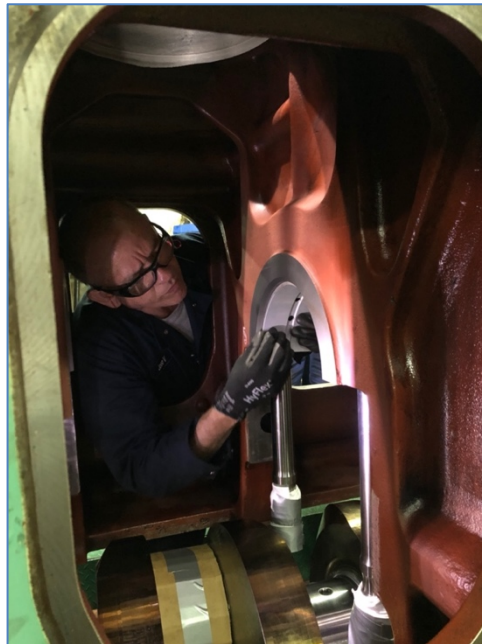
Figure 10: Installing new upper bearing shells before lifting crankshaft into position

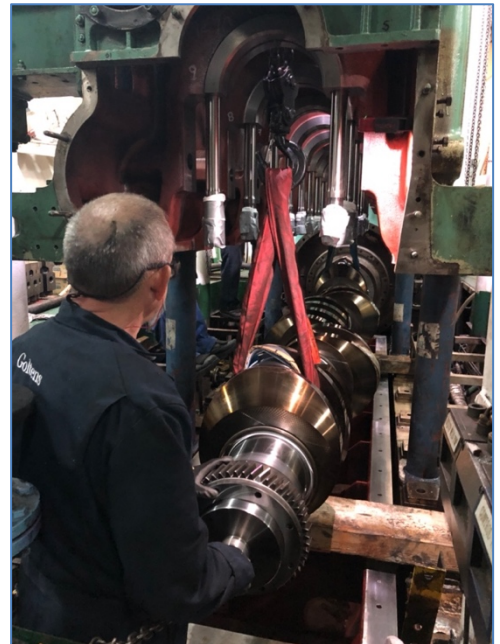
Figure 11: Crankshaft ready for final lift into position
