HIGH-PRECISION IN-PLACE MACHINING ON STERN TUBE HOUSING

GREG MORTIMER – CHINA’S FIRST EXPEDITION CRUISE SHIP NEW BUILDING

PROJECT FACTS: STERN TUBE MACHINING

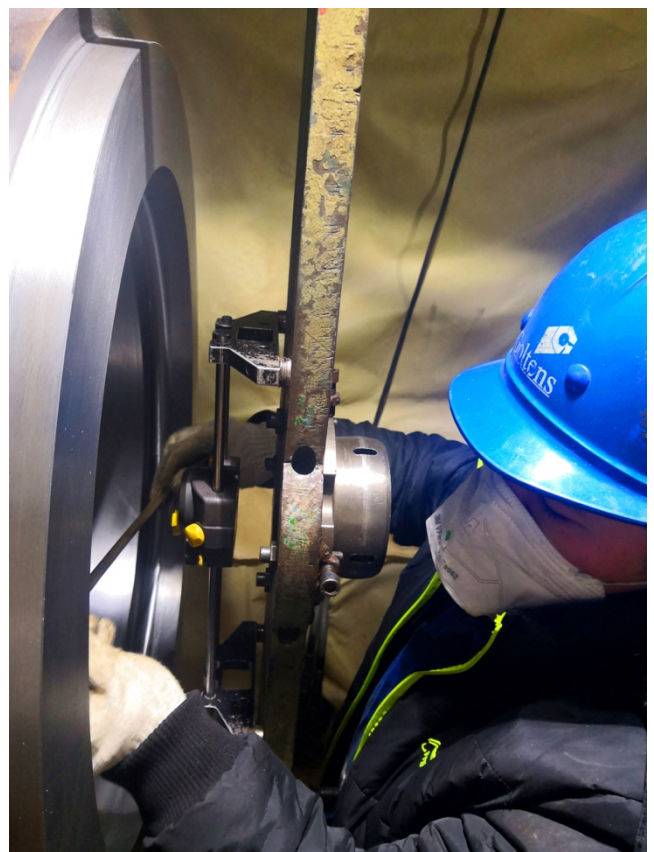
Figure 2: Laser Alignment Adjustment

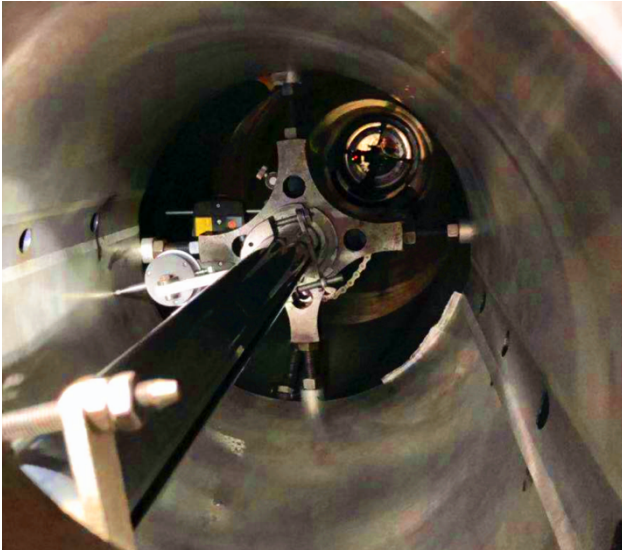
Figure 3: Realigning Boring Bar

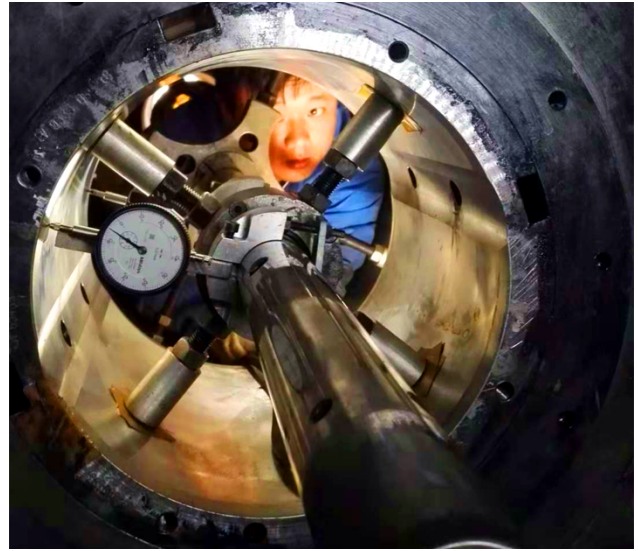
Figure 4: High Precision Alignment Control

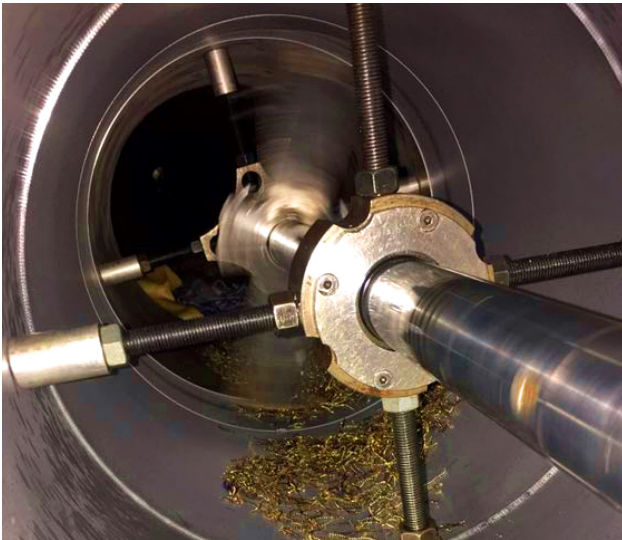
Figure 5: Line Boring In Progress

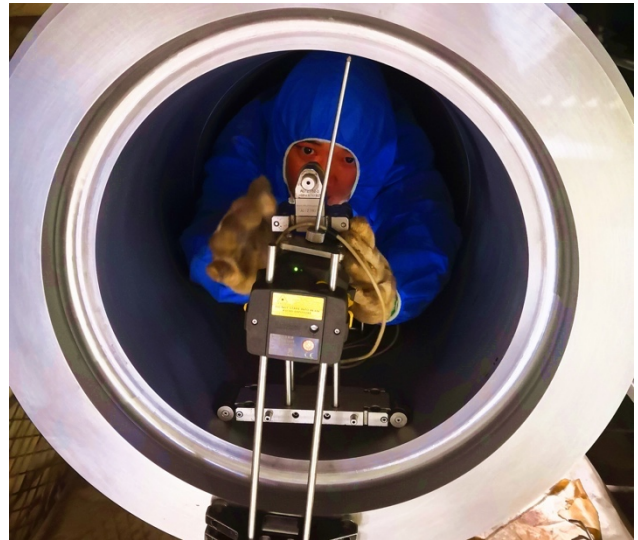
Figure 6: Bore Alignment Measurement after Machining

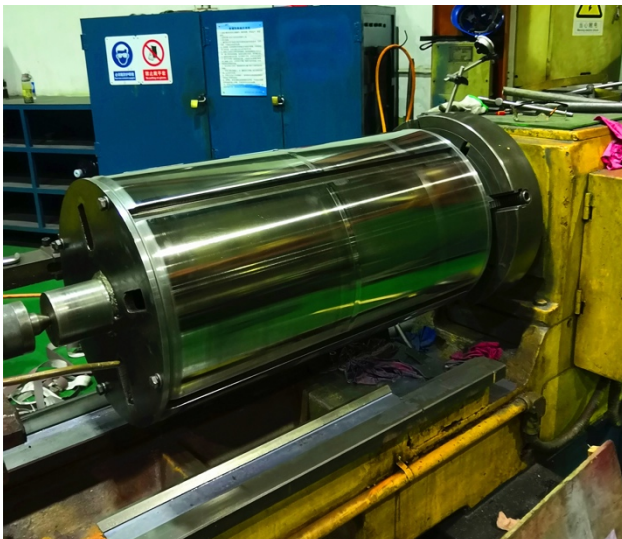
Figure 7: High Precision Machining - New S/T Bushes OD

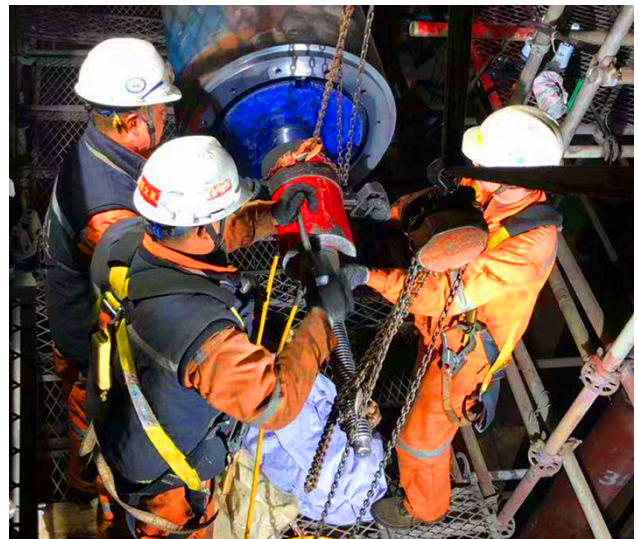
Figure 8: Perfect Performance on Bush Reassembling under Customers Monitoring
