# SHAFT SEAL LINER REMOVAL FOR THE USNS RED CLOUD

## IN-PLACE MACHINING BAYONNE DRYDOCK

### PROJECT FACTS: SHAFT SEAL REMOVAL

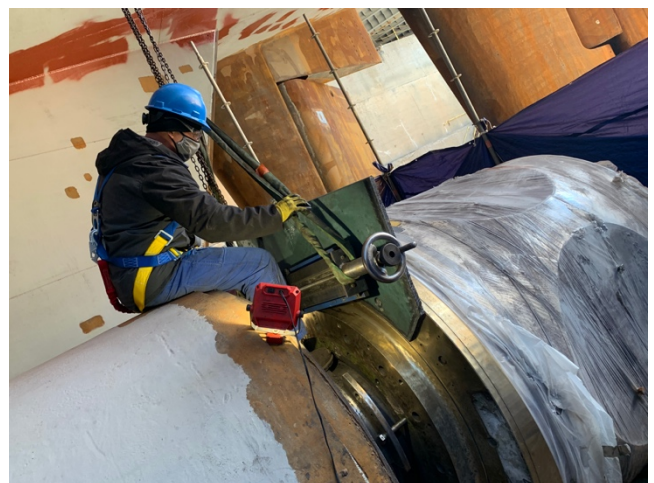
Figure 2: Installation of milling machine on prefabricated brackets

After preparations were complete, the team arrived on site, observing as many precautions as possible and proceeded with mounting the prefabricated brackets and milling machinery to begin the works.

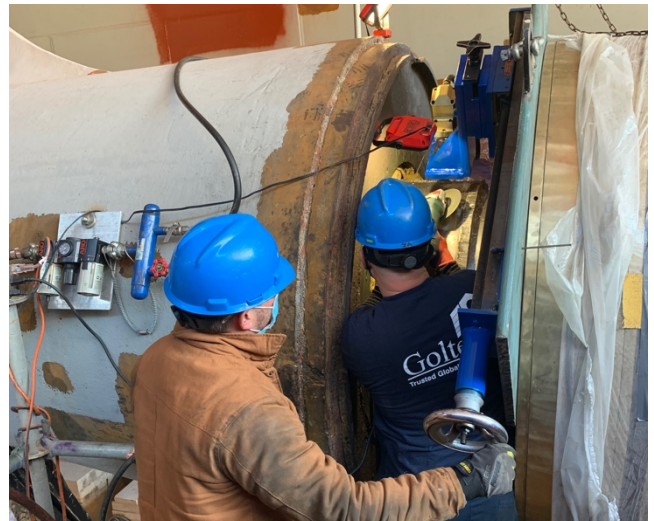
Figure 3: Utilizing diamond grinding Discs to remove tungsten surface layer.

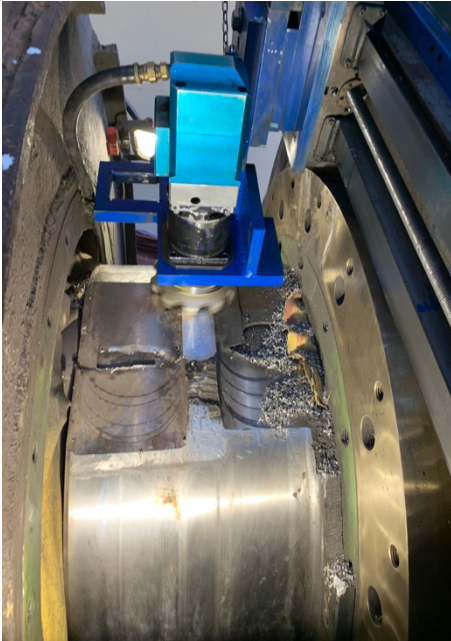
Figure 4: Milling shaft seal liner

Goltens determined that the shaft seal liner could be removed from the shaft but due to the short space between the shaft and shaft housing, special tooling and brackets would have to be fabricated at Goltens Miami to carry out the on-site machining. Having all of the required measurements, Goltens' specialist returned to Miami to fabricate the mounting brackets and repurposed one of their milling machines to mill across the outside liner surface to split the liner.

While Goltens is renowned for its ability to conduct high precision journal repairs, this project was not as delicate, but still required a high degree of care and control to ensure the propeller shaft surface was not damaged during the machining of the liner.

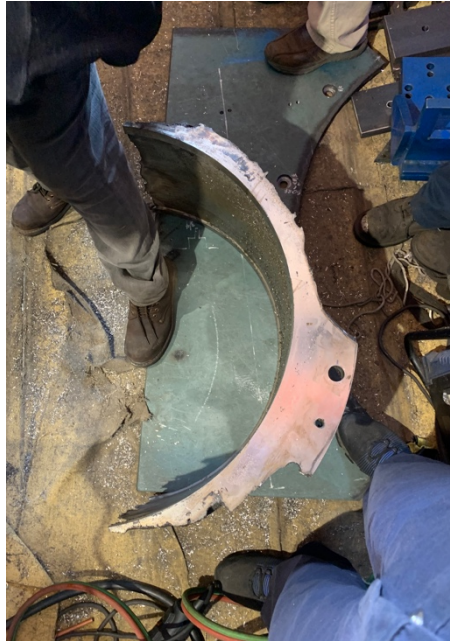
Figure 5: half of shaft seal liner removed

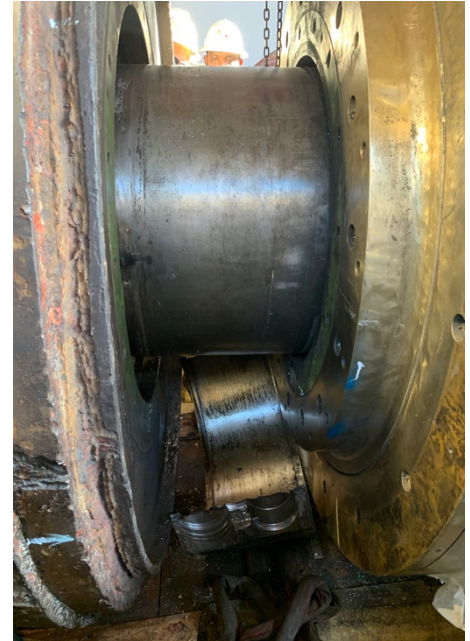
Figure 6: Shaft after liner removal

The liner removal was completed using two shifts of machinists working around the clock. Goltens completed the repair successfully over an 11-day period onsite in Bayonne and the shaft was left in good condition with no damage from the removal process.
