CREATIVE ON-SITE MACHINING SOLUTION RESTORES KILN TO OPERATION

MACHINING CORRECTS POST WELD DEFORMATION ON KILN PADS

PROJECT FACTS: Kiln Pad Machining

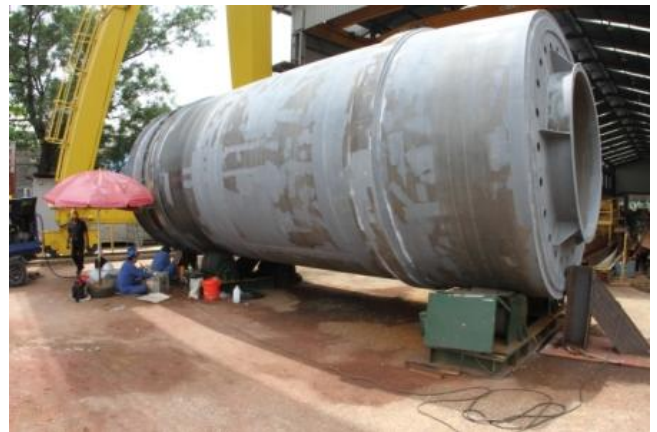
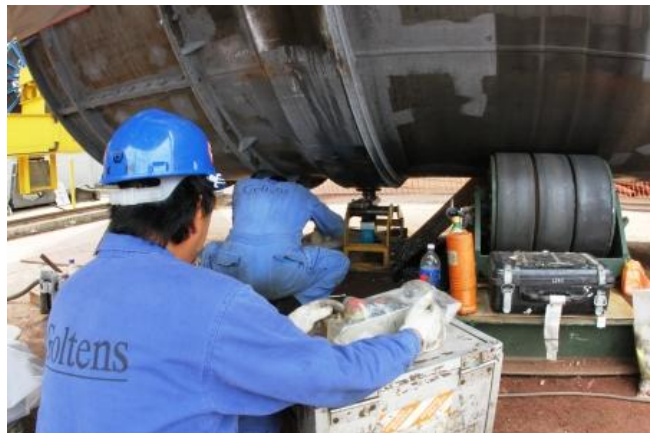
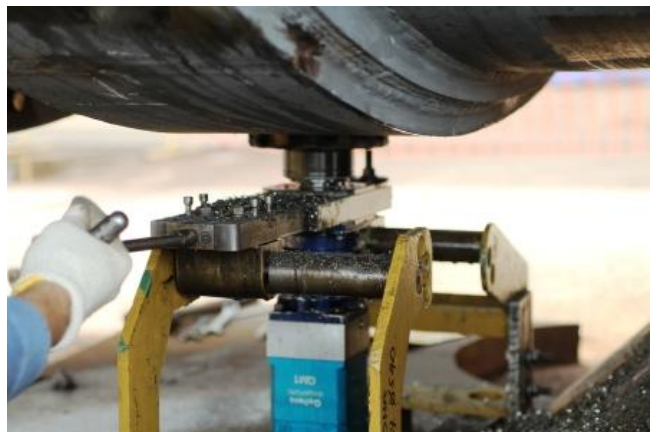
A local steel fabrication and repair company contacted Goltens to propose a solution to rectify post weld deformation on the running pads on a kiln. The 17-ton kiln's 350mm wide pads had developed Ovality along the running surfaces that needed to be cleared and restored to round.

Goltens modified the customer's existing cradle setup to enable machining while keeping the machining head in a fixed position and rotating the piece. Goltens technicians then loaded the kiln onto the cradle and machined the kiln back to round in short order.

- Fabricated custom cradle
- Machined 4 mm from the radius of both 350mm wide pads
- Completed grinding and polishing on pads

Goltens removed Ovality from the kiln pads and completed this job from start to finish in only 4 days allowing the customer to meet delivery schedules.
