IN-SITU MACHINING KEEPS NEWBUILD OFFSHORE VESSEL ON SCHEDULE

JACK-UP WINDCARRIER VESSEL BOLD TERN

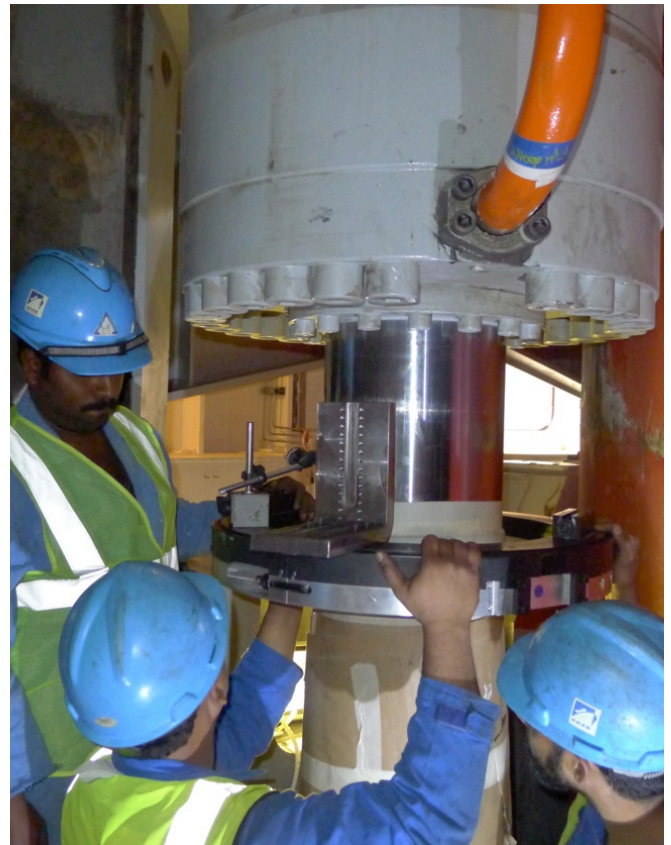
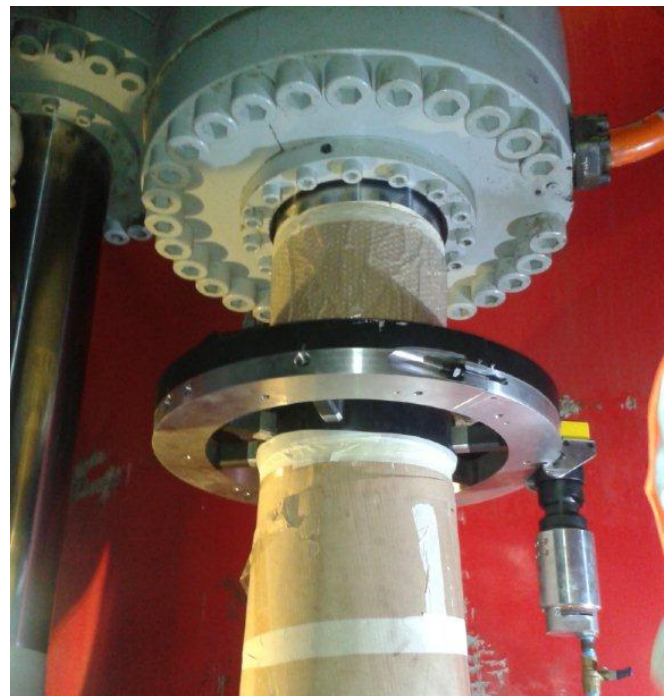
During the final construction and commissioning of Windcarrier jack-up vessel Bold Tern in the Lamprell Yard in Jebel Ali, vessel owners Fred Olsen noticed the jacking cylinders for the legs were being damaged during actuation by the scraper ring which had been installed to remove debris from the cylinder. The conclusion was that the scraper ring material was too hard and was retaining some of the debris between the scraper ring and the jacking cylinder. This debris was in turn causing scratch marks to the hydraulic cylinder on the longitudinal plane, each time the cylinder was actuated.

With no time for full disassembly of the cylinders as the vessel was due to sail in 3 days, Goltens Dubai installed a split frame orbital cutting machine onto the jacking cylinder and inverted the tool post ninety degrees and installed the modified tooling. Goltens removed a small section of the hydraulic jack body to allow the scraper ring to be removed intact for analysis.

The job required precision so as not to damage the jacking cylinder during rotation and also not to cut too far into the hydraulic jack body, but just enough to remove the retaining ring and allow the scraper ring to be removed.
