LASER CLADDING AND MACHINING SALVAGES SLURRY PUMP SHAFT FOR MINE

ORIGINAL DIMENSIONS RESTORED TO SHAFT

PROJECT FACTS: SLURRY PUMP SHAFT

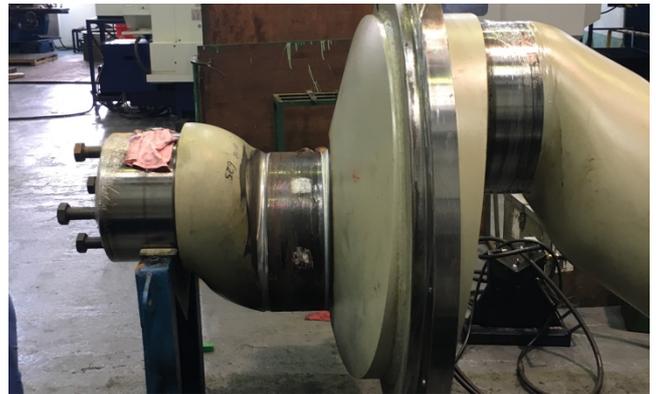
Inspection revealed the crankpin had suffered severe damage resulting in surface hardness levels as high as 397 HB and heat cracks on the pin surface. Goltens offered a solution to machine the pin to undersize but the pump maker required the pin diameter at original specification. To meet the requirement, Goltens proposed an alternative repair solution using laser cladding to rebuild the crankpin diameter and machine it back to original size and tolerance.

Figure 1: Damaged journal before pre-machining and cladding

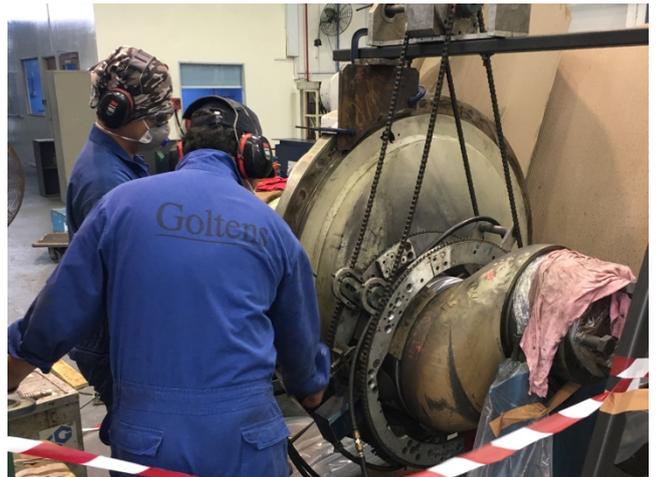
Figure 2: Removing cracks and hardness before cladding

The crankpin was machined to 2 mm undersize to clear all heat cracks and inspected again by MPI. Once satisfied the cracks and hardness were removed from the surface, the shaft was ready for laser cladding to rebuild the crankpin diameter.

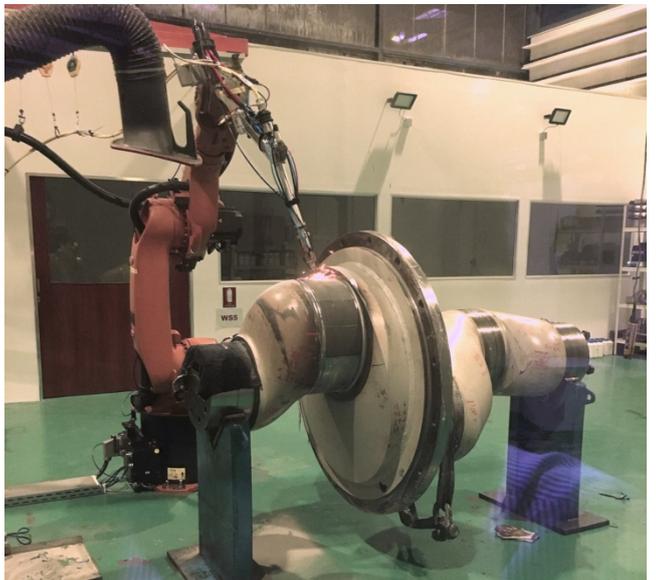
Figure 3: Laser cladding of pre-machined crankpin journal to restore original journal diameter

Laser cladding is an efficient way to build up any shaft diameter without inducing high temperature, thus avoiding any kind of distortion or affecting the original metal properties. The process involves a laser beam which creates a molten pool at the workpiece surface, to which the laser coating material is simultaneously added. The result is a layer that is connected with the basic material metallurgically and free of pores and cracks.

The machined crankpin was cladded with 3mm Inconel 625 material. The shaft did not experience any distortion or change in material property. The laser-powder cladding procedure on this shaft material was approved by DNV GL.

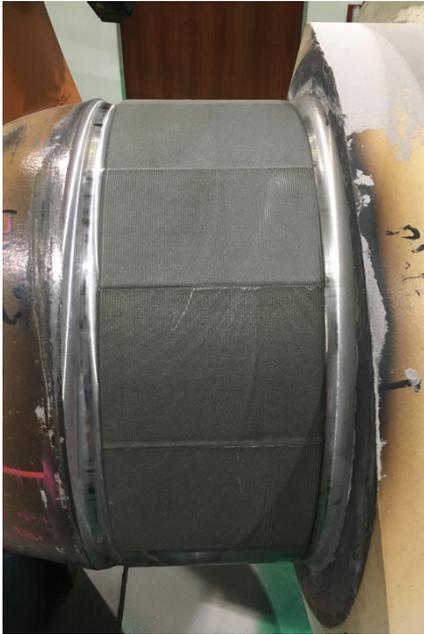
Figure 4: Laser cladding complete

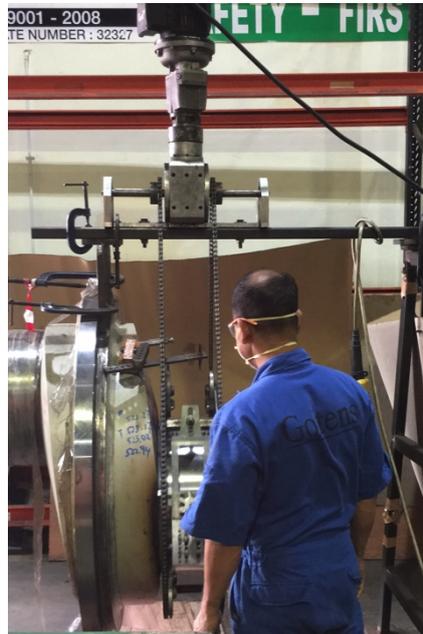
Figure 5: Journal Machining in process

The crankpin was machined, honed and polished to final size. A precision-machined "bluing" dummy bearing was used to perform blue fitting to ensure good contact surface. Lastly, a portable CMM, Leica Laser Tracker, was used to check and generate a 3-dimensional report indicating the shaft alignment, geometry and tolerances of the crankpin. The customer was fully satisfied with the final outcome and shaft was sent back to the mines for installation.

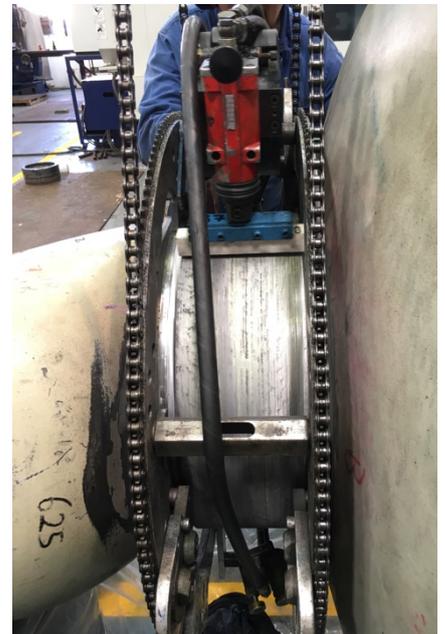
Figure 6: Machine honing to finish diameter

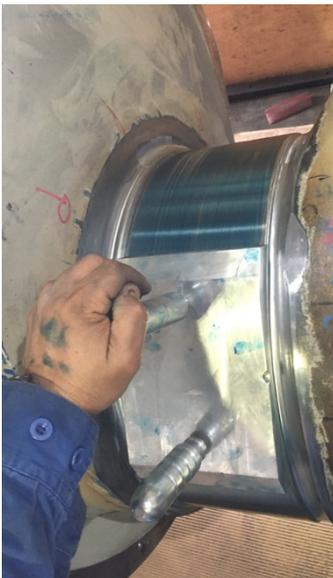
Figure 7: Blue fitting the journal

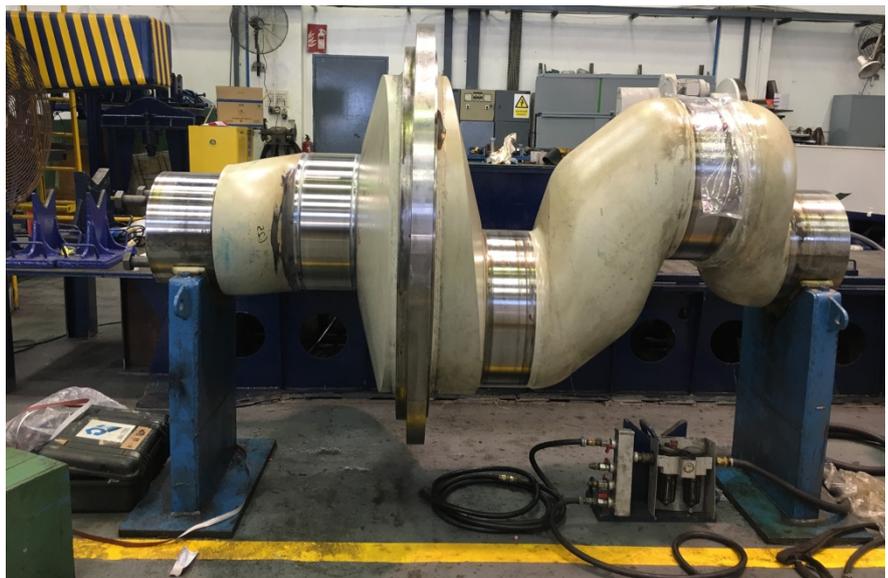
Figure 8: Sludge pump crankshaft restored to original diameter and specifications

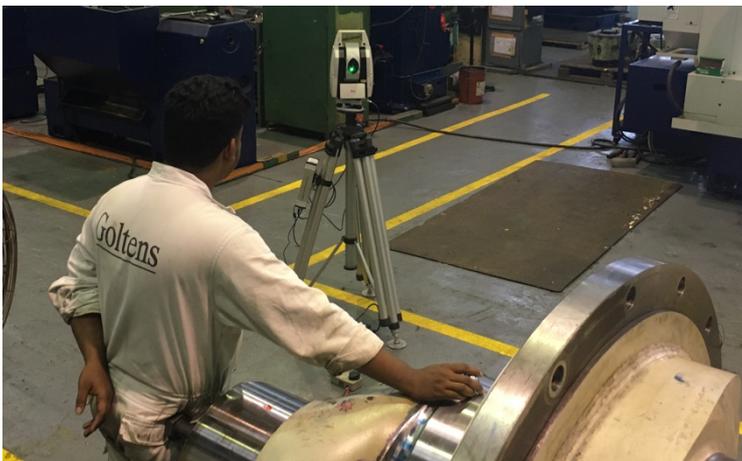
Figure 9: Final inspection with portable CMM (Leica Laser Tracker)

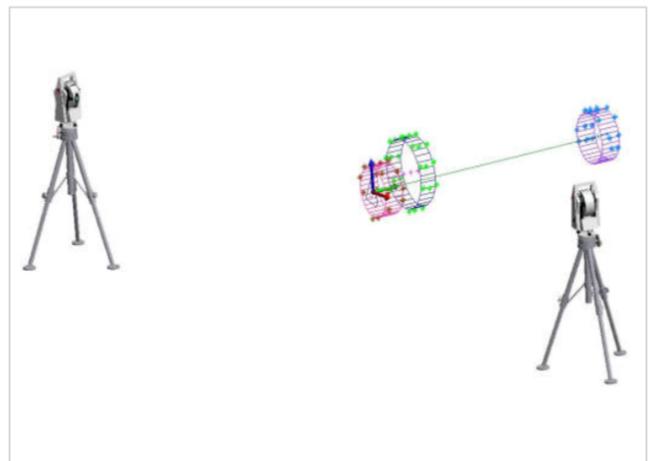
Figure 10: 3D Report checking tolerances and alignment
