## FAST TURNAROUND LINER CHANGE, PISTON OVERHAUL AND CYLINDER COVER MAINTENANCE

### WARTSILA 8 RT-FLEX 96 MAINTENANCE ONBOARD LARGE CONTAINER SHIP DURING SHORT PORT STAY

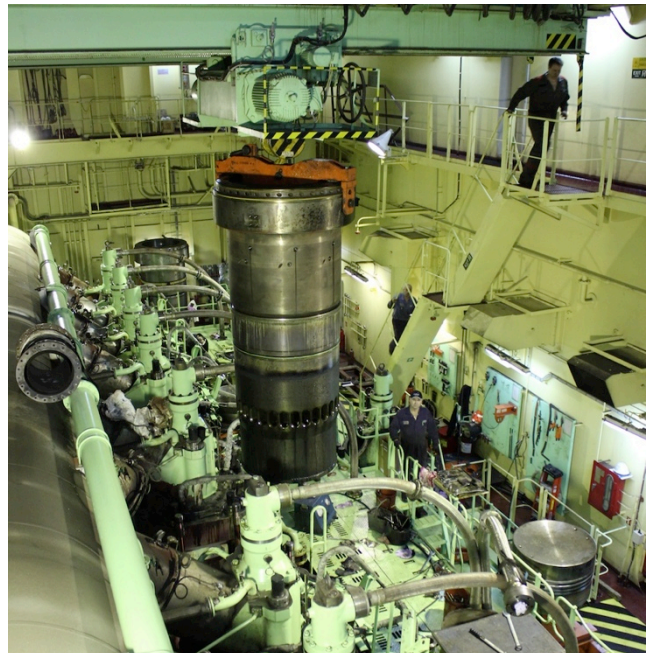
Worn liner being removed from the engine

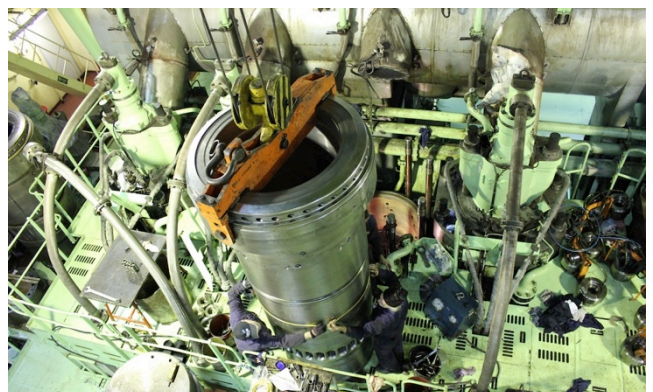
Replacement liner prepared for installation

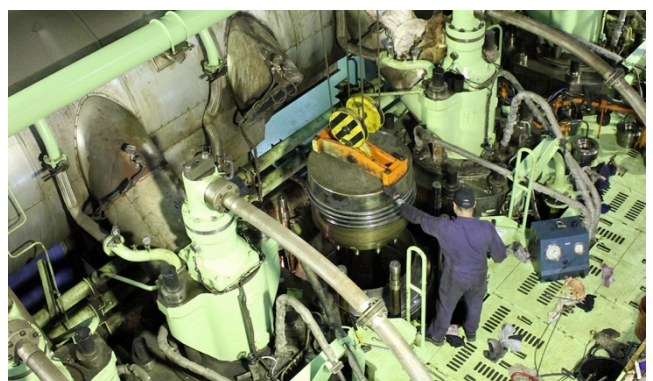
Installation of overhauled piston
