## COMPLETE MAN B&W 12V32/40 ENGINE OVERHAUL AND LINE BORING

### VESSEL CONVERSION IN BATAM, INDONESIA

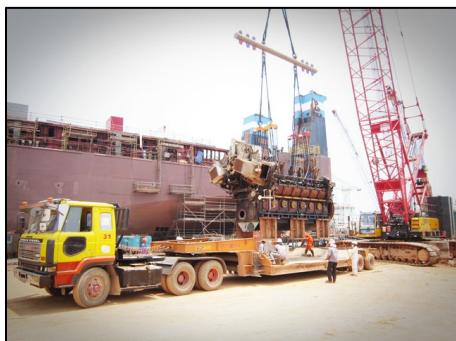
**Rigging of the engine block ashore**

Given the restricted space for line boring and the magnitude of the required repairs, Goltens determined the best approach would be to remove the engine block from the engineroom and complete the required in-situ line boring in the yard's workshop. Goltens' diesel experts, disassembled the engine and rigged the block and the crankshaft shoreside for the repair. Simultaneous with this, Goltens arranged for the supply of the liners, bearings and other spare parts required for the engine overhaul.

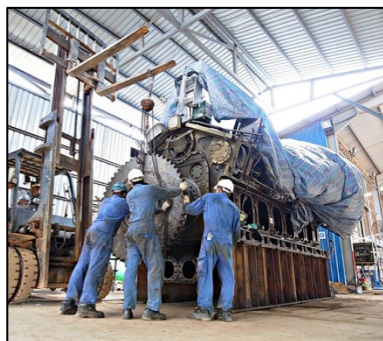
**Disassembly at yard workshop**

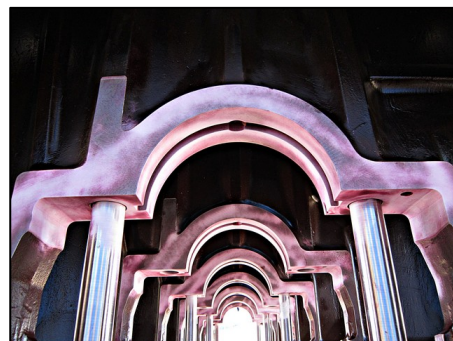
**Dye penetrant check of bearing pockets**

Prior to line boring, Goltens specialists completed straightness checks on the foundation and dye penetrant checks on the main bearing pockets to make sure there was no additional damage. Once satisfied on the magnitude of the damage, Goltens proceeded to line bore the engine, polish the crankshaft and blue fit the crankshaft counterweights. Goltens then installed the crankshaft and main bearings and rigged the block back into the engineroom for reassembly with the supplied spares.

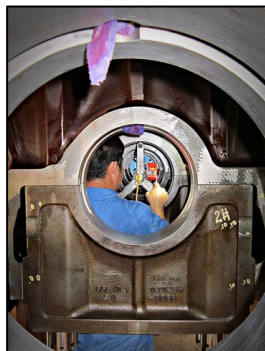
**Bore alignment and crankshaft calibration**

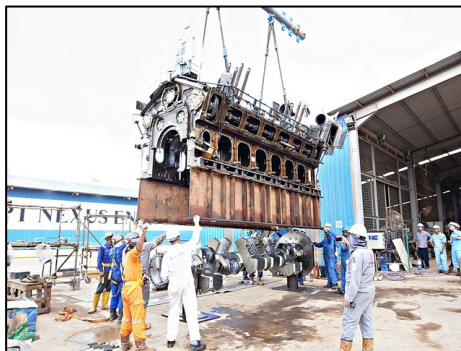
**Crankshaft Installation**

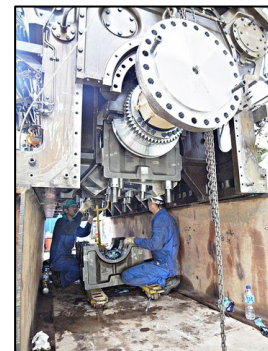
**Main bearing installation**

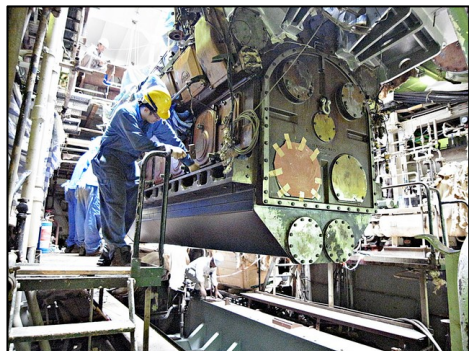
**Lowering the engine into position**

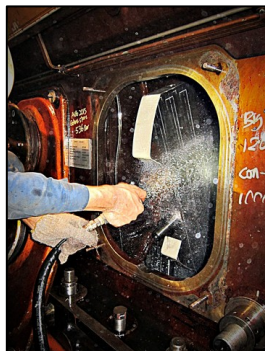
**Lube Oil Flushing**

Once the engine was fully overhauled and reassembled, the engine was flushed, laser aligned and chocked before operational testing and full sea trials. During sea trials, the engine was successfully tested on both MDO and HFO with 75% load at 14 to 16 knots with all engine parameters within the acceptable range.

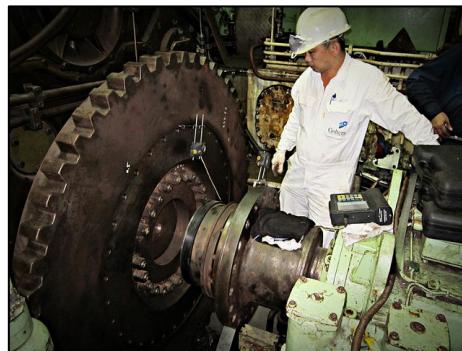
**Laser Alignment**

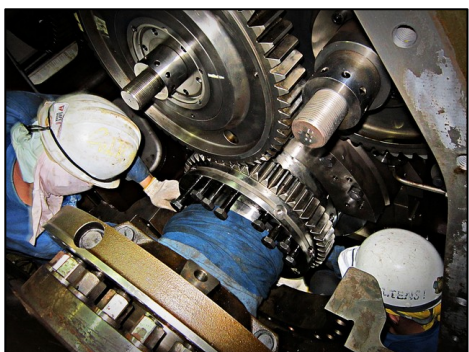
**Adjusting engine timing**

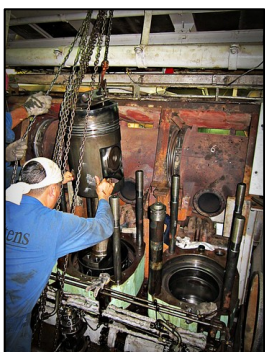
**Piston Installation**

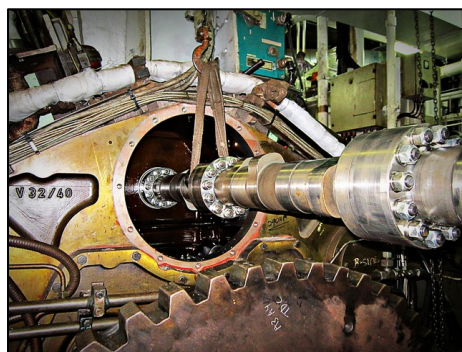
**Camshaft Reassembly**
