THE PRICE OF SAVING MONEY ON WOODWARD SERVICE

WHAT USING A NON-AUTHORIZED GOVERNOR REPAIR COMPANY CAN COST YOU

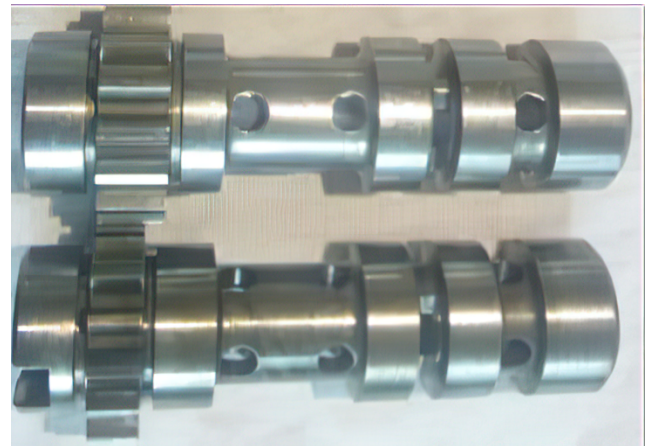
- **Incorrect Parts** - a smaller pump, incapable of the designed 240 psi output pressure, was used. This meant the governor could not create the required output torque during load transients. This potentially causes sluggish engine performance and even an overspeed, especially during load rejection or starting.
- **Incomplete Service** - The shutdown solenoid had not been serviced at all and was dirty. Further, the spring washer protecting the solenoid from engine vibration was damaged. This could cause the solenoid windings to fail making it inoperative during an emergency shutdown.
- **Reuse of Worn Parts** - The oil seals had not been replaced and were hard which would cause the governor to leak oil.

Figure 1: Pilot Valve bushings indicating the pump difference

The importance of using Woodward approved and authorized governor service is to ensure your Woodward Governors are maintained to Woodward standards to ensure proper function, minimize risk and not compromise safety.

Only Woodward approved AISF’s have access to correct specialized tooling, processes, bill of materials, latest revisions, work instruction, training, support and genuine Woodward parts. Goltens prides itself on delivering a quality service to the above requirements and is audited accordingly.

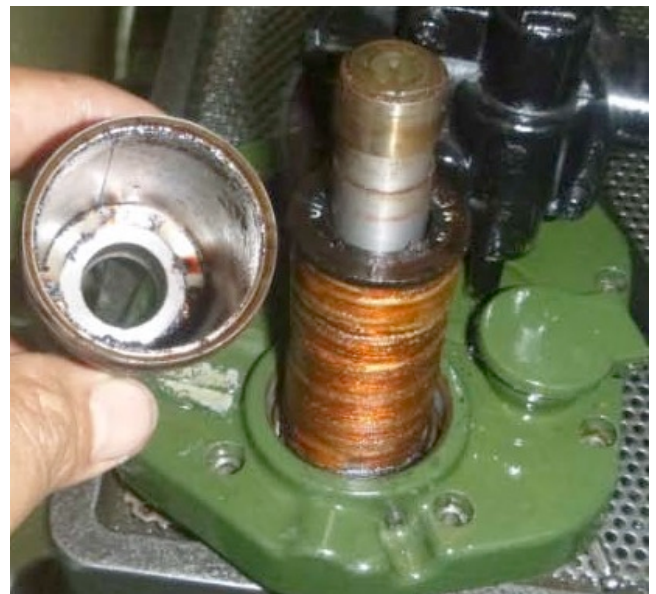
- This governor would not perform as designed potentially leading to overspeed and under frequency events as well as load sharing variations with other engines during system disturbances. **This might not be noticed until the vessel is in a critical situation such as maneuvering or in a storm.**
- The complete failure to service the shutdown solenoid is a safety issue. The solenoid must be checked mechanically and electrically to ensure its integrity and failure to do so could cause serious damage should the engine fail to stop after a trip initiation from the engine safety system.

Figure 2: Neglected, un-serviced stop solenoid

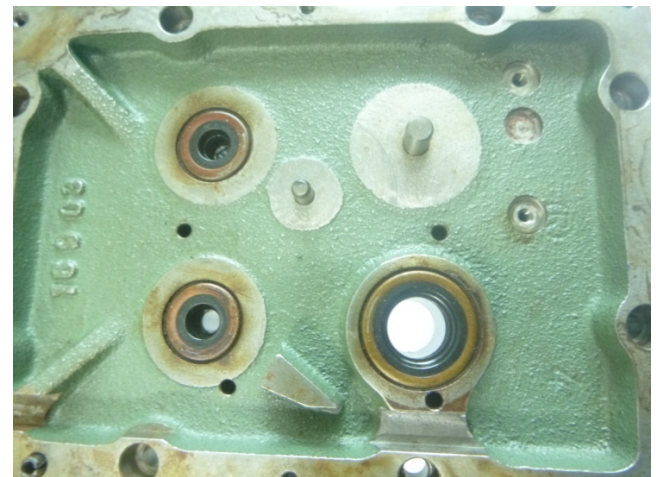
Figure 3: Hardened oil seals on UG15D front panel
