## CREATIVE IN-SITU SOLUTION RESTORES GENERATOR TO OPERATION

### PIELSTICK 2.3 GENERATOR SHAFT

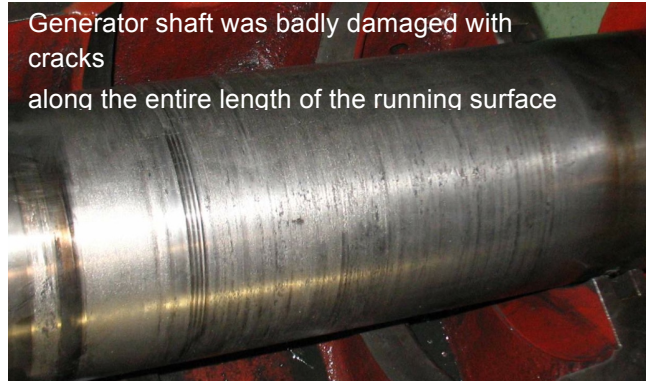
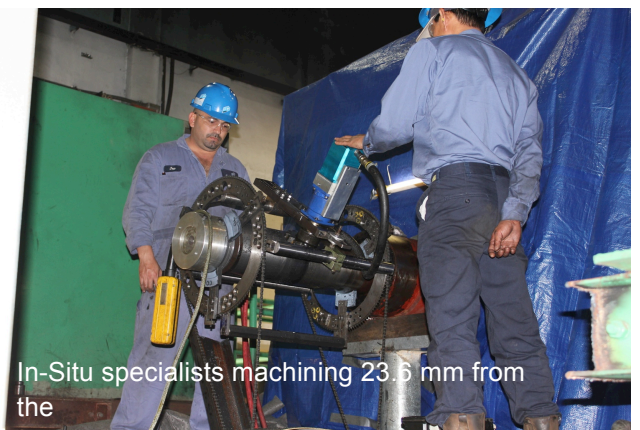
Generator shaft was badly damaged with cracks along the entire length of the running surface

Goltens proposed machining the shaft until it was free of cracks and fabricating a sleeve that could be shrink fit to the shaft to return it to its original diameter. The customer accepted the proposal and Goltens mobilized tools and in-situ machinists to site to undertake the repair. Cracks were significant and Goltens stopped machining at numerous diameters to evaluate the extent of the cracks. At 23.6 mm undersize, 4 cracks remained and a decision was made to local grind the cracks until removed prior to sleeving the shaft.

Once completed, the sleeve was heated to obtain the necessary clearance and shrink fitted to the shaft before it was finish machined and the generator reassembled and aligned.

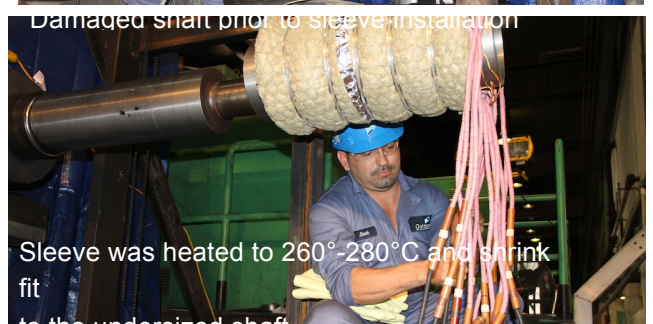
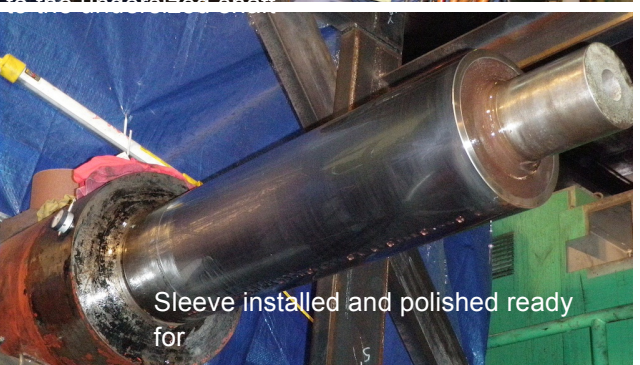
Damaged shaft prior to sleeve installation
