30-TON BERGEN CRANKSHAFT REPLACEMENT FOR RUSSIAN POWERPLANT

9 DAYS IN ARKHANGELSK

PROJECT FACTS: CRANKSHAFT REPLACEMENT

Customer:	Power Plant
Location:	Arkhangelsk, Russia
Engine Make:	Bergen
Model:	B32:40V12
Job Duration:	9 days on-site

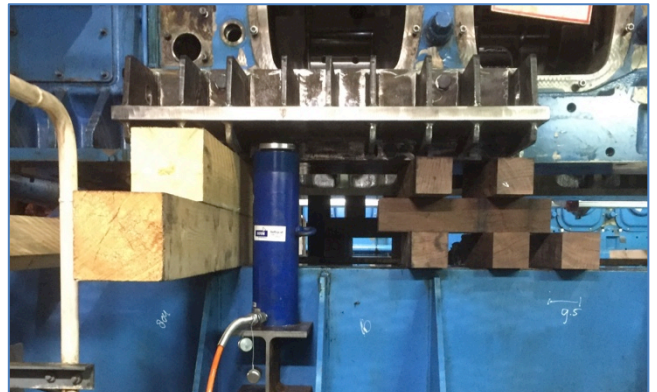
Block lifting arrangement with wooden supports

Goltens lifted the block in stages inserting wooden blocks underneath to support the block during lifting operations. Once the block was lifted to a height of 135cm, prefabricated, steel vertical supports were installed to secure all in place during the crankshaft removal.

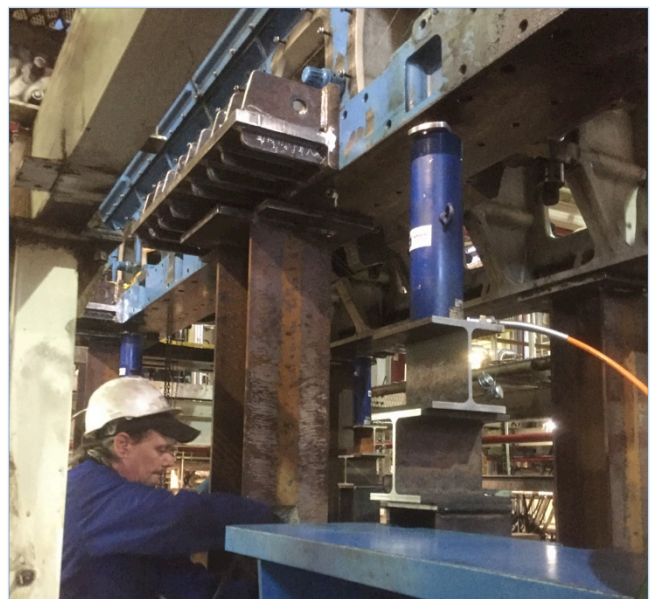
Block lifted with vertical steel supports installed

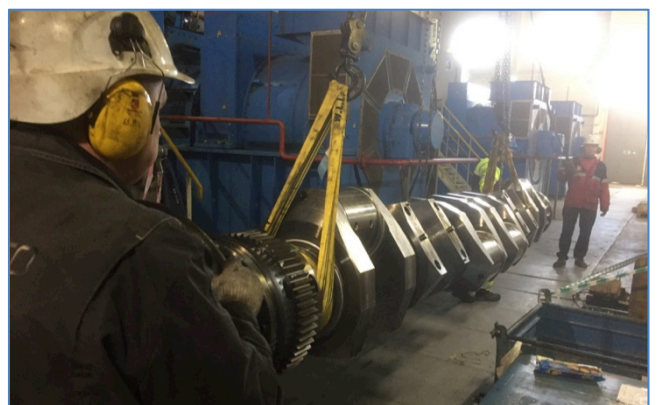
Rigging condemned crankshaft from the engine

With the block lifted and secured, the counterweights were removed and plant personnel removed the vibration dampener. With chain blocks and lifting slings fitted on the crankshaft, the main bearing caps were removed and the crankshaft was carefully lowered and maneuvered out from under the block.

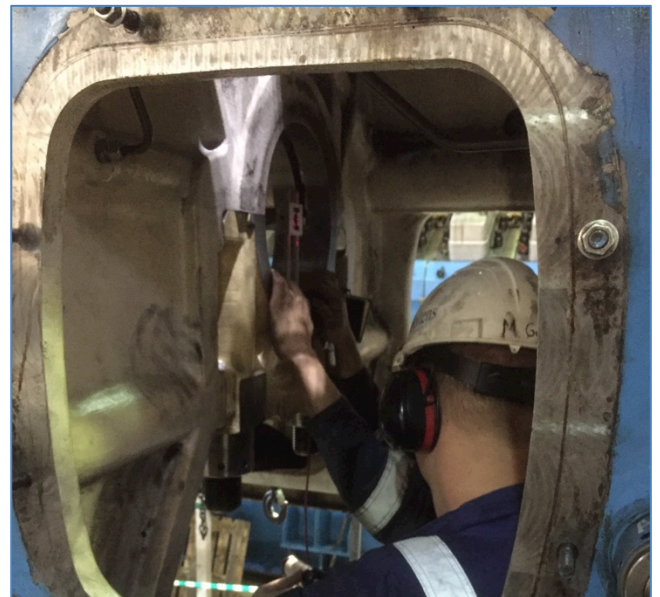
Laser alignment check of main bearing pockets

Bearing caps were then reinstalled and all bearing pockets were calibrated at 6 points before carrying out a laser alignment check on the main journal bores. All readings were accepted by the client and the OEM.

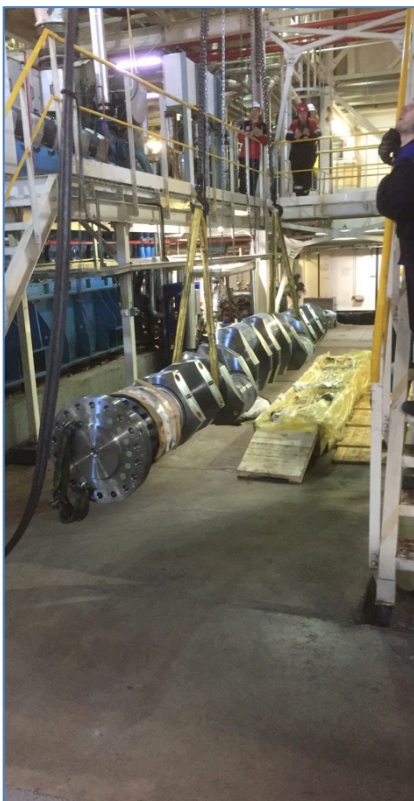
Rigging new crankshaft

With the bearing caps removed again, the new crankshaft was inspected and all journals protected for the lifting operation. The crankshaft was then carefully moved by

crane to the end of the engine where the crankshaft was gradually moved underneath the block and lifted into position.

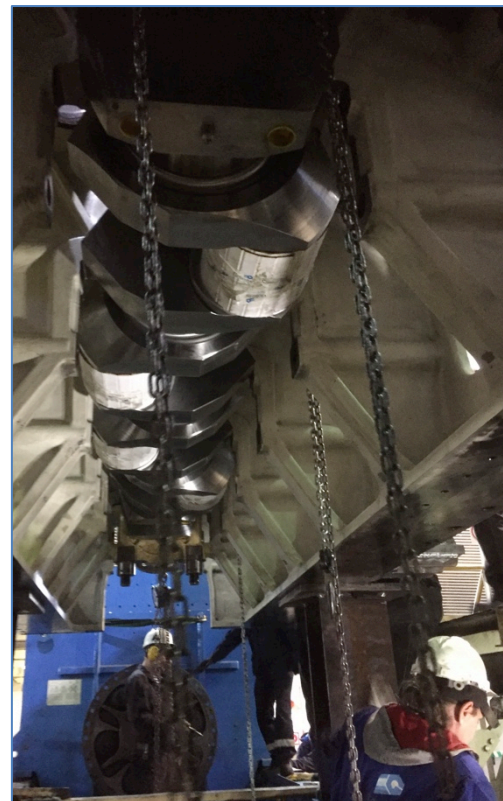
New crankshaft lifted into position

All main bearing caps were then reinstalled with new bearings, side bolts tightened and counterweights reinstalled on the crankshaft.

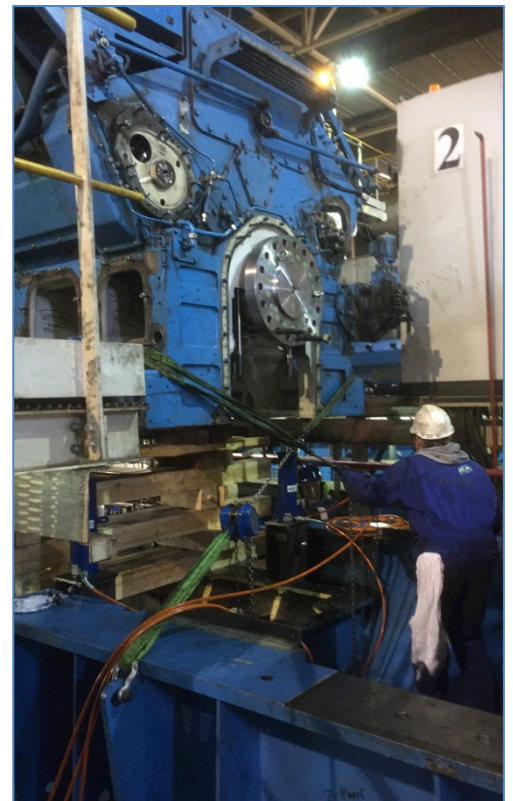
Lowering block back to bedplate

Now, following the reverse of the lifting procedure, the block was lowered back onto the bedplate with a new gasket and foundation bolts were tightened.
