GOLTENS SOLVES COMPLEX RUDDER STOCK PROBLEM FOR BEN KIEN SHIPYARD

M/V 9200T-03 - THE RUDDER STOCK RECTIFICATION

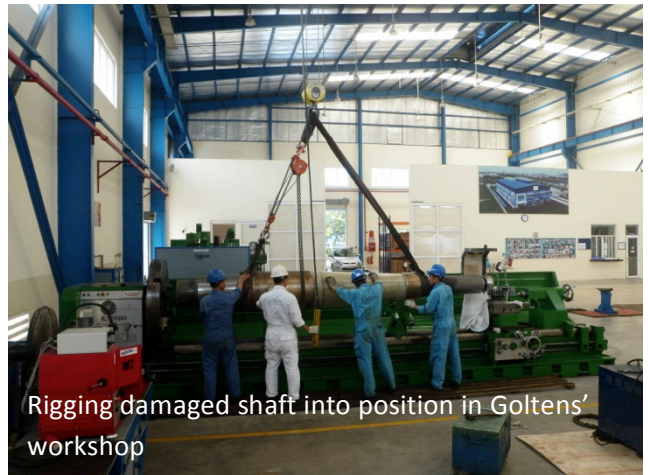
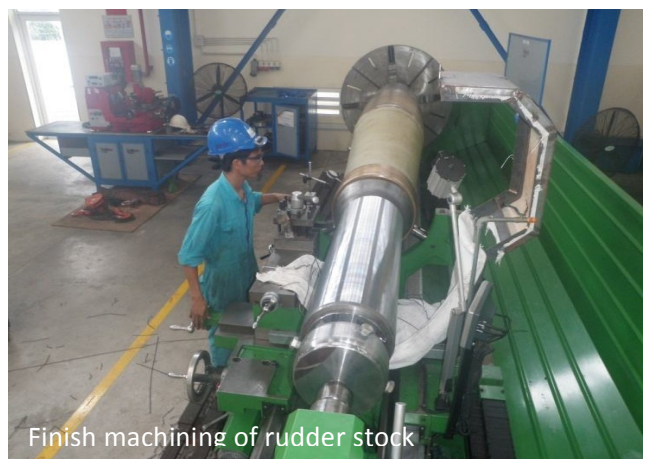
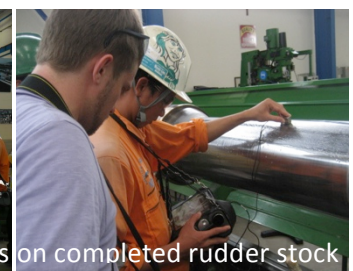
M.V 9200T -03 is a new build vessel in Ben Kien shipyard-Hai Phong in the North of Vietnam. Prior to installation of the rudder stock on the vessel, it was found that some heavy corrosion had taken place on the shaft surface. The ship owner required that the shaft be returned to a new condition prior to installation and that the procedure had to be approved by BV class.

- Rudder stock cleaned & measured (before & after repair)
- Completed alignment check & machining on long bed lathe
- PMI inspection prior to welding
- Heating and welding following set procedure
- Heat treatment of rudder stock
- Final machining and polishing of rudder stock
- Final inspected by MPI and UT

The shipyard was unable to find a local repair company to handle this work as a complete repair package with an acceptable procedure. Goltens Vietnam based in Vung Tau in the South of Vietnam was able to propose a procedure that was accepted by BV Class. This involved removal of defective material, heating the shaft using Goltens' annealing equipment, rebuilding the defective area and machining it back to original size.

Goltens repair package solution was presented to ship owner and completed within the expected schedule of 7 days with excellent results achieved.
