## ON-SITE MACHINING OF 870MM RUDDERSTOCK IN BAHAMAS

### GOLTENS IN-SITU MACHINISTS RECTIFY DAMAGE TO CRUISE SHIP RUDDERSTOCK

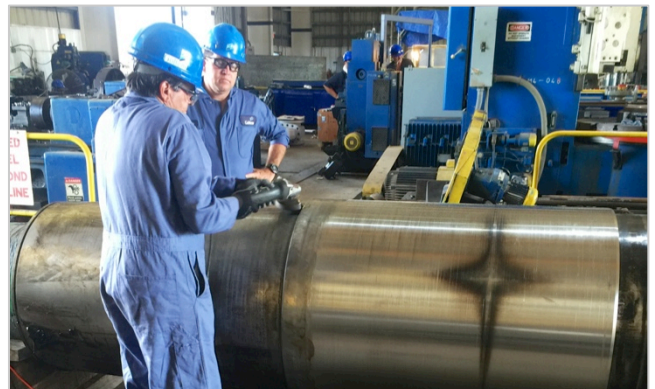
Preparing rudderstock for tool installation

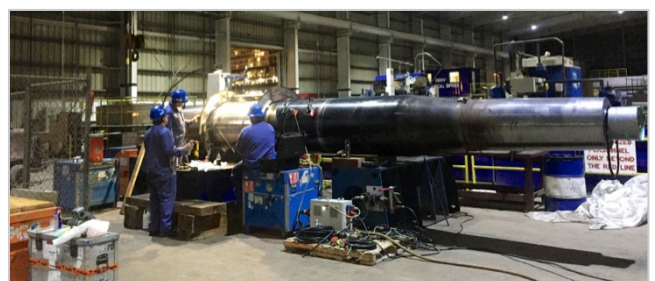
Single point cutting tools mounted

- Single point cutting/machining of damaged rudderstock removing 0.80mm from the diameter for a finished diameter of 869.20mm
- Machine polishing of journal surface to required roughness
- Grinding of journal end surfaces

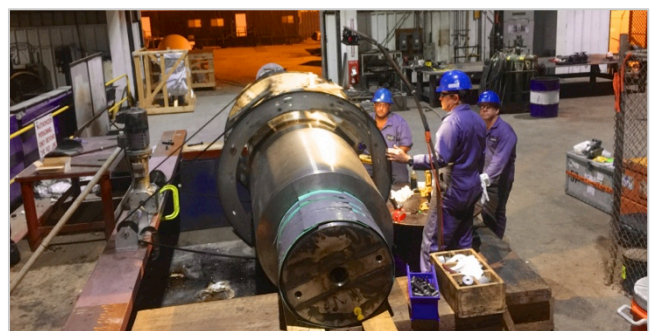
Journal Machining in progress

Goltens' in-situ machinists completed the large diameter machining job working 2 shifts in 5 days and the shipyard machined an undersized bearing to suit the new diameter of the rudderstock.
