CHOCKFAST® ORANGE SOLUTION RESOLVES FOUNDATION CORROSION ISSUE FOR SPORTS STADIUM

SPORTSHUB STADIUM ROOF- SINGAPORE

PROJECT FACTS: SPORTSHUB STADIUM

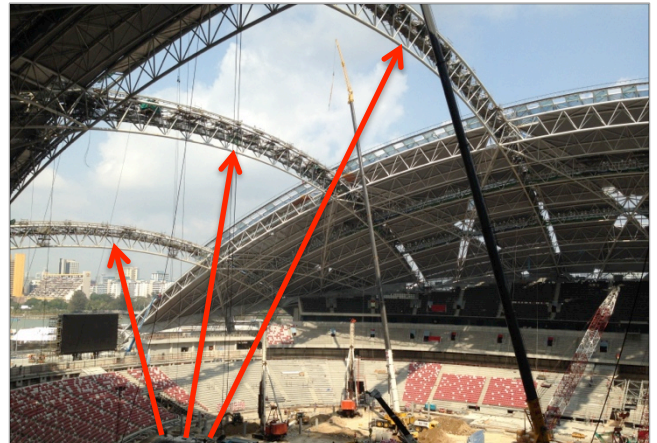
Location of winches high above stadium floor

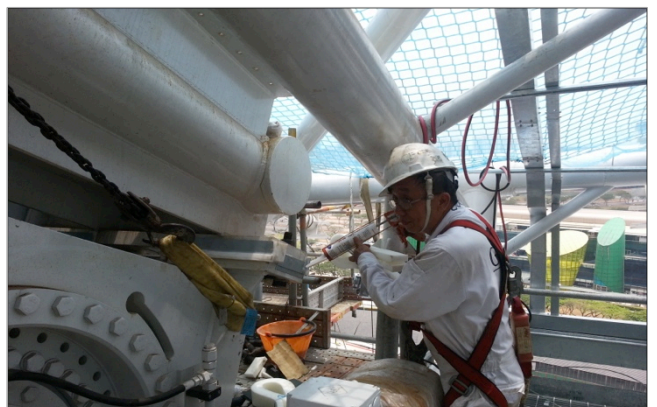
Filling in gaps on the winch footings

- Cleaned winch foundation surface of all dirt, rust and corrosion
- Prepared and pre-conditioned the Chockfast® Orange PR 610 TCF epoxy resin prior to installation.
- Mixed the Chockfast® Orange compound according to the manufacturer's specifications and poured an average of four sets of Chockfast® Orange for each of the 16 units.
- Application of a cosmetic surface layer after 24 hours of curing/hardening.
- Grinding of the grout surface to a fine finish after grout had fully hardened.

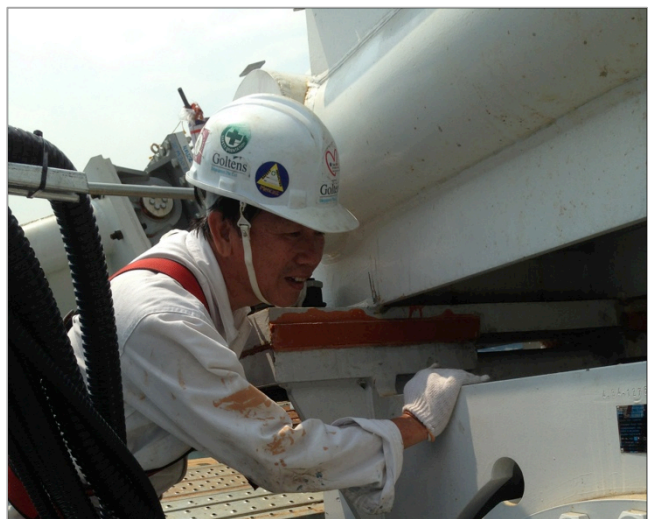
Specialist performs final inspection of foundation
