IN-PLACE MACHINING OF STEAM TURBINE ROTOR SHAFT IN FOUR DAYS

ATLAS ENERJI - TURKEY

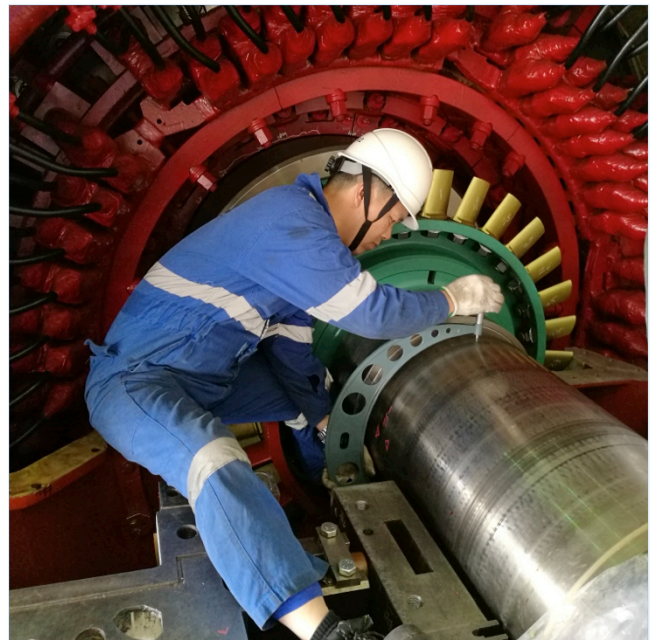
Complete inspection of turbine journal

- Complete inspection of the rotor shaft including hardness checks, MPI, measurement etc;
- Machining of journal radius/fillets;
- Machining of the shaft journal to undersize 1.00mm;
- Honing and polishing of rotor shaft journal;
- Fabrication of bluing dummy shell and performance of blue fitting test;
- Post machining inspection

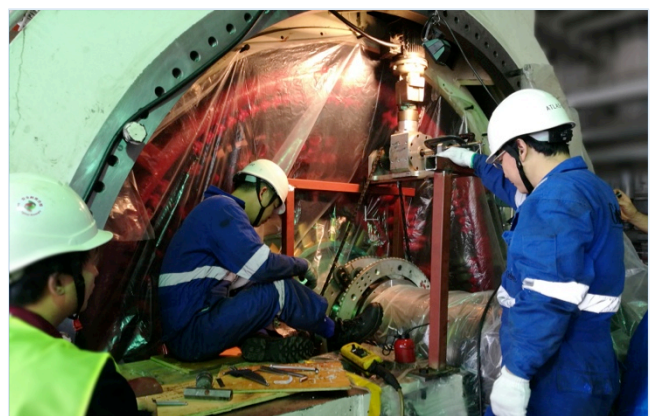
In-place machining of rotor shaft journal

Goltens' experienced in-place machining team completed the repair 2 full days earlier than the 6 days initially proposed allowing the power plant to keep up with its planned maintenance schedule.
