## WORTHINGTON CRANKSHAFT REPLACEMENT FOR MIDWEST NUCLEAR PLANT

### IN-SITU CRANKSHAFT INSPECTION LEADS TO COMPLETE CRANKSHAFT REPLACEMENT AND ENGINE REBUILD

**PROJECT FACTS:** NUCLEAR PLANT  
CRANKSHAFT REPLACEMENT

Engine Make/Model: Worthington SWB-VEE-12  
Engine Output: 3.5MW  
Project Duration: 61 Days

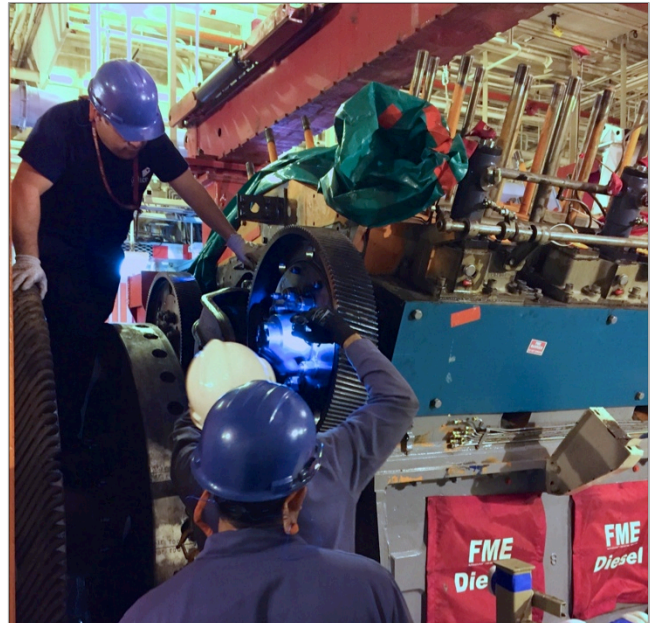
Disassembly and removal of gear train

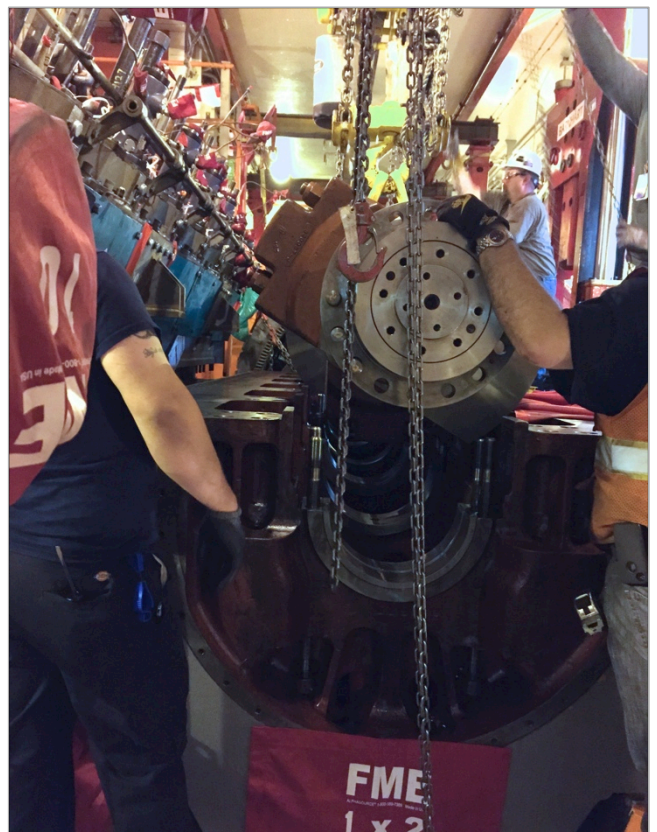
Rigging of damaged crankshaft from the engine

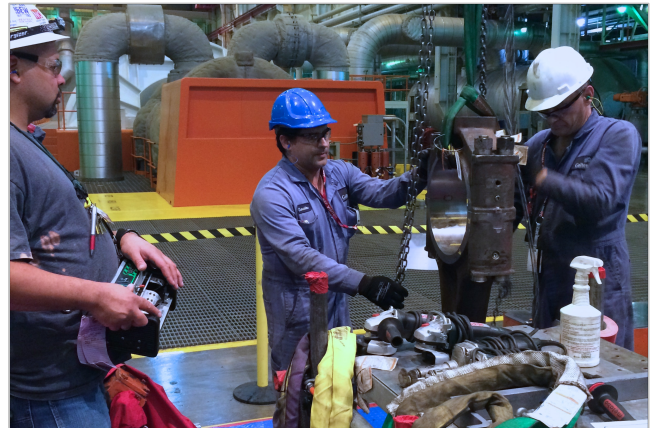
Calibration check on connecting rods

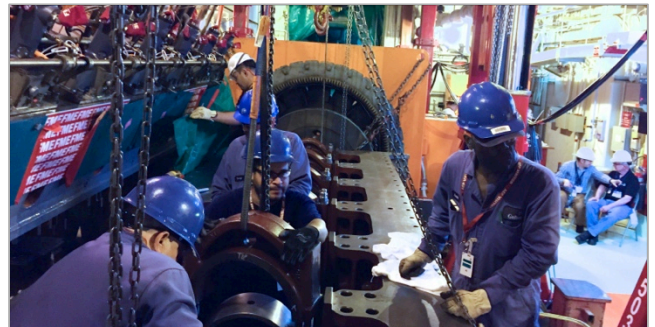
Replacement of bearing caps to check line bore

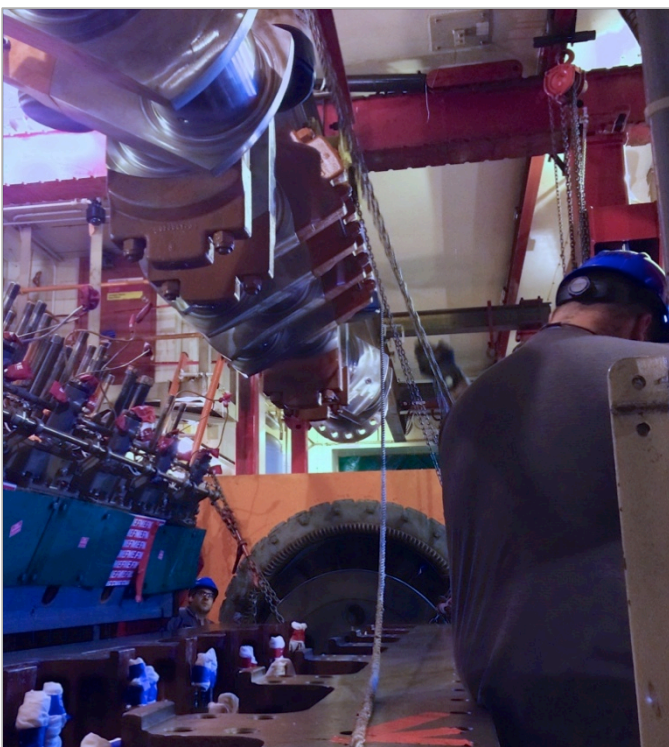
Replacement of bearing caps to check line bore

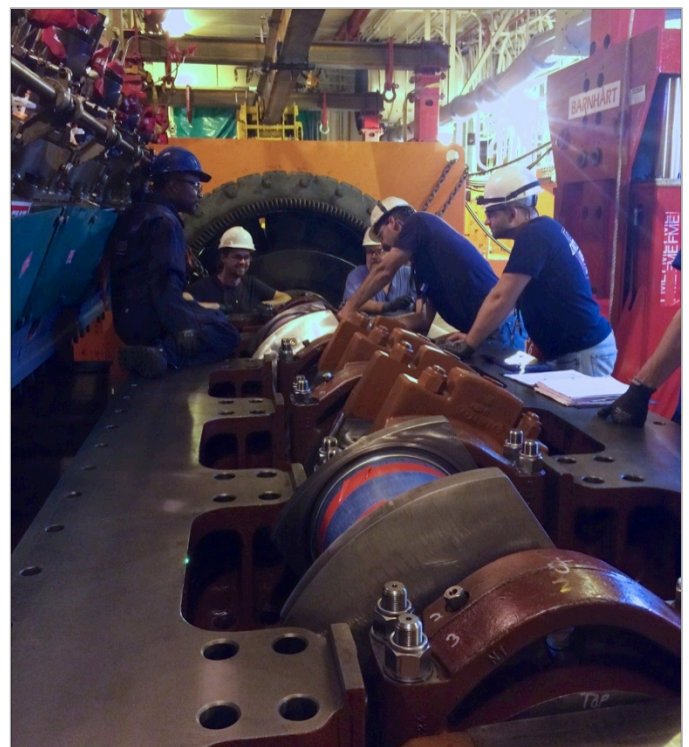
Replacement of bearing caps to check line bore

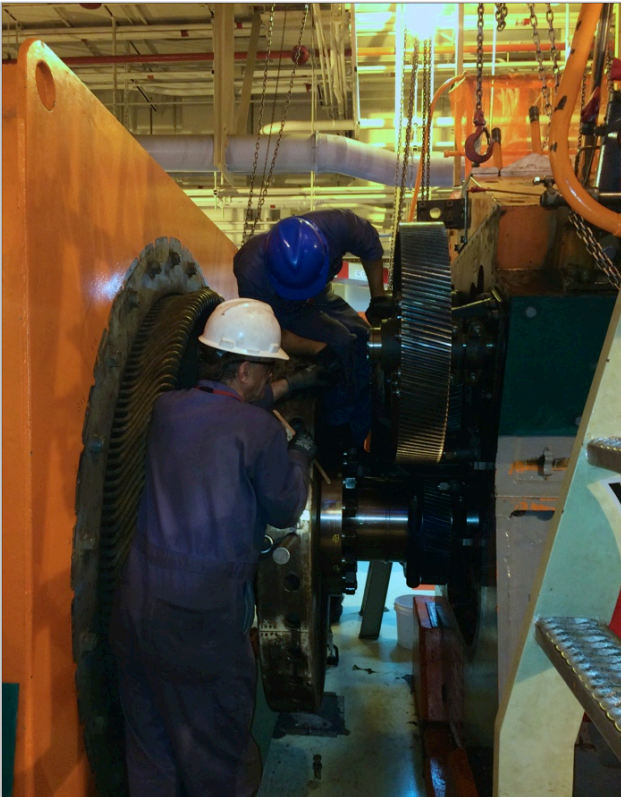
Reassembly of front end of the engine

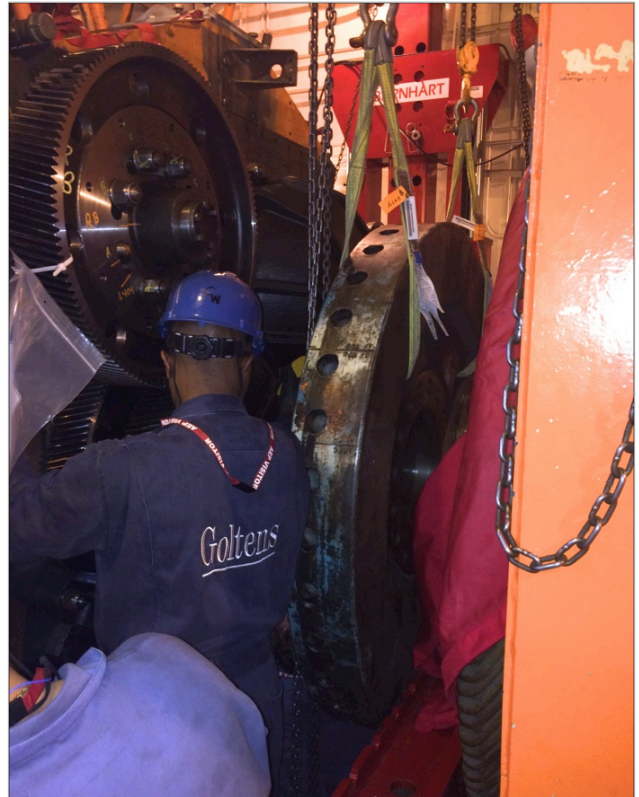
Rigging flywheel into position

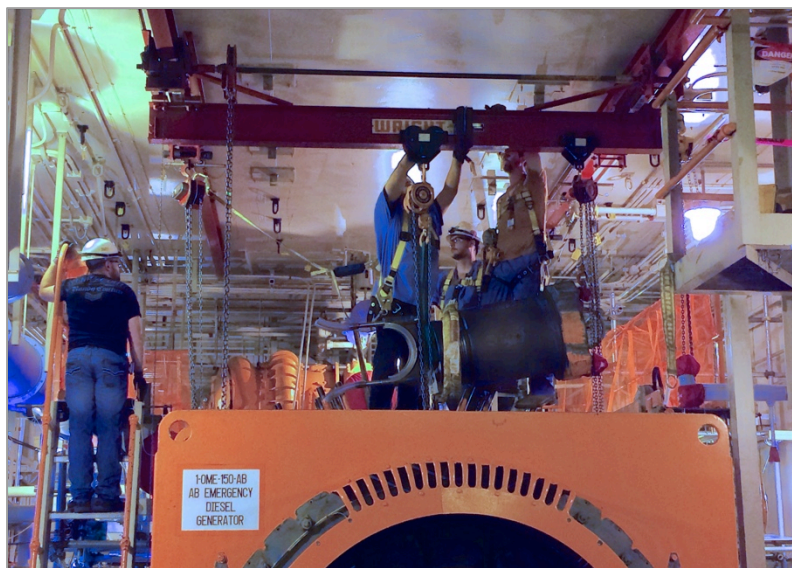
Rigging power pack into place during rebuild
