IN-SITU JOURNAL MACHINING BULK CARRIER RUDDERSTOCK REPAIR

STATISTICS: Bulk Carrier Rudderstock

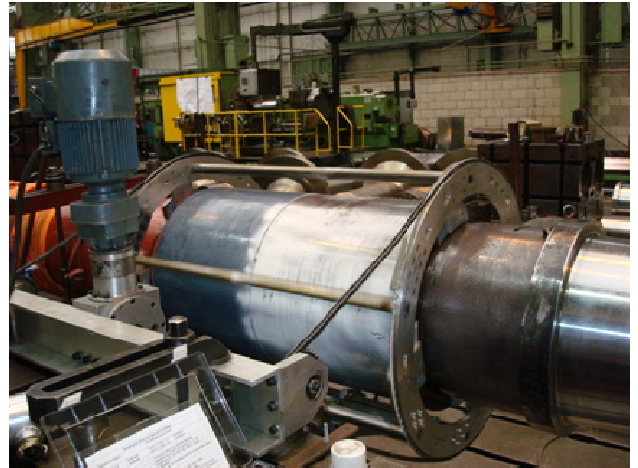
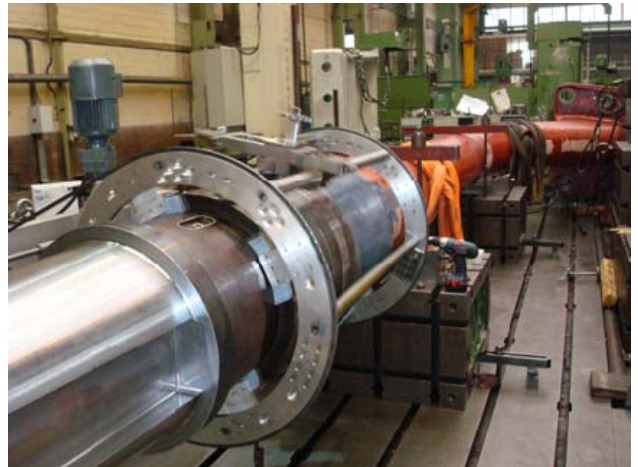
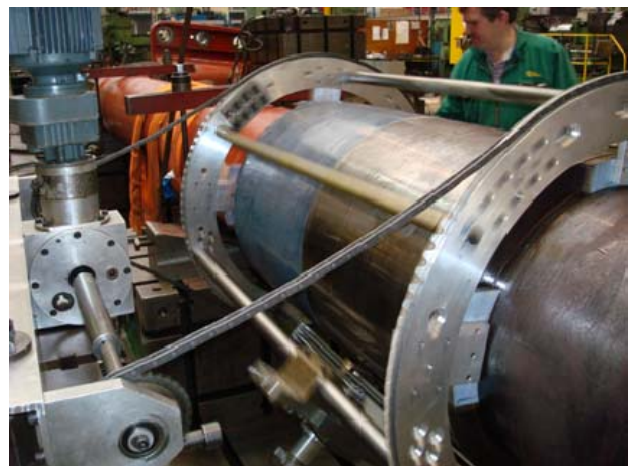
Goltens' evaluation of the rudderstock revealed that the stock's surface had damage that required machining and that part of the shaft had been filled with Belzona, but that it could be salvaged.

- Machining rudderstock from original damaged diameter of 660mm to finish diameter of 658mm over a length of 1,000mm.
