IN-SITU FLANGE FACING – CRANE POST BEARING SUPPORT SURFACE RENEWAL

PROJECT FACTS: M/V MIMI SELMER

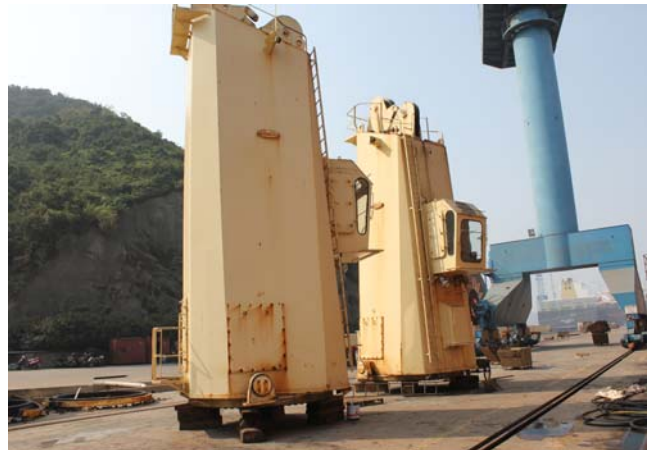
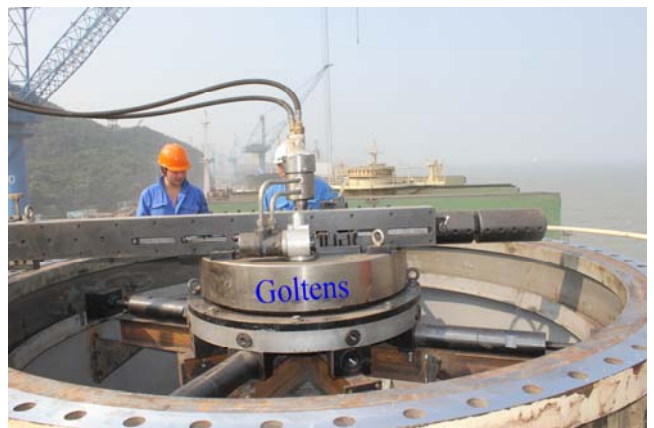
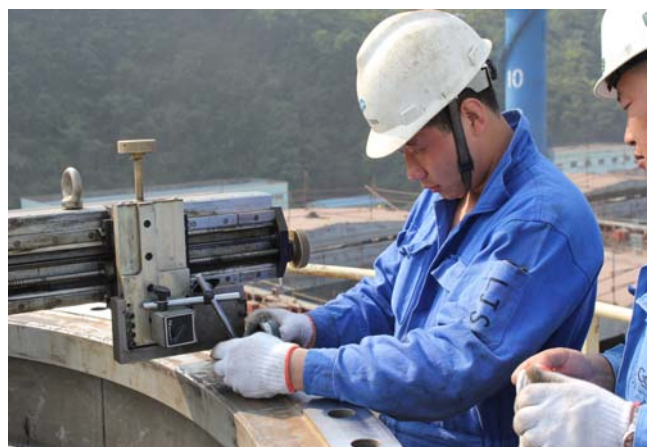
Goltens deployed tools and technicians to the ship and carried out the laser checking and flange facing on the 2.8 meter diameter surfaces. With work completed to the owner's satisfaction, Goltens was subsequently awarded the machining work for units 2, 3 and 4

- Flatness checking with laser equipment on crane No.1, No.2, No.3 and No.4;
- Machining the bearing support surface on crane No.1, No. 2, No. 3 and No.4;
- Double flatness checking with laser equipment on crane post No.1, No.2, No.3 and No.4
