Trusted Globally

See why over 3,000 clients a year across industries trust Goltens' global capability to deliver expert, innovative and cost-effective solutions for their most challenging maintenance and repair requirements.

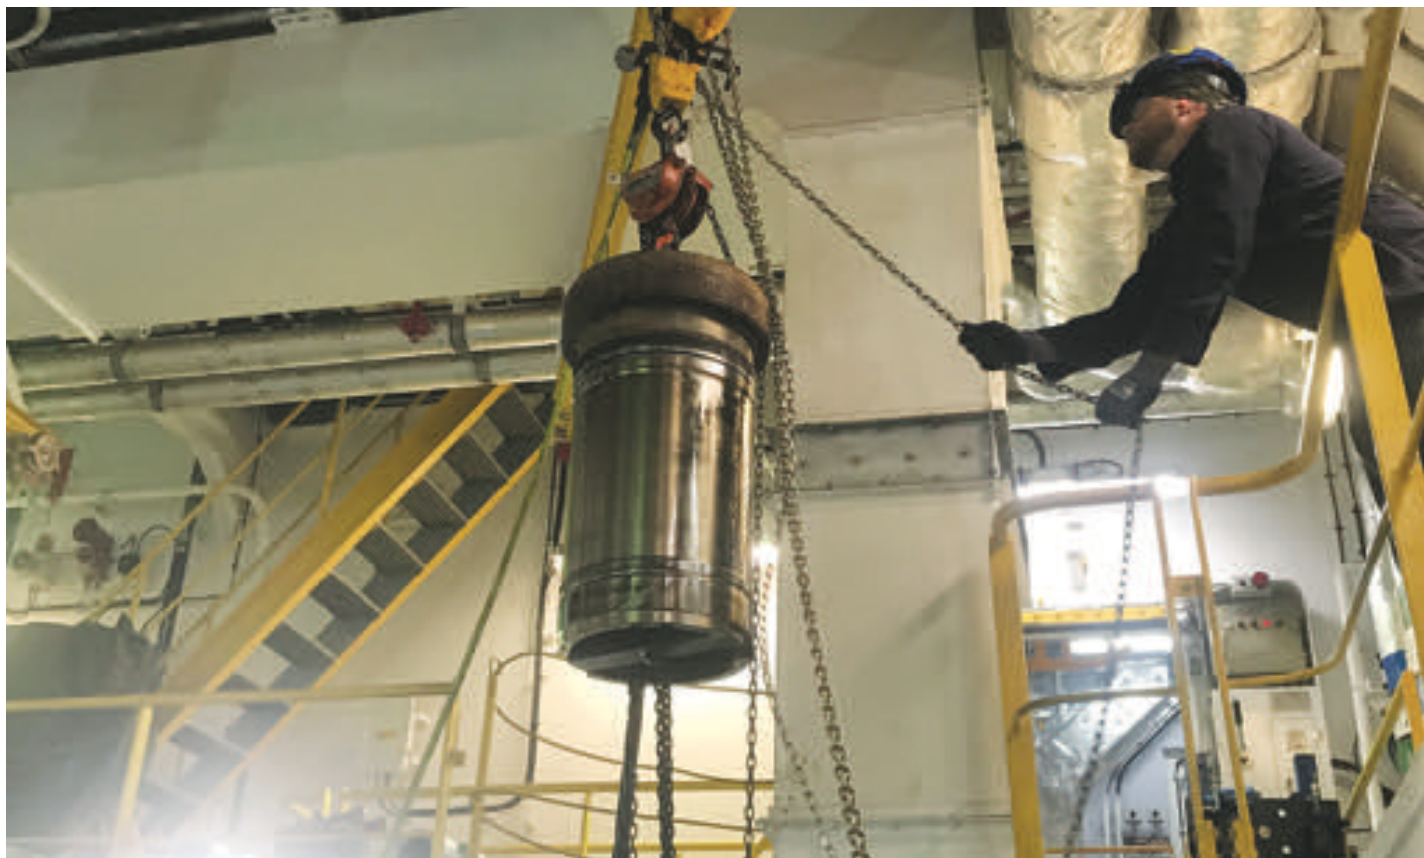
Rigging of liner to calibration/overhaul area

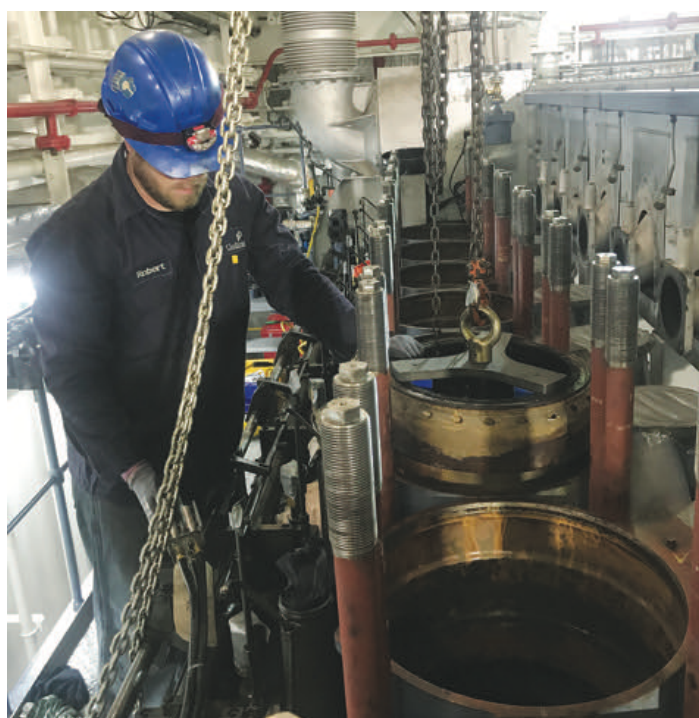
Removal of cylinder liners from engine

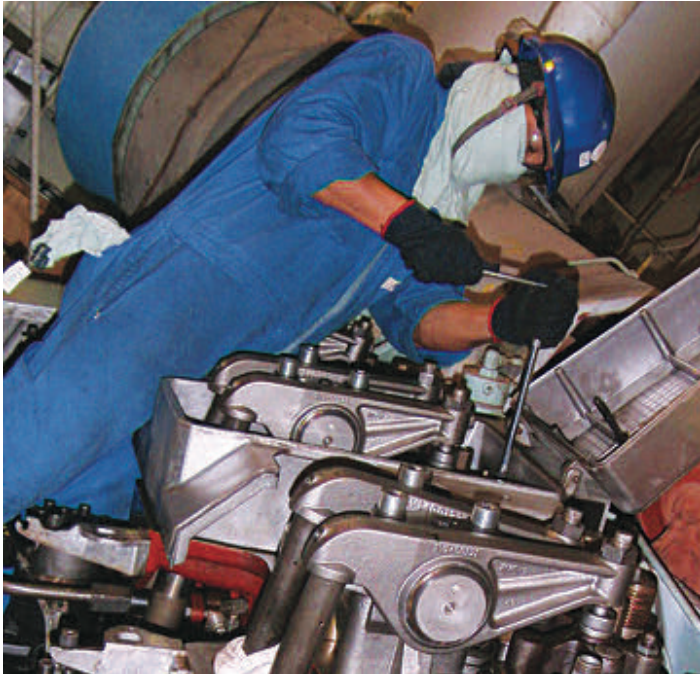
Wartsila 16V32 – 48,000 hour overhaul in West Africa
Installation of Rocker Gear during engine rebuild

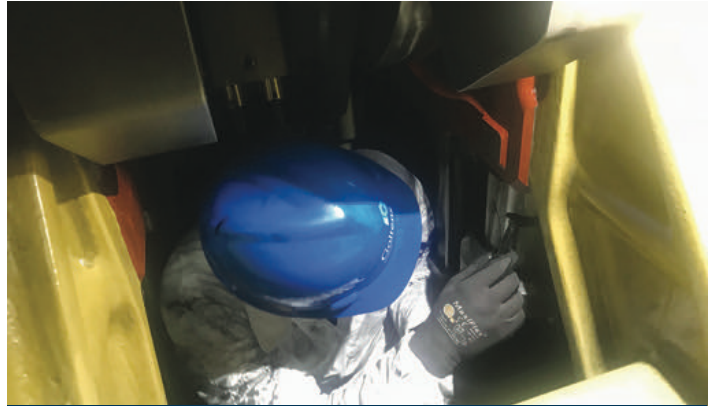
Wartsila 12V32 20,000 hour overhaul in US Gulf
Goltens technician tensioning main bearing cap bolts on Wartsila 12V32

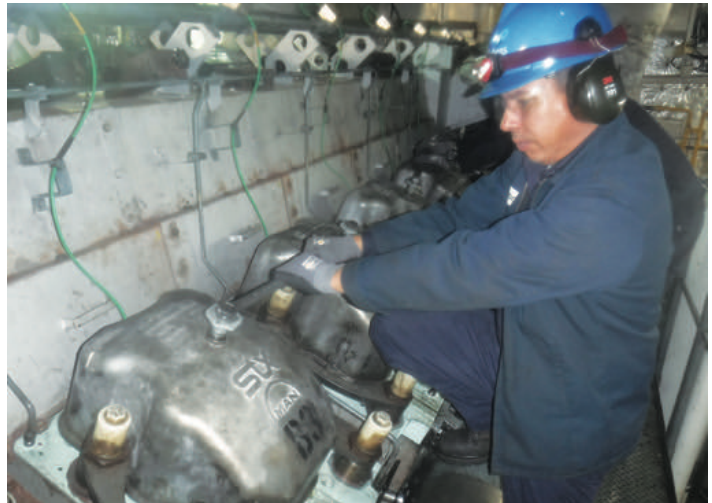
STX MAN 14V32/40 – 36,000 overhaul in US Gulf
Goltens technician completing installation of Rocker Arm covers

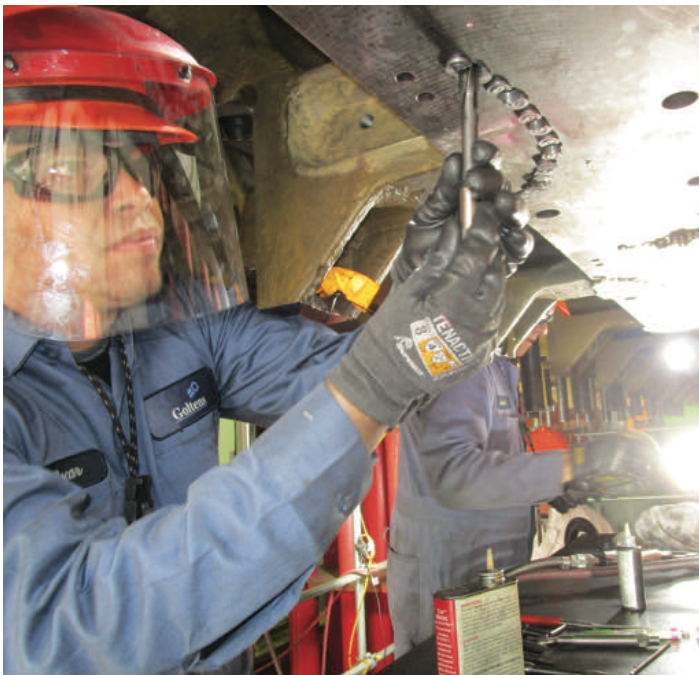
Metal stitching large cracks in the underside mating surface

When one of the Cooper Bessemer KSV-20-T EDBGs at the Palo Verde III Nuclear Generating station in Arizona experienced a casualty on two connecting rods, they immediately called Goltens to inspect the damage and propose a plan for repair. Inspection revealed the engine had suffered the same casualty on the same cylinders 30 years previous. There was significant damage to the block, and repairs would involve extensive metal stitching and machining. Damage to the crankshaft would mean line boring of the engine as well.

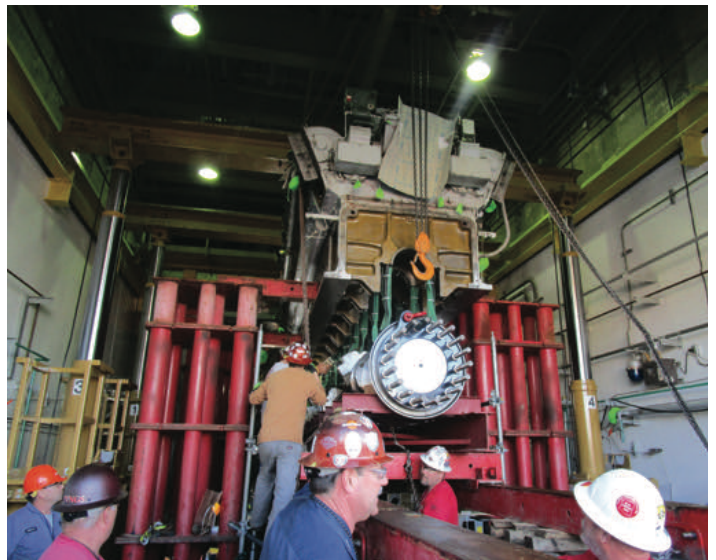
Crankshaft lowered to skid for removal from powerhouse

The plant had a spare crankshaft on hand, and the decision was made to replace rather than repair the shaft in-situ. Goltens repair teams worked 24/7 through the Christmas holidays to restore the engine, completing all work in 57 days, five days under the defined time limit.

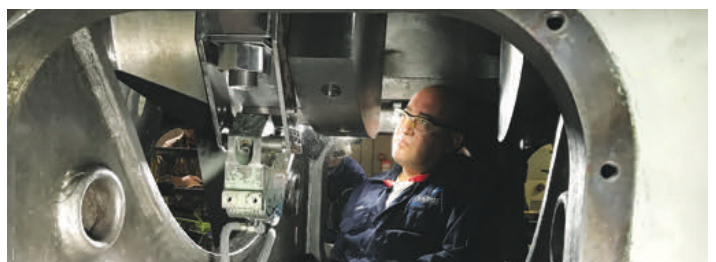
Machine honing of the damaged crankpin journal

tion of the shaft and identify a repair method for the damage on the EDBG. Goltens undertook an inspection of main journals 7 and 8 and found a breakdown of bearing integrity and signs of improper wear.

In order to address the plant's urgent requirements and help to avoid a shutdown of the reactor, Goltens deployed its in-situ machining tools and technicians to the site on Thanksgiving Day to carry out repairs. Work included machine honing of main journals, straightening of the crankshaft at main journals 7 and 8, and repair of surface irregularities. All repairs were completed within required timelines for restoration and a reactor shutdown was avoided.

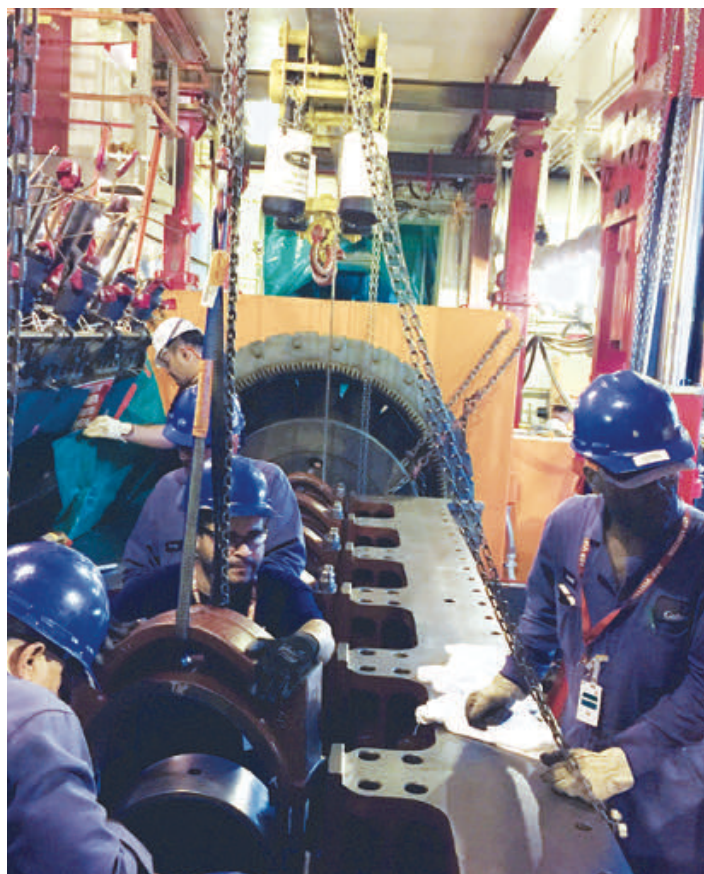
Lowering bearing caps into position to complete line bore

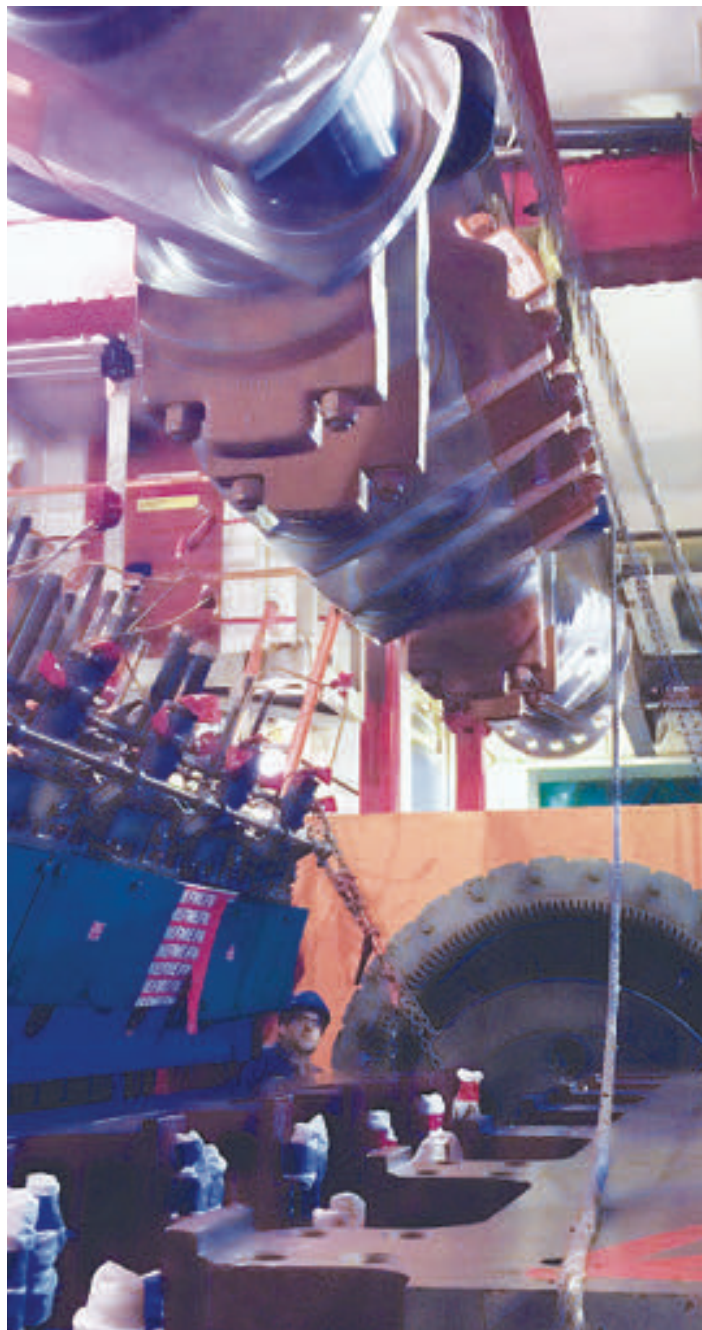
Lowering the replacement crankshaft into position

A nuclear power plant in midwestern USA experienced a bearing failure on one of its four Worthington SWB-VEE-12 backup diesel generators. The 3.5MW engine was revealed to have crankpin journal damage, leading to concern that excessive heat may have introduced high hardness to the shaft. Goltens was requested to inspect and advise, and Goltens in-situ technicians mobilized immediately to conduct an inspection of the 40 year-old engine.

Goltens determined it could repair the crankshaft but discussions with the plant and the engine OEM revealed that employing these standard procedures would be unacceptable, preventing the engine from operating at the plant's required 3.5MW load requirement under strict nuclear standards.

longer than normal, due to the strict regulations and procedures in place. Teaming up with the plant's technical resources, Goltens completed the replacement in 61 days. Upon successful completion of the work, plant management offered this praise:

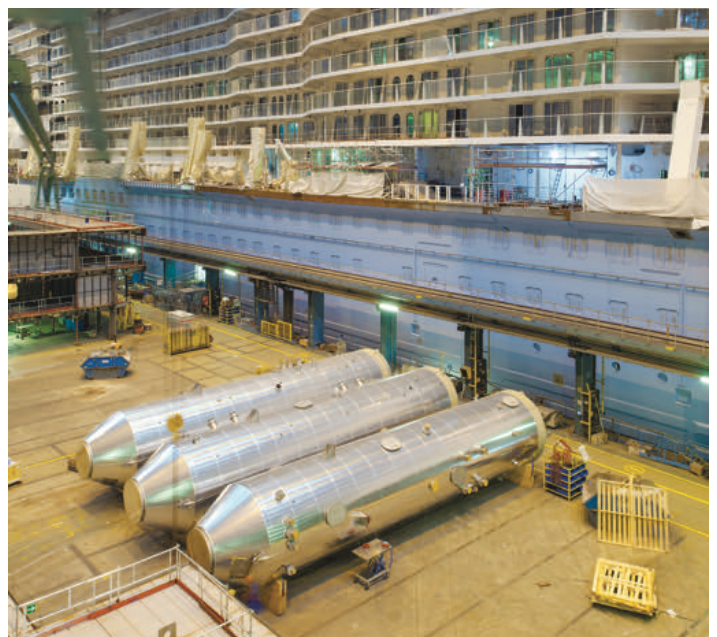
Yara scrubbers ready for installation on Norwegian Escape

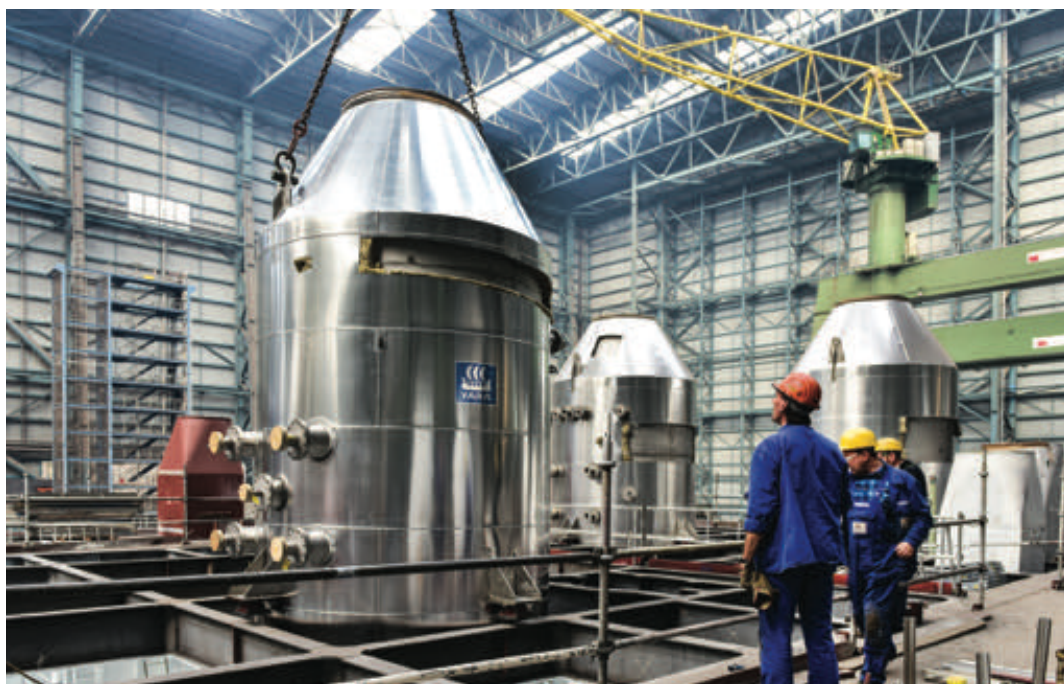
Yara Marine scrubber at the factory

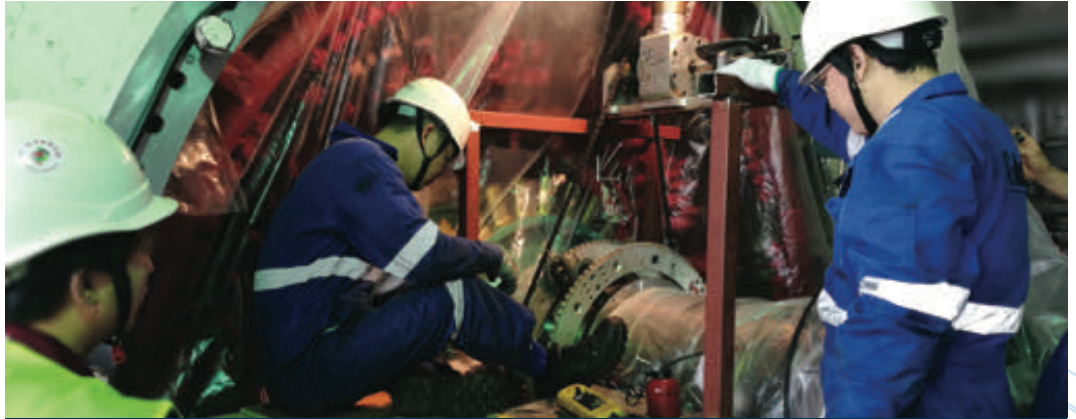
In-place machining of steam turbine rotor shaft in four days – Atlas Enerji, Turkey

Goltens' in-place machining team completed the repair of the 600 MW turbine generator's 500mm diameter journal in just 4 days. Goltens completed the repair 2 full days earlier than the 6 days initially proposed allowing the power plant to keep up with its planned maintenance schedule.

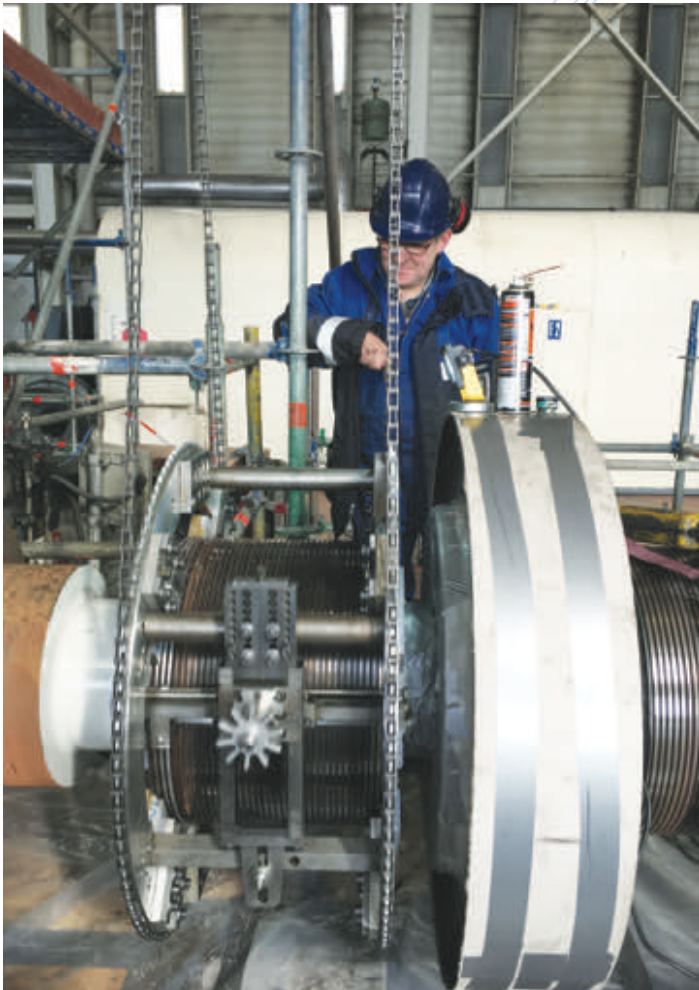
In-place machining of slip rings in the Netherlands

Goltens' In-Situ machinists deployed their single point cutting tools to machine two sets of badly worn slip rings on a 43 year old, BBC, coal fired steam turbine. Goltens completed the repair inside of 5 days minimizing the downtime of the generator for the customer.

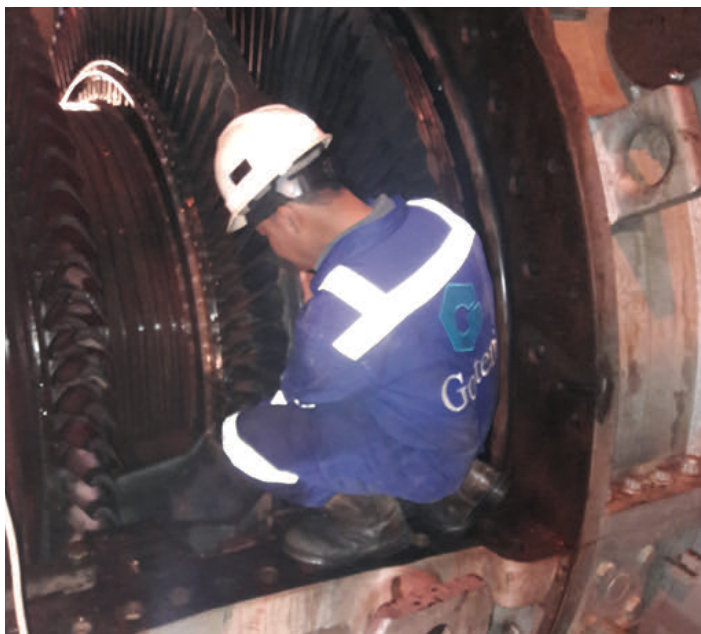
GE frame 9001 DLE troubleshooting

Goltens turbine specialists performed a hot gas path inspection to isolate the damage to a 107MW GE Frame 9001 DLE turbine. Goltens isolated the primary damage on the cross fire tube, combustor liner, and first stage bucket and secondary FOD damage on the turbine stage. Goltens determined the damage was caused by poor HSD fuel quality and provided recommendations for correction. Goltens repaired the damage and rebuilt the turbine.

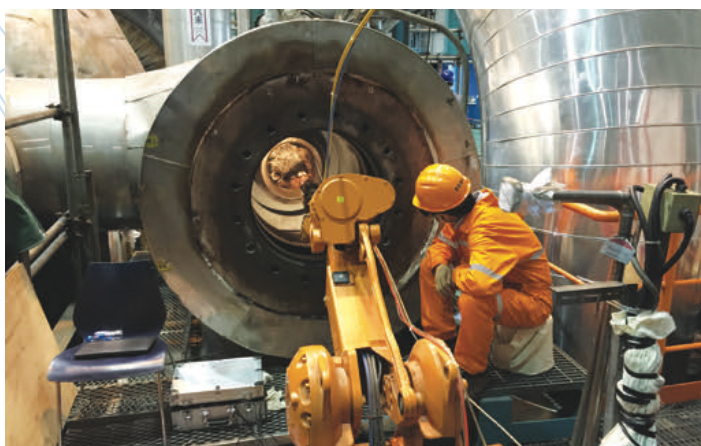
In-Situ laser cladding & machining for Shanghai Steam Plant

Goltens pre-machined, laser clad and finish machined four HPSV, HPCV, ISV and ICV valve seats to original dimensions for two 900 MW Siemens THDF 125/67 coal-fired supercritical thermal units.

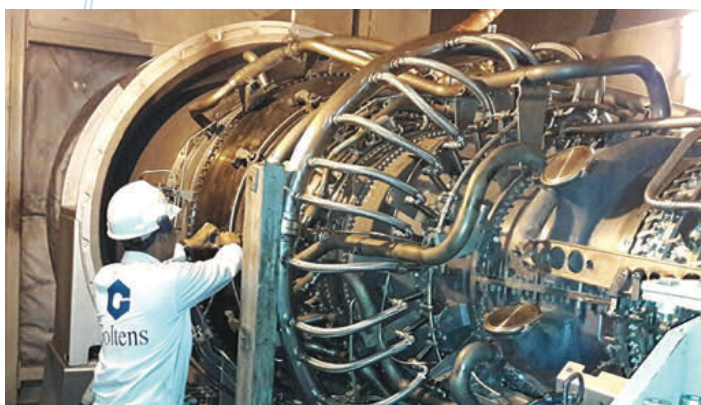
General Electric 7LM6000 gas turbine powerplant repair – Indonesia

Goltens was brought in to troubleshoot problems on a GE 7LM6000 and discovered chipped gear teeth on the 7LM6000 turbine's gear box. To limit expense and downtime, Goltens used selective electroplating to repair the damage to the chipped teeth. Once complete, Goltens specialists reassembled the gear box and laser aligned the gear box to the turbine output shaft.

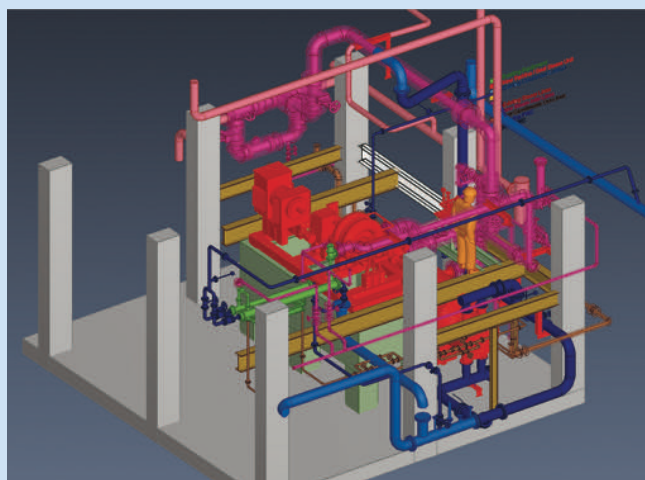
New STG Model with complete piping layout

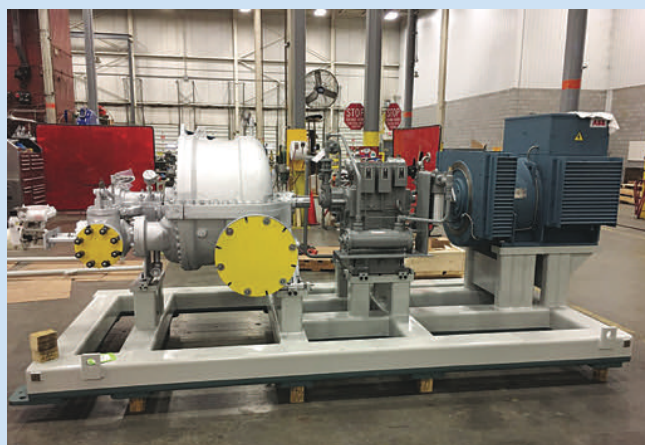
415KW Elliott Model 2DYR3 condensing steam turbine

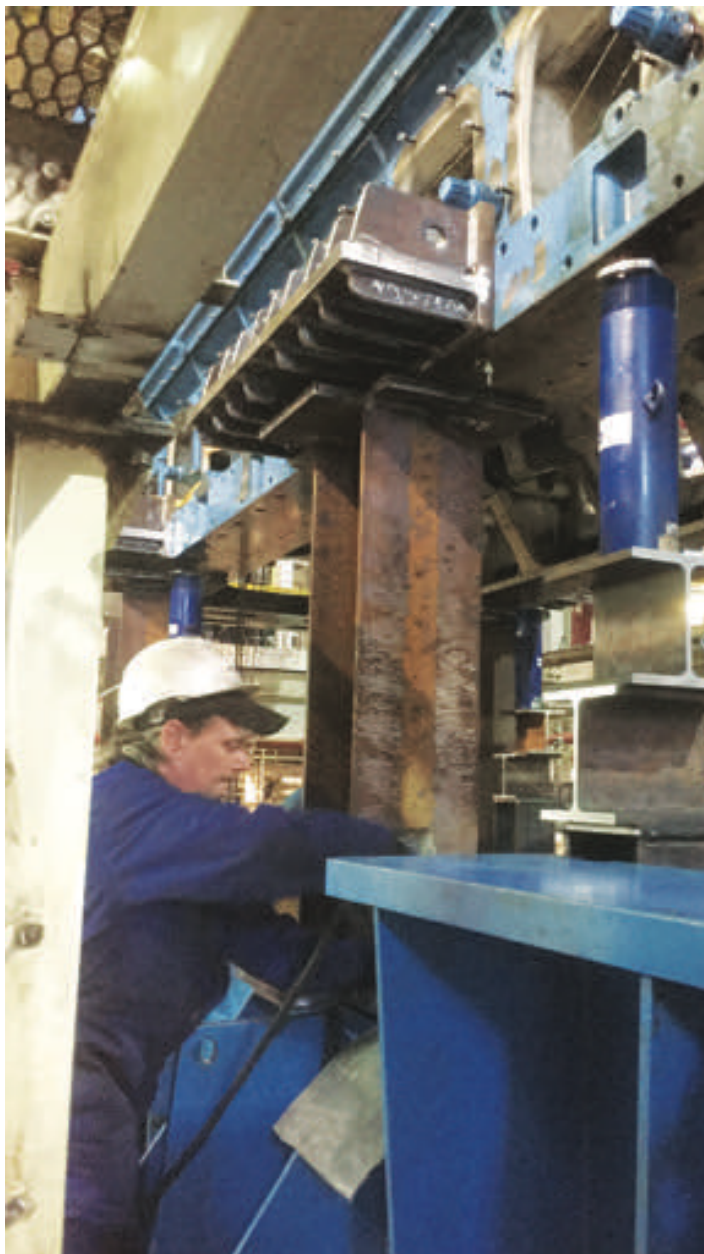
Steel supports installed under prefabricated braces at the completion of lifting operations prior to removal of crankshaft

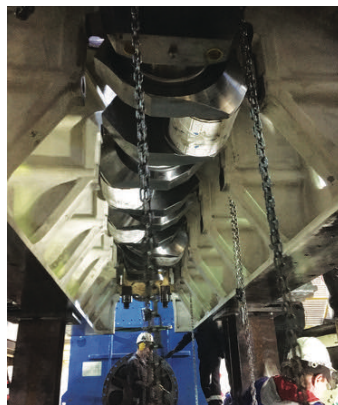
Replacement crankshaft lifted up into place under the engine block

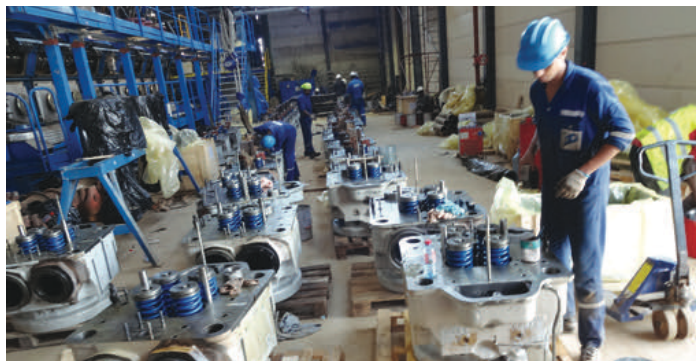
Overhauling of cylinder heads in powerhouse

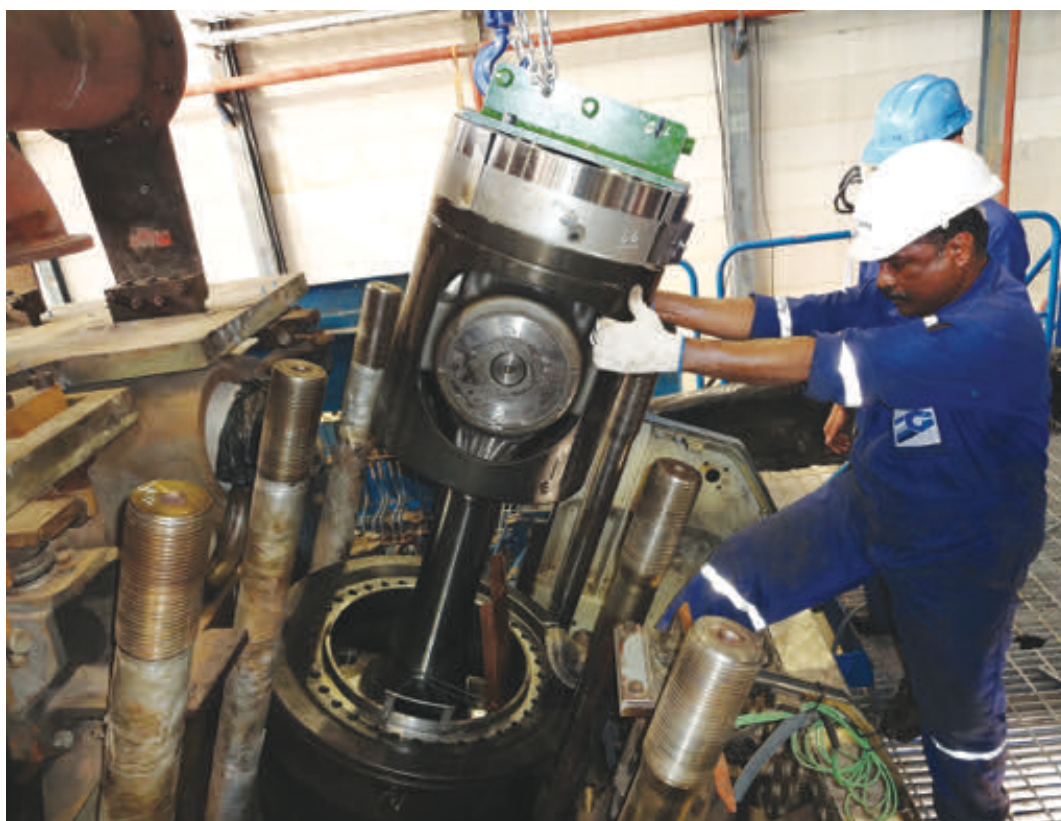
Installation of piston assembly during rebuild

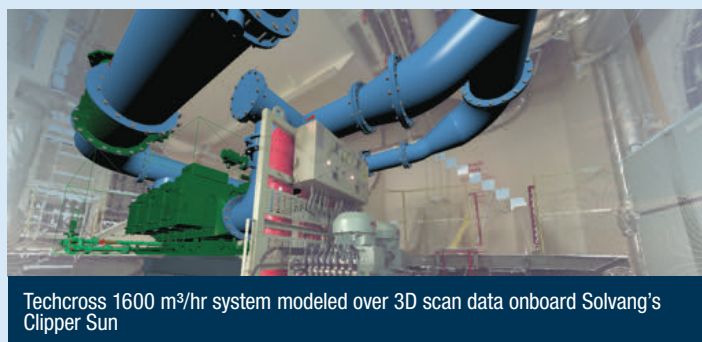
Techcross 1600 m³/hr system modeled over 3D scan data onboard Solvang's Clipper Sun

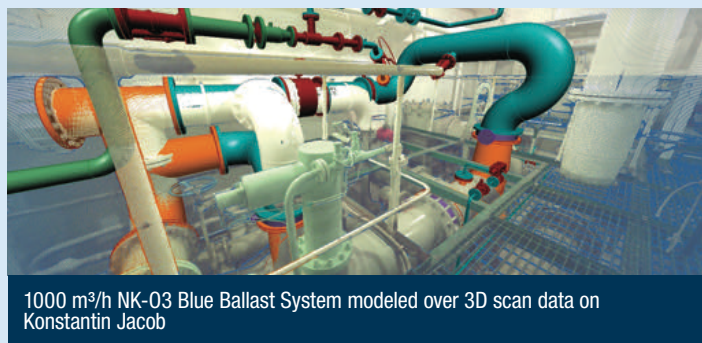
1000 m³/h NK-O3 Blue Ballast System modeled over 3D scan data on Konstantin Jacob

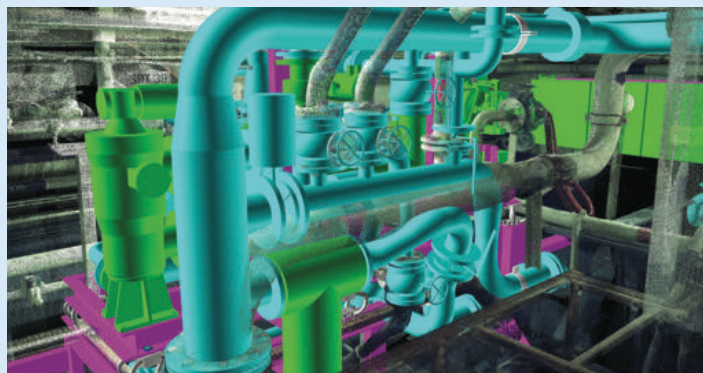
Optimarin OBS system modeled over 3D scan data on the frigate Zr.Ms. Evertsen

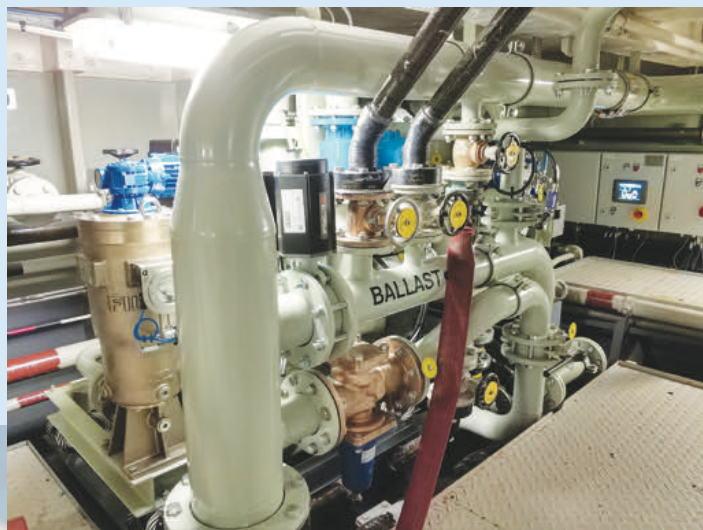
Optimarin OBS installed onboard frigate Zr.Ms. Evertsen

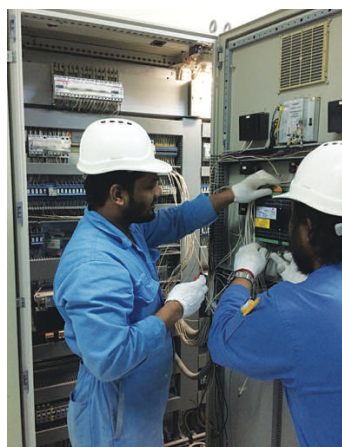
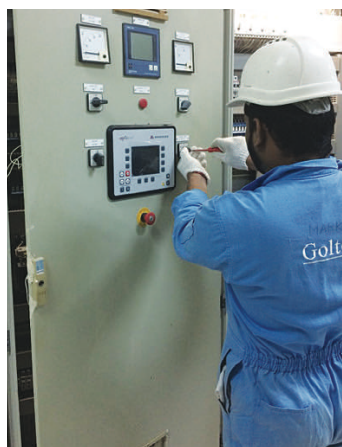
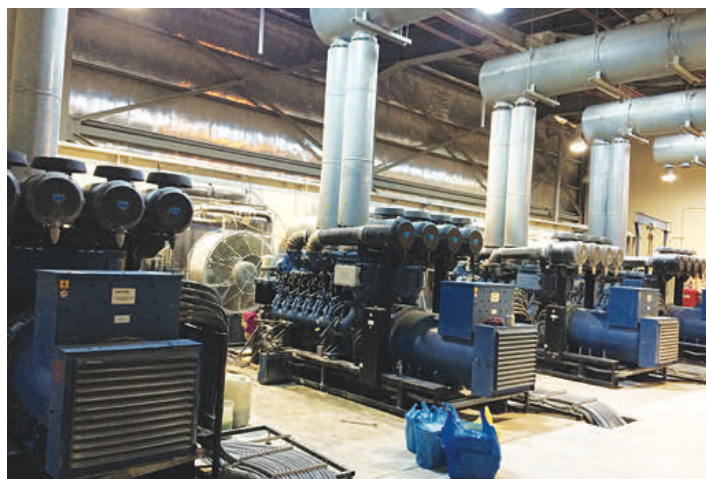
Goltens governor technicians performing upgrade of four Woodward AMG2 controls to easYgen 3500XT-P2 Genset Controls at Al Watana Gypsum Company in Inbu, Saudi Arabia. The original controls on the 15 year-old 1400KVA MTU generators were obsolesced and two of the four units had failed, requiring replacement to restore the plant to full operation. The total project was completed in 14 days.

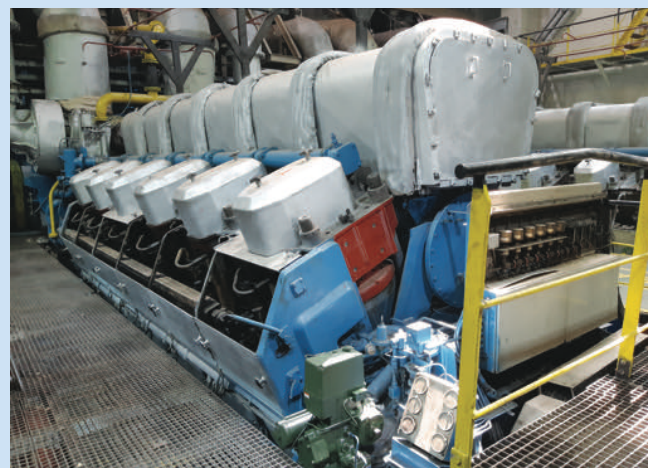
PG-EG actuator (bottom center) installed on the newly overhauled Wartsila 12V46 in Sierra Leone

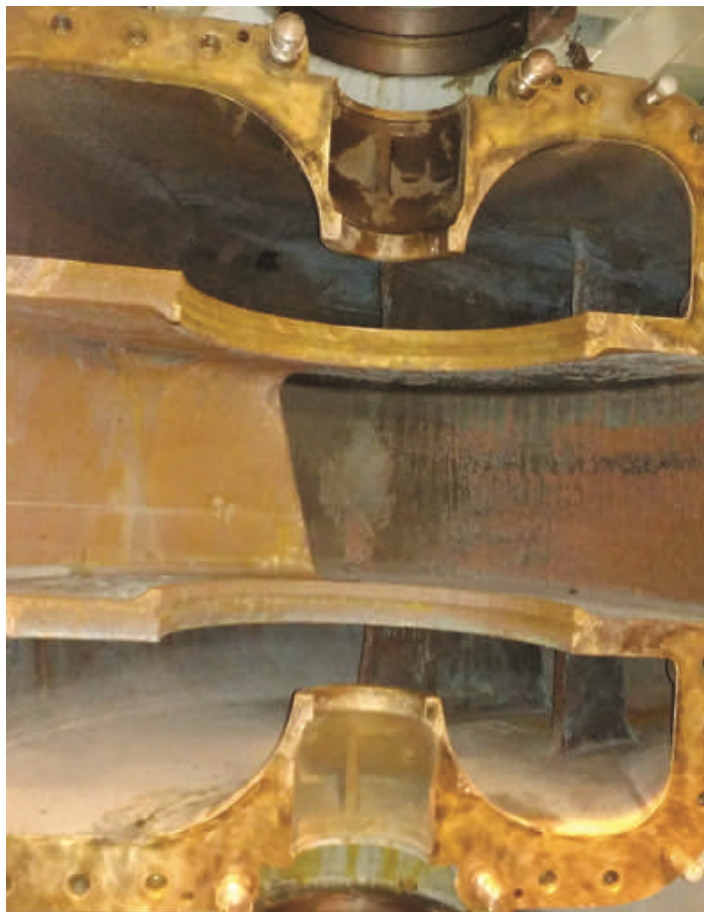
Heavily worn pump casing prior to repair

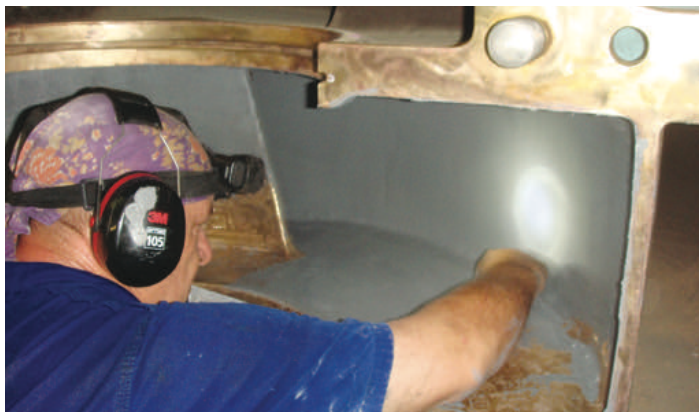
Goltens technician applying Belzona to pump casing

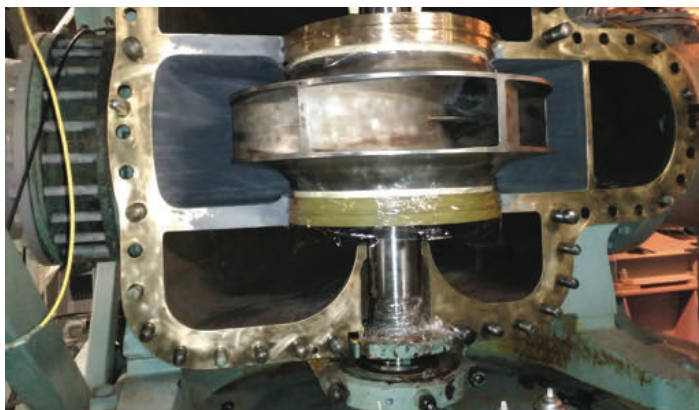
Pump assembly after casing refurbishment

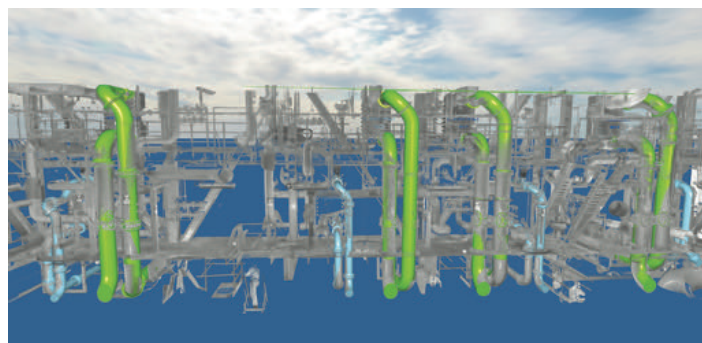
3D modeled piping overlaid on 3D scan data

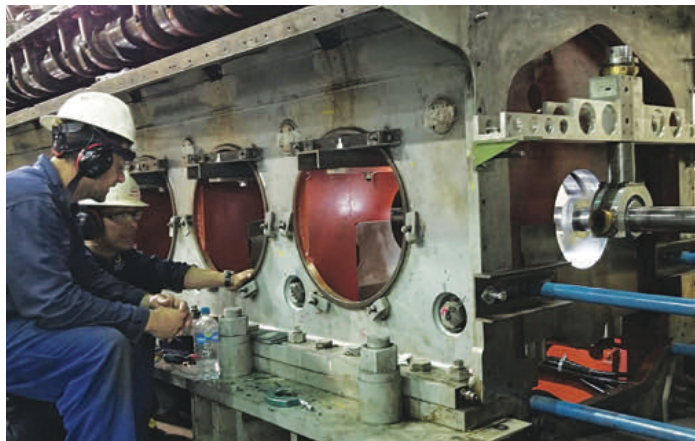
Goltens In-Situ specialists completing line boring on Niigata 18PC2.6-2 in Colombia

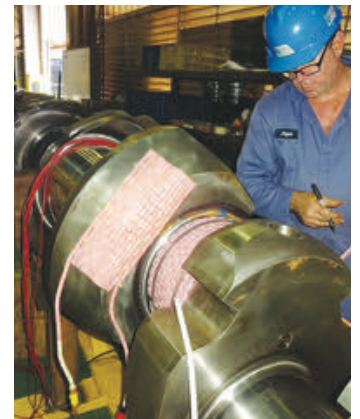
Goltens technician applying ceramic annealing tiles to the damaged main journal for heat treatment

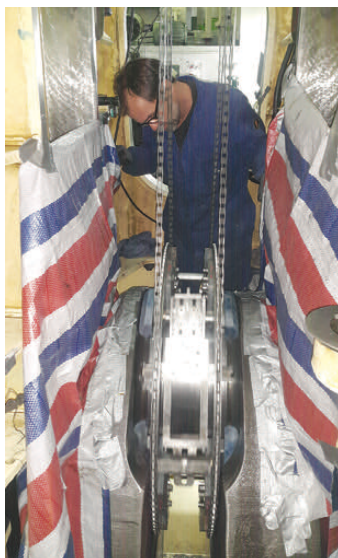
Machining of damaged/dented crankpin journal

Goltens' machined 7.69mm and 5.70mm from the two 560mm main journals to remove the surface cracks caused by the bearing failures. As a result, the hardness on both main journals was returned to acceptable limits. The main journals were then honed and polished before moving on to the damaged crankpin. Goltens machined 4.5mm of material to remove the dents and restore the surface. All were inspected and accepted by vessel's class and the ship returned to service. ■

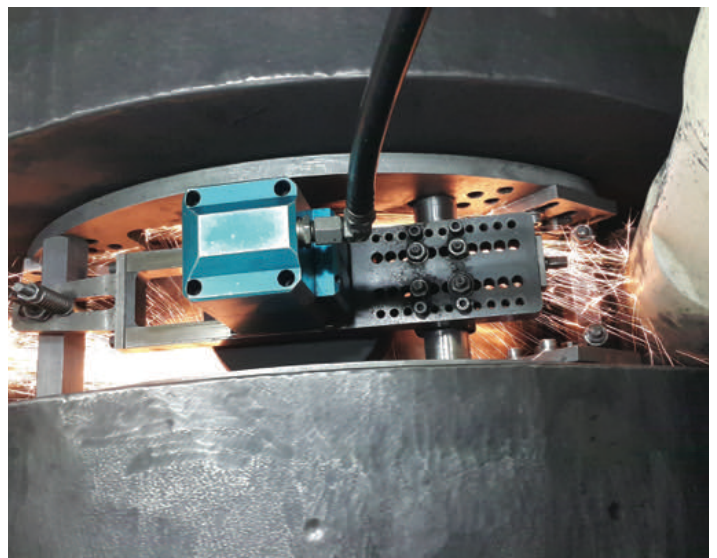
Grinding of main journal after machining

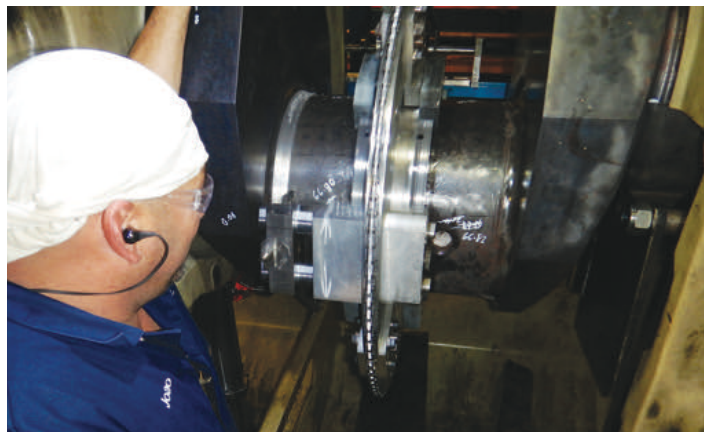
Machining new fillet radii after annealing completed

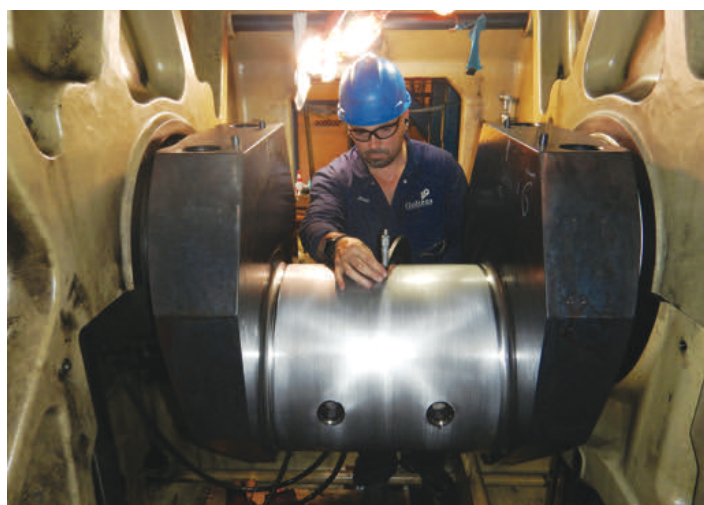
Final calibration checks on repaired crankpin after annealing and machining completed

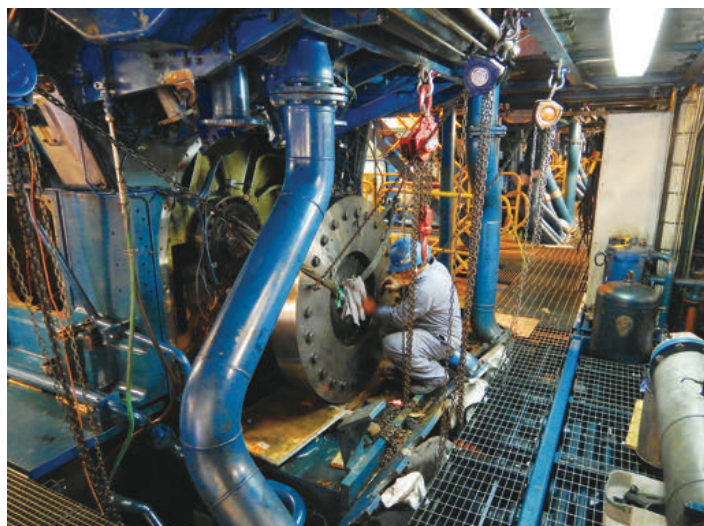
Removal of vibration dampener for overhaul

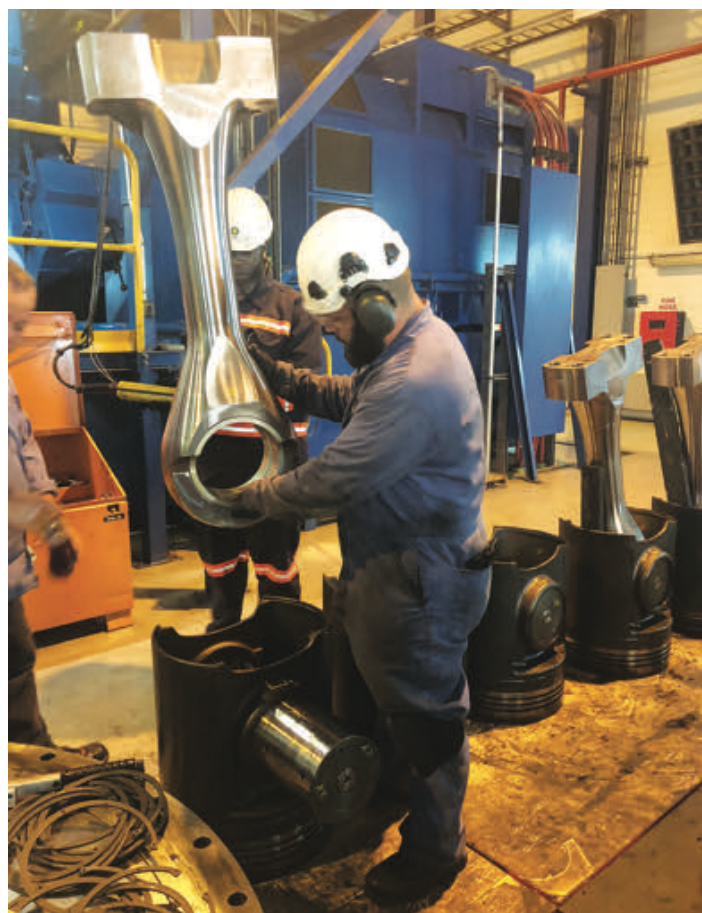
Lowering connecting rod to reconnect to piston

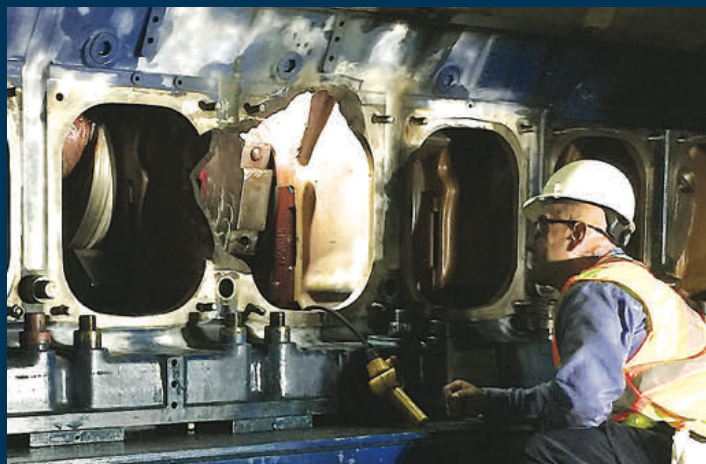
Goltens In-Situ Machinists inspecting the exterior block damage

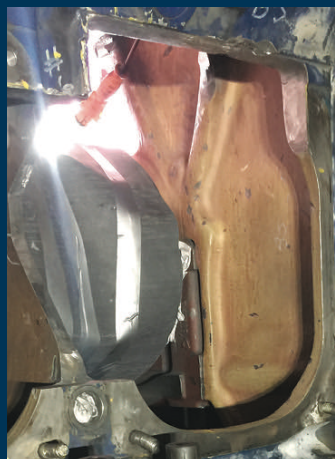
Damaged section of block cropped for cast insert

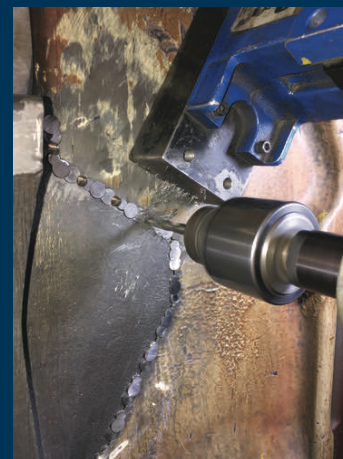
Stitching pin insertion on center wall insert

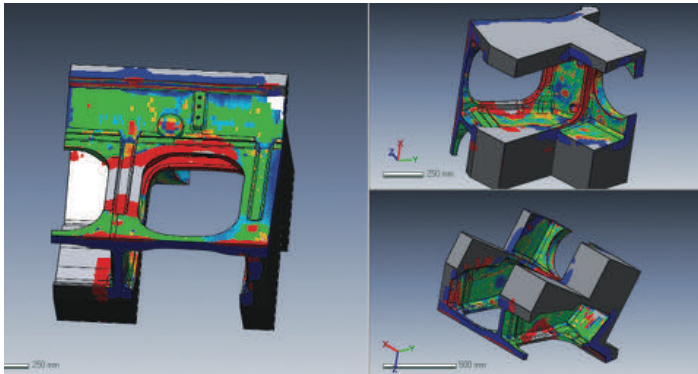
3D Laser scan of block damaged section of the block

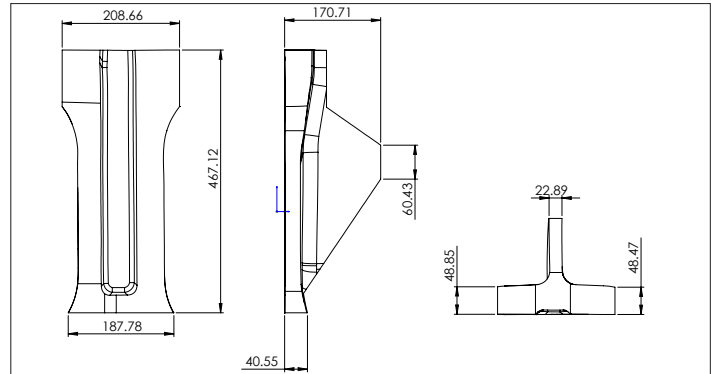
Design for center wall cast insert from laser scan data

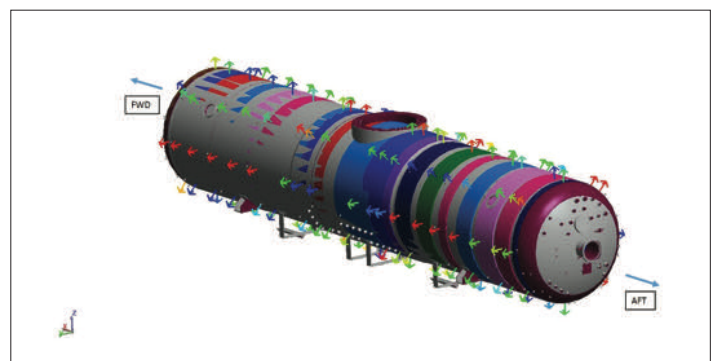
Measurement of total chamber length (26 sections)

The 3D dimensional check and detailed report provided a clear and concise picture of the as-built condition of the chambers, allowing the customer to verify whether deviations were within tolerances, also providing the customer with the cause of deformation to determine the surface machining process required. ■

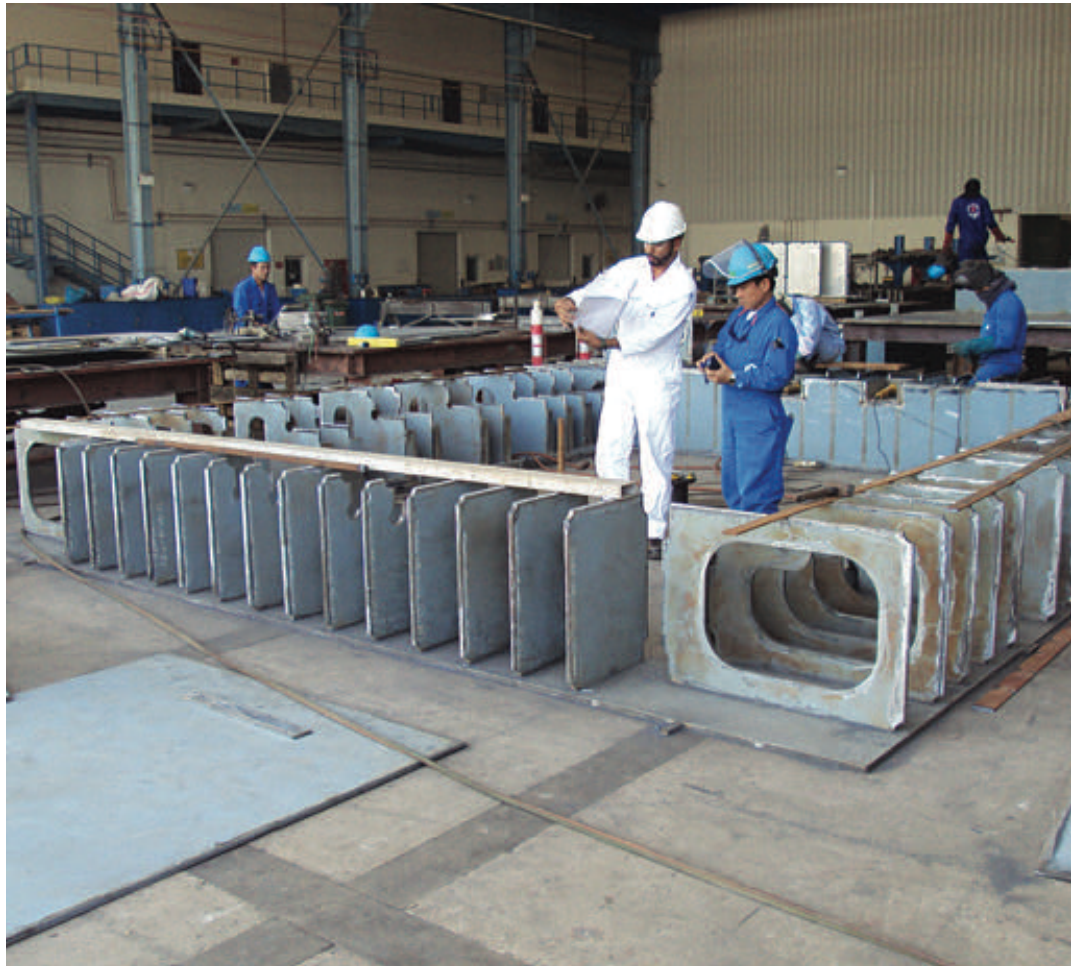
Fabrication of blast door in progress at Goltens Dubai
