STEAM TURBINE BULL GEAR ON-SITE MACHINING OF MAIN JOURNALS

PROJECT STATS: STEAM TURBINE BULL GEAR

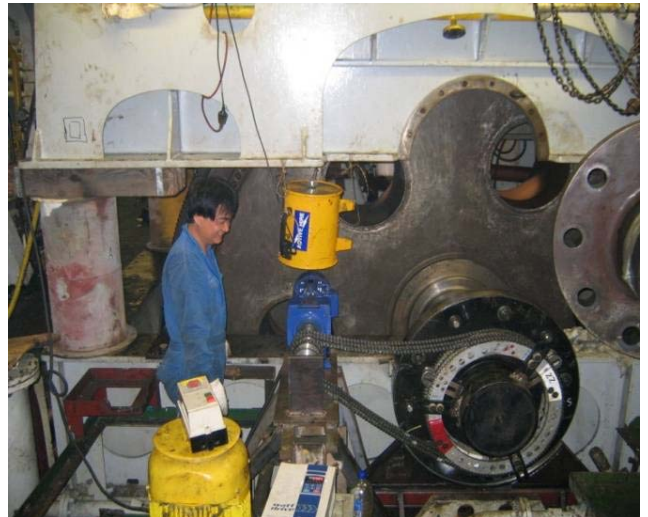
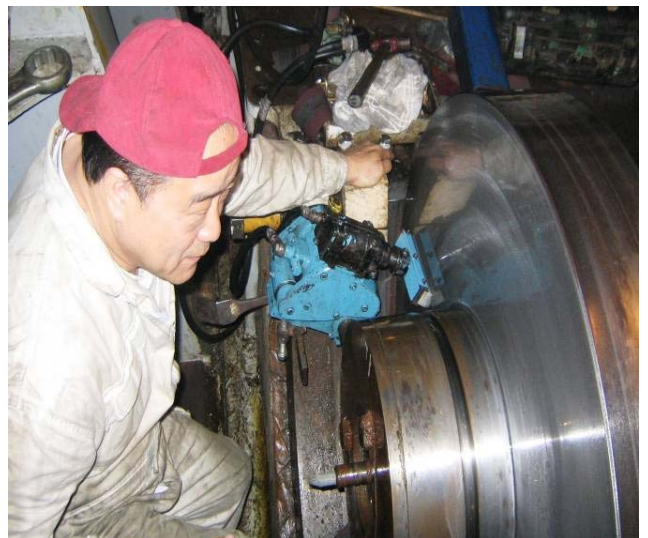
Goltens was approached by an Australian shipyard to come up with an In-Situ solution to save a damaged steam turbine bull gear for the main propulsion shaft on a vessel.

Based on the In-Situ machining experience and expertise gained over the last 60 years in the Goltens group of companies, Goltens made a proposal for repair of the damaged 539mm diameter main journals In-Site.

- Manufacture of white metal bearings for temporary support of the gear
- Grinding of both main journals until free of damage
- Blue fitting of surface with dummy bearing
- Super polishing by special honing machine
- Super polishing of the thrust face

After 14 days of long working hours, the bull gear repair was approved by the maker. The end result for the owner were dramatically reduced costs and an accelerated return to service as a result of engaging Goltens to perform the work In-Situ.
