OVERHAULING OF 10MW STEAM TURBINE & GENERATOR SET BY GOLTENS INDIA

LONG LEAD TIME AND COST LEADS TO COMPLETE OVERHAUL OF TURBINE IDLE FOR 10 YEARS

PROJECT FACTS: STEAM TURBINE GENERATOR Location: Goltens India Workshop, Mumbai Rating: 10MW Years Idle: 10 Years

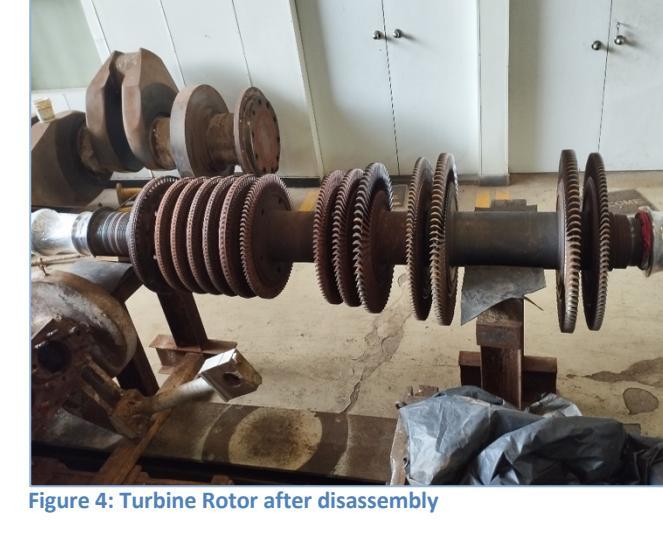
Figure 5: Run out checks on Rotor

After replacement of 8 damaged turbine rotor blade stages, dynamic balancing, and reassembly, run out and clearances were checked and brought within OEM allowed tolerances. Blue contact checks were completed and a joint inspection with the customer and the end user was successfully completed. The entire generator set was then sprayed with a preservative coating and reassembled.
